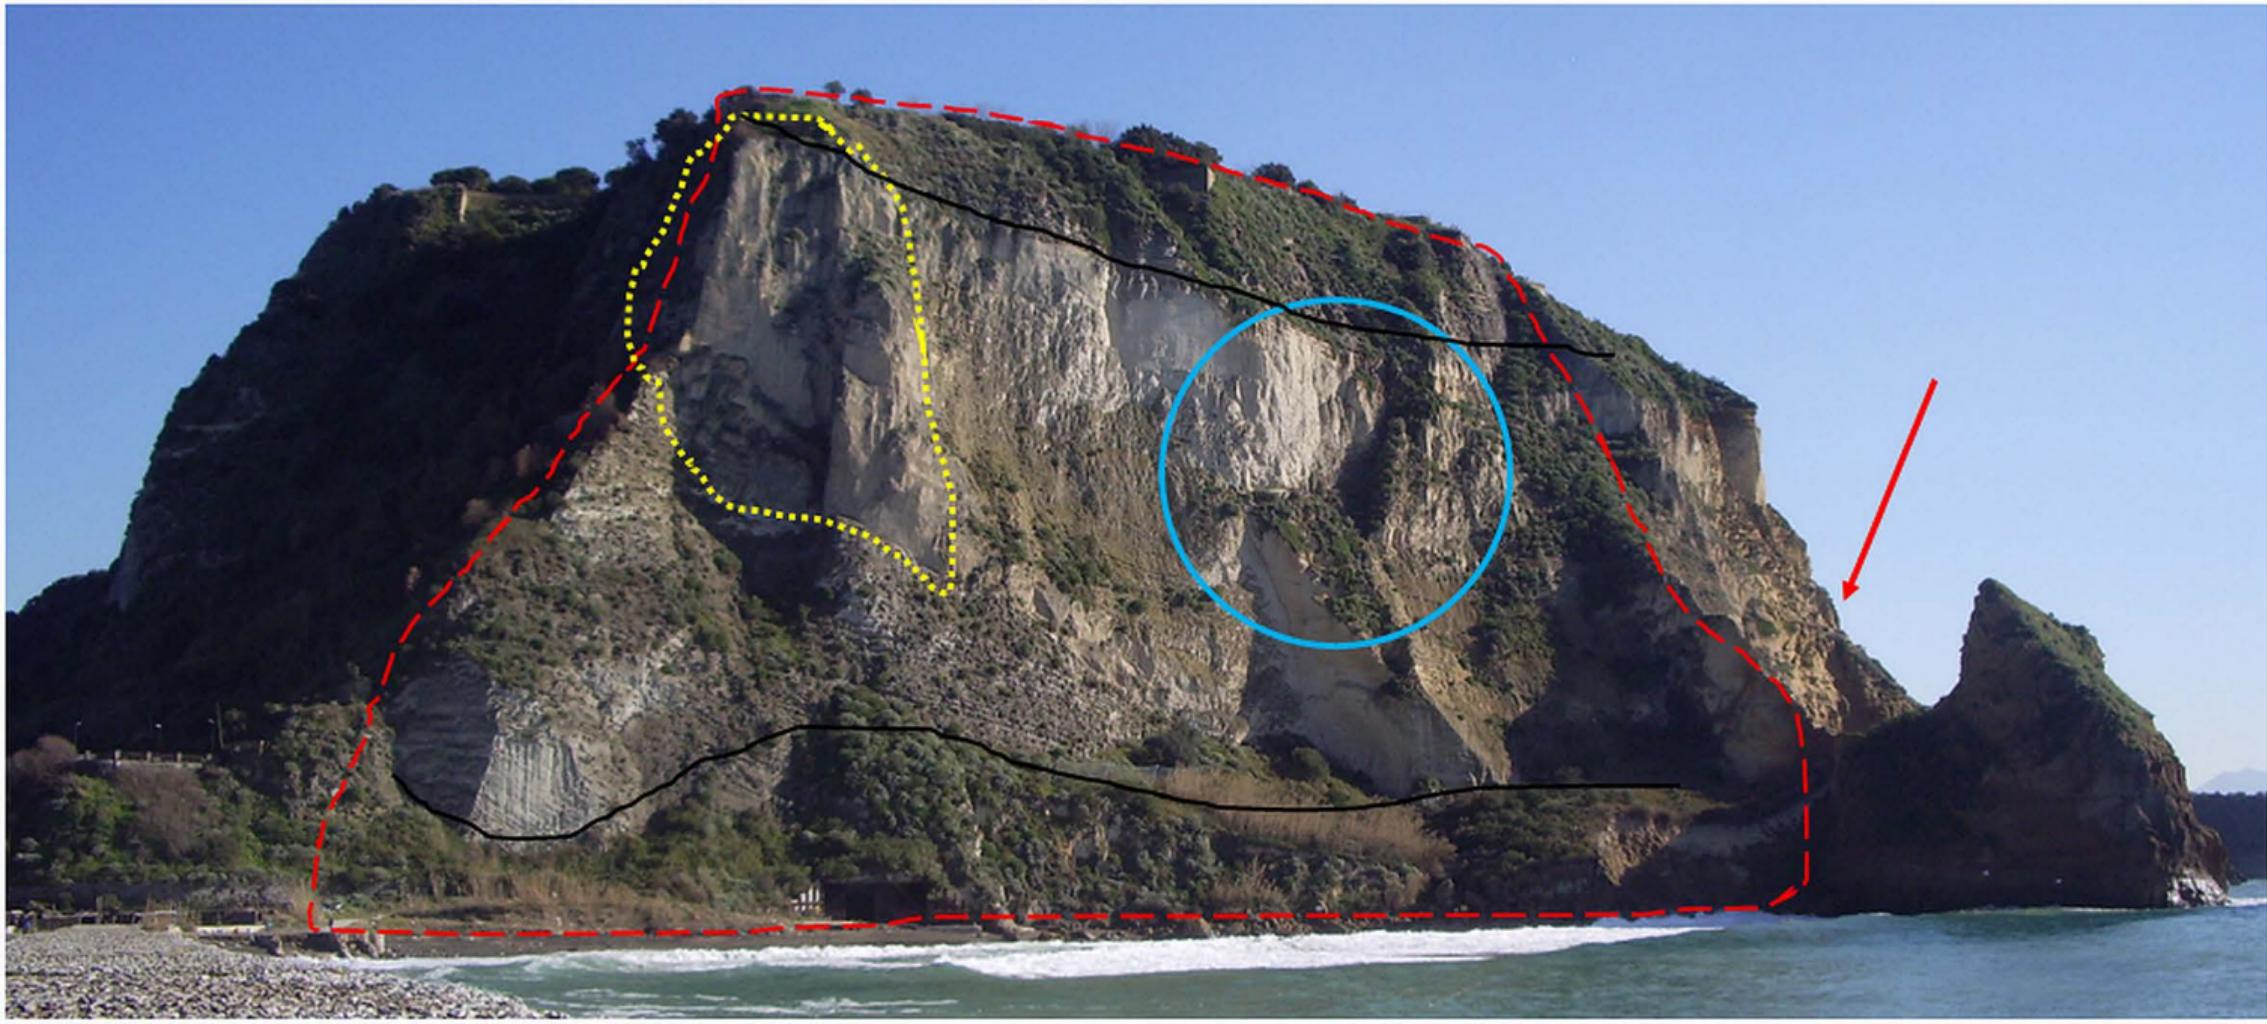
**Figure 2:** Coroglio cliff view from WSW. Red dashed line shows the area mapped in Fig. 3; yellow dotted line shows the area involved by reinforcement works; light blue circle shows the area with unstable tuff blocks; red arrow shows the detachment area of the failure occurred around 1990, located outside the area mapped in Fig.3. Black lines separate upper, median and lower parts of the cliff.

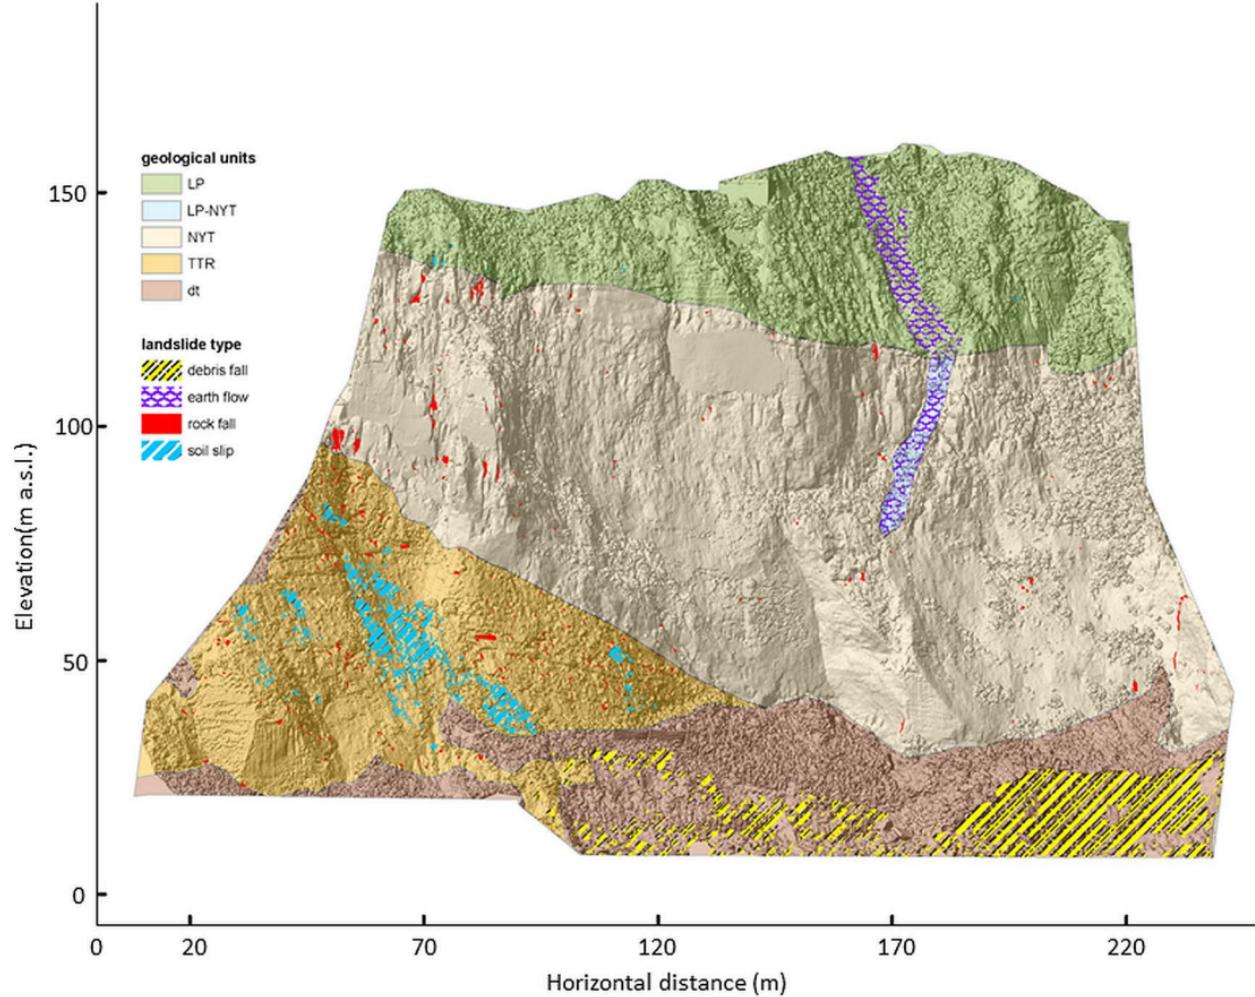
**Figure 3:** Geological vertical map of the Coroglio cliff (modified after Matano et al., 2016). Landslide types occurred during 2013-2015 interval (Caputo et al., 2018) are also showed. Geological units: LP, stiff to loose recent pyroclastic deposits and soils; LP-NYT, thin layer of LP deposits on NYT unit; NYT, Neapolitan Yellow Tuff; TTR, Trentaremi Tuff; dt, slope talus breccia and gravelly beach deposits.

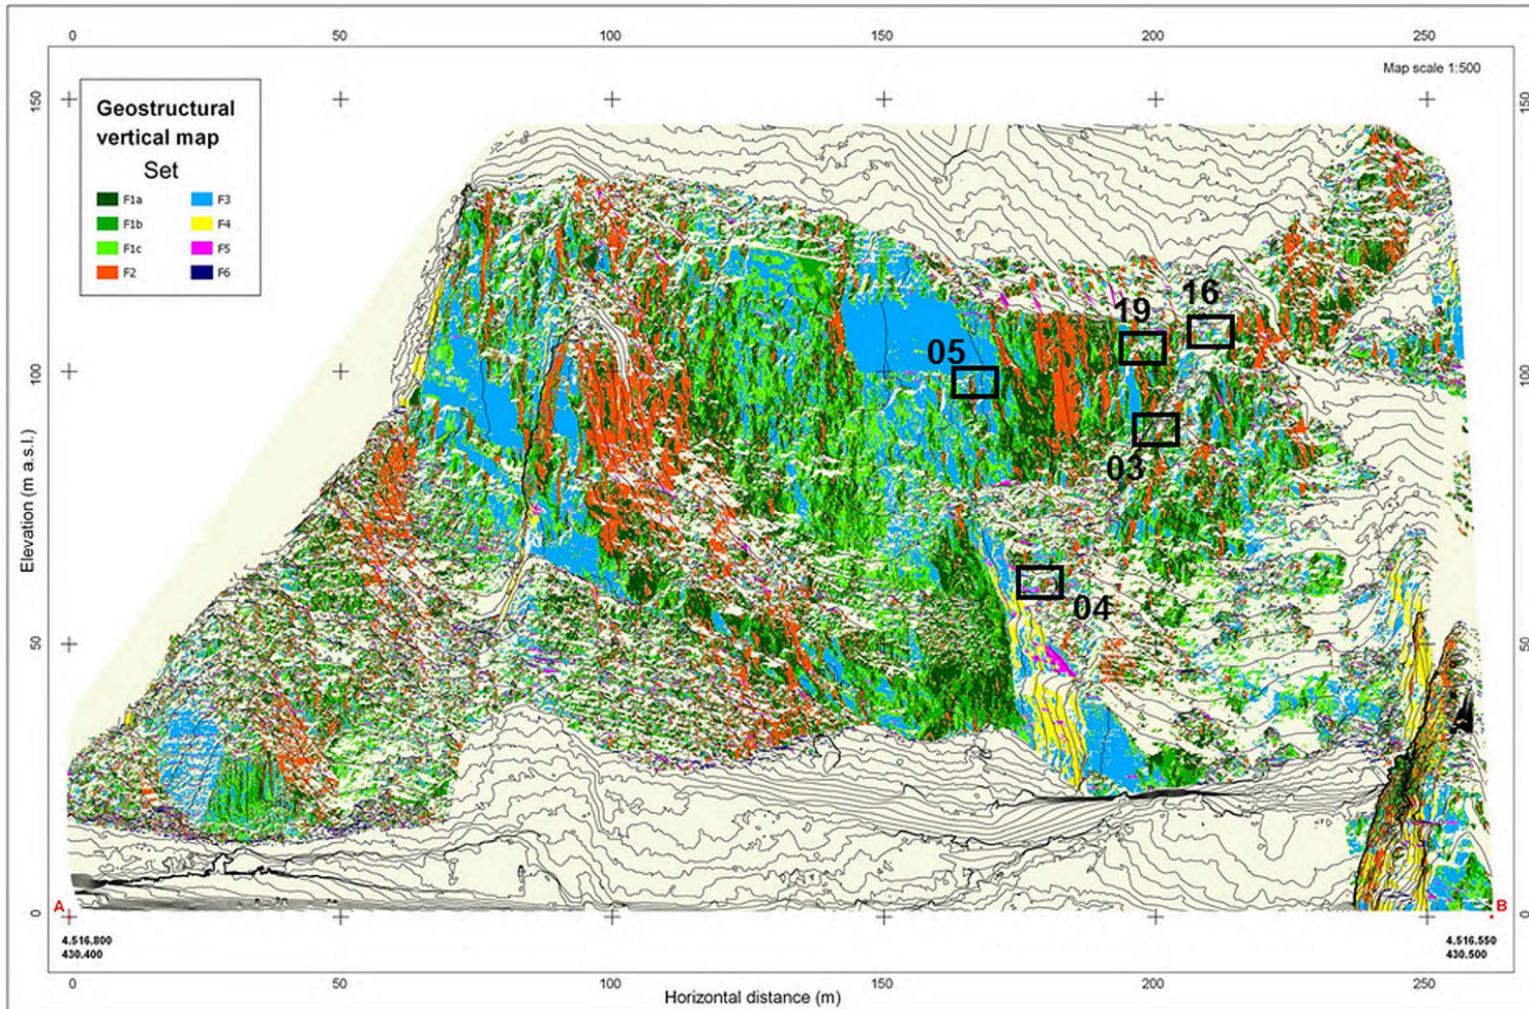
**Figure 4:** Geostructural vertical map (modified by Matano et al., 2016). Black boxes show location of the monitored unstable tuff blocks. Set legend (dip/dip direction): F1a (>65°/30-50° and 220-235°), F1b (>65°/50-60° and 235-245°), F1c (>65°/55-65° and 245-255°), F2 (>65°/0-30° and 180-220°), F3 (>70°/60-110° and 255-280°), F4 (>70°/110-180° and 300-355°), F5 (20-65°/50-195°), F6 (< 20°/0-360°).

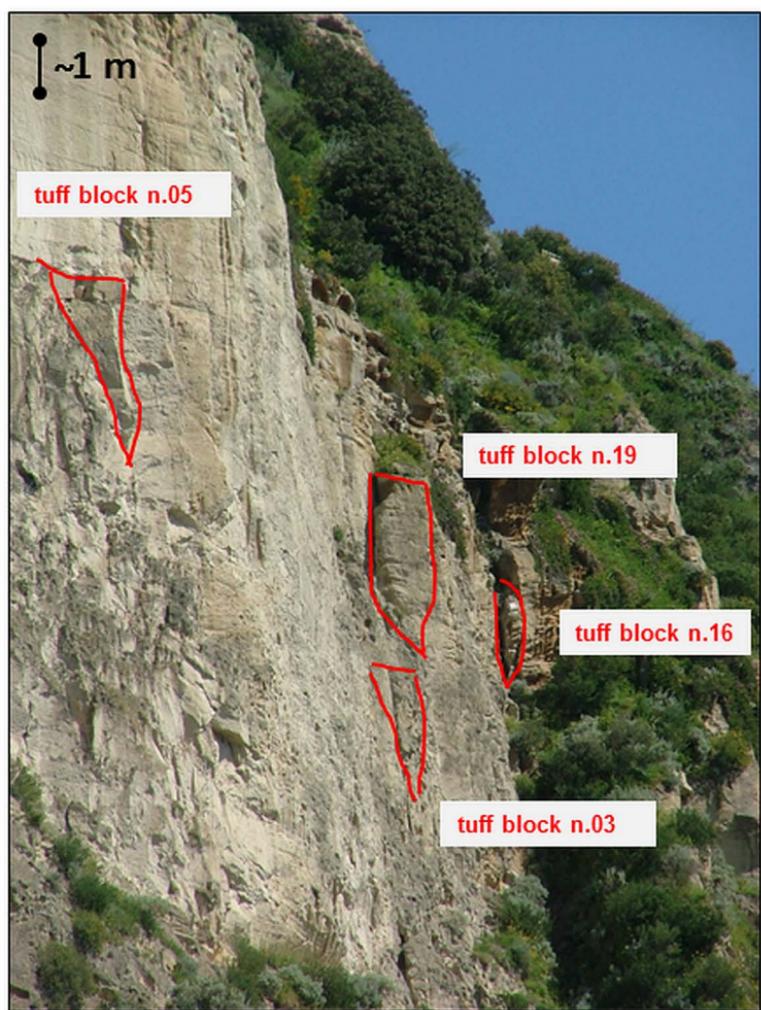
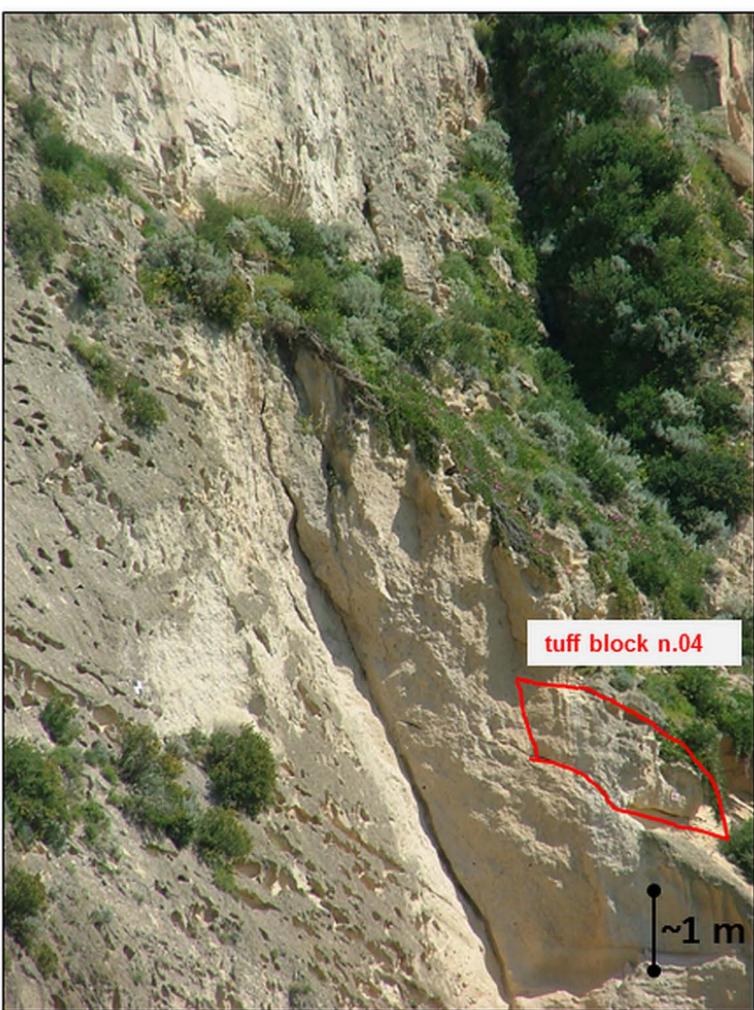
**Figure 5:** Unstable tuff blocks of the NYT unit selected for monitoring activity (red lines).

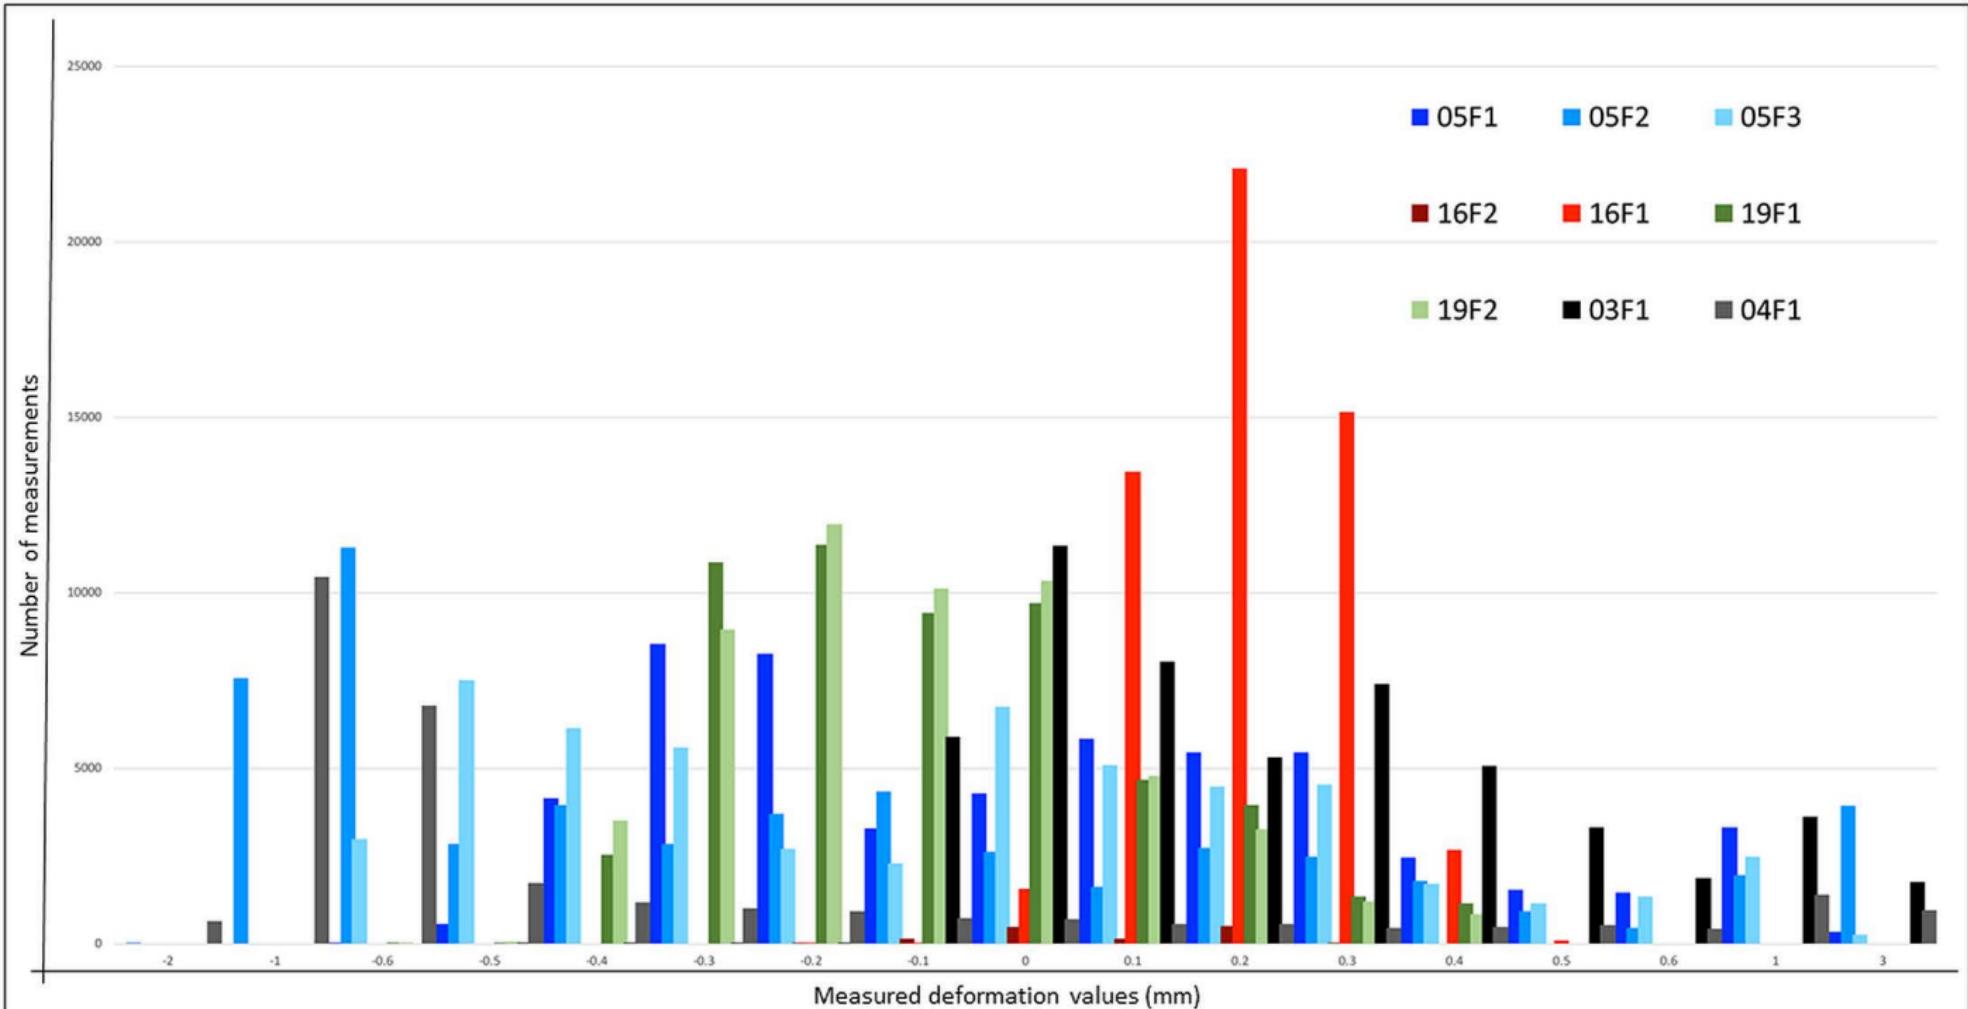
**Figure 6:** Data distribution of measurements of crackmeters (03F1, 04F1, 05F1, 05F2, 05F3, 16F1, 16F2, 19F1 and 19F2).

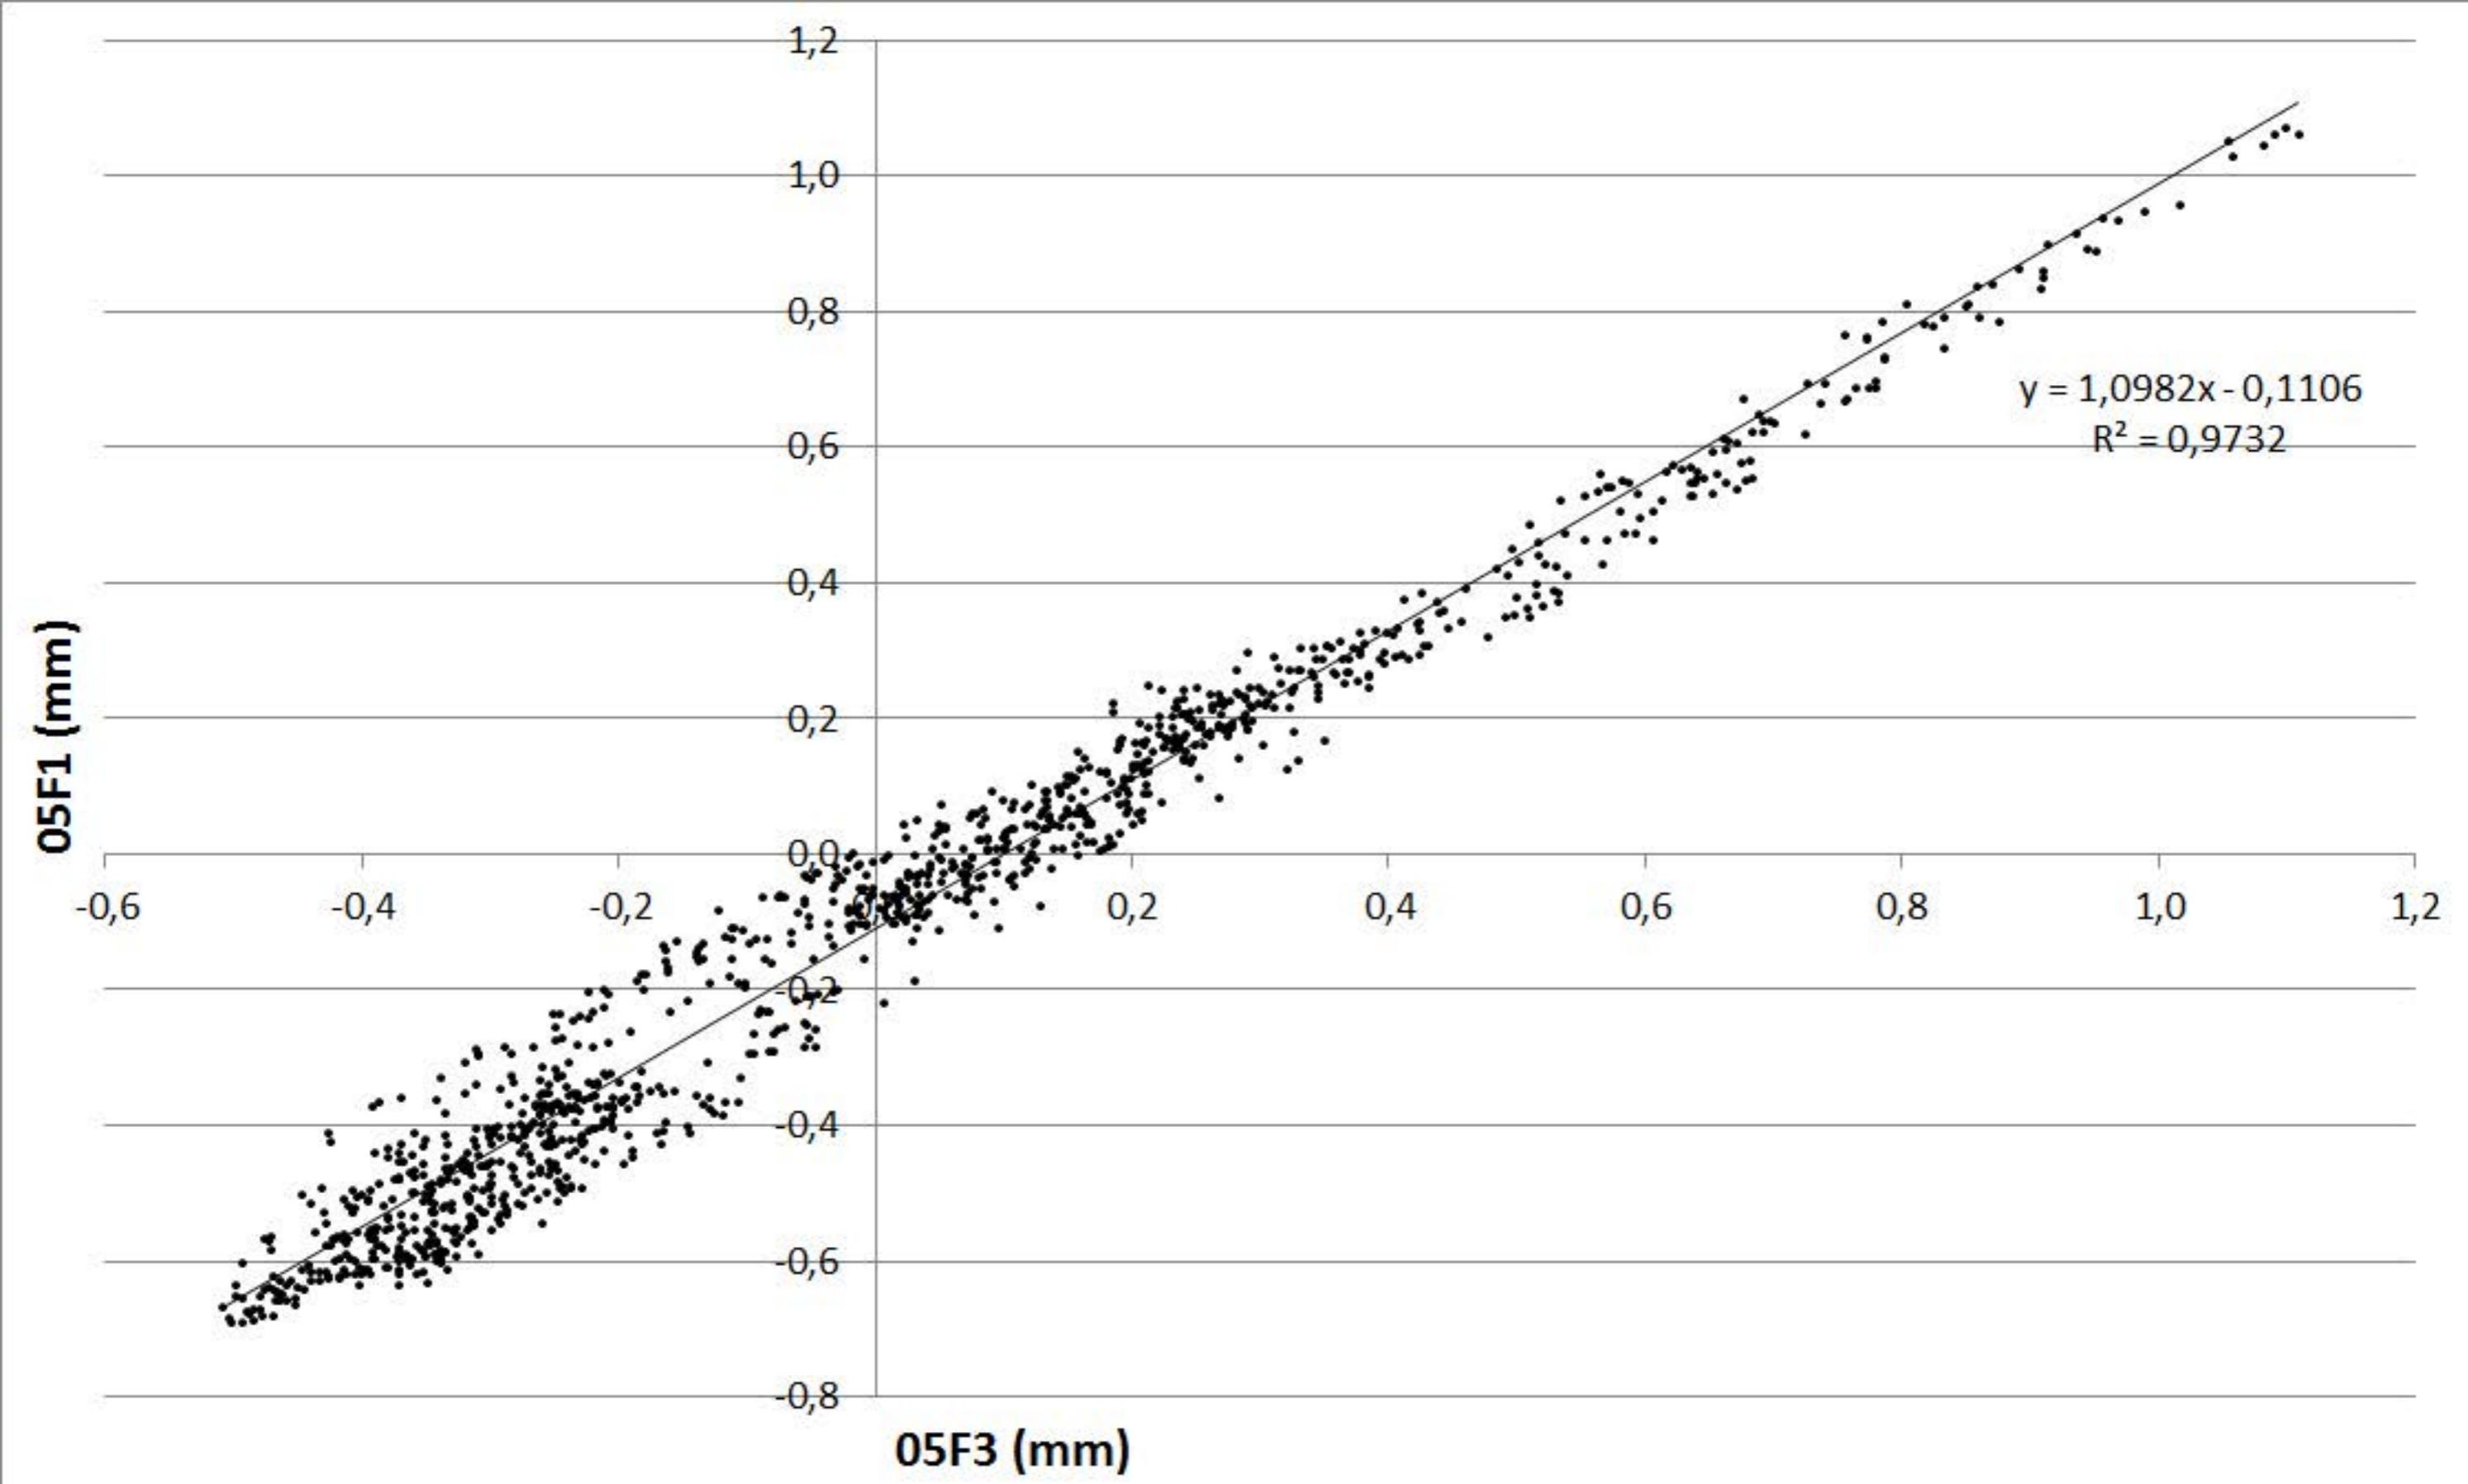
**Figure 7:** Correlation plot between 05F1 and 05F3 data.

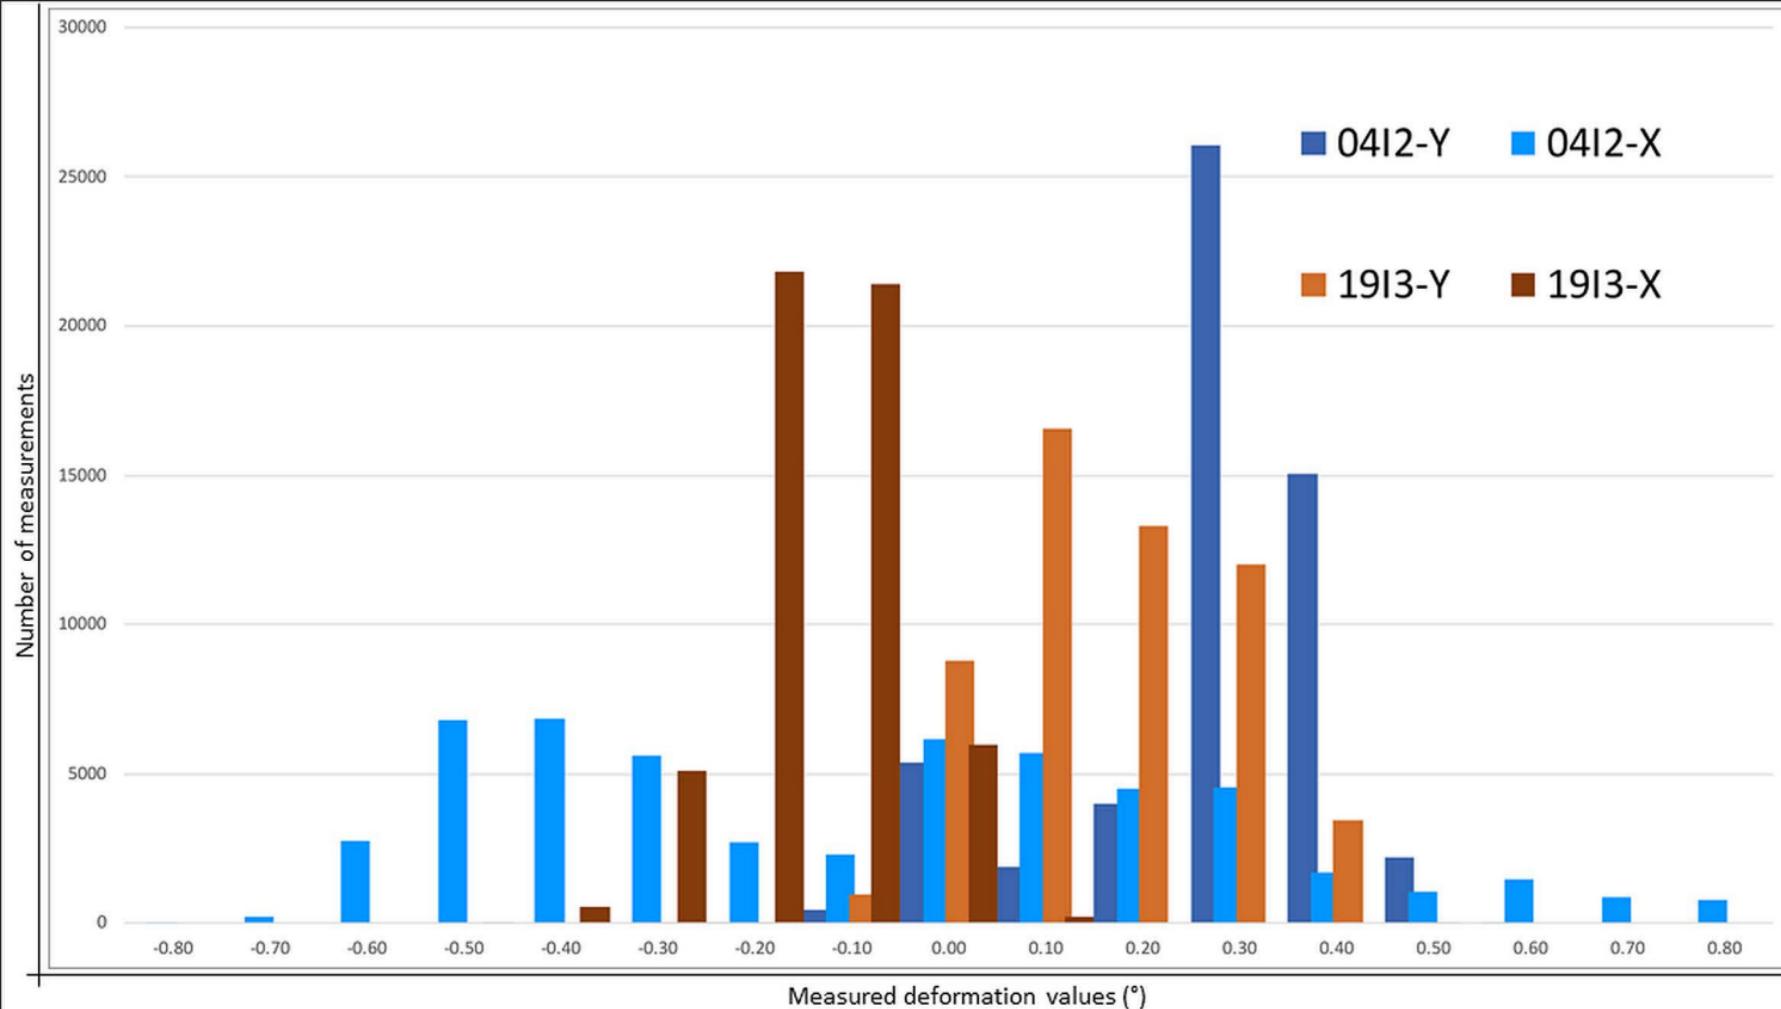
**Figure 8:** Data distribution of measurements of tiltmeters (04I2-X, 04I2-Y, 19I3-X and 19I3-Y).

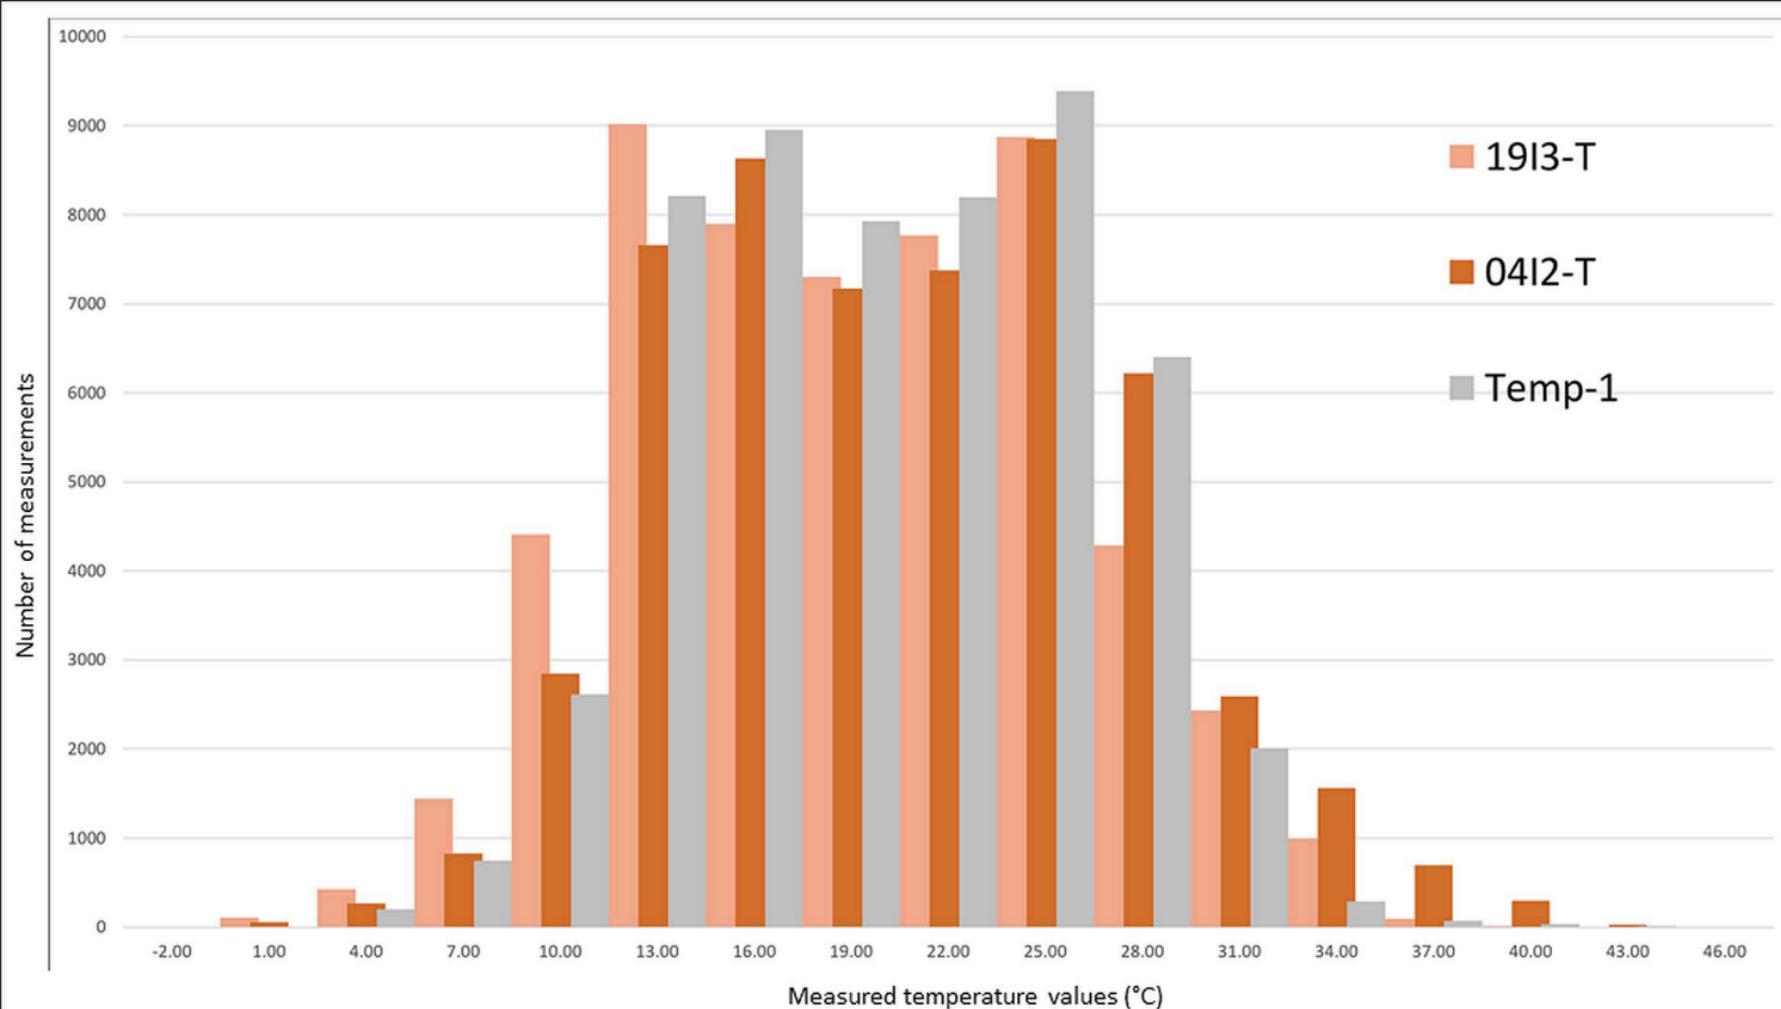
**Figure 9:** Data distribution of measurements of thermistors (19I3-T, 04I2-T and Temp-1).

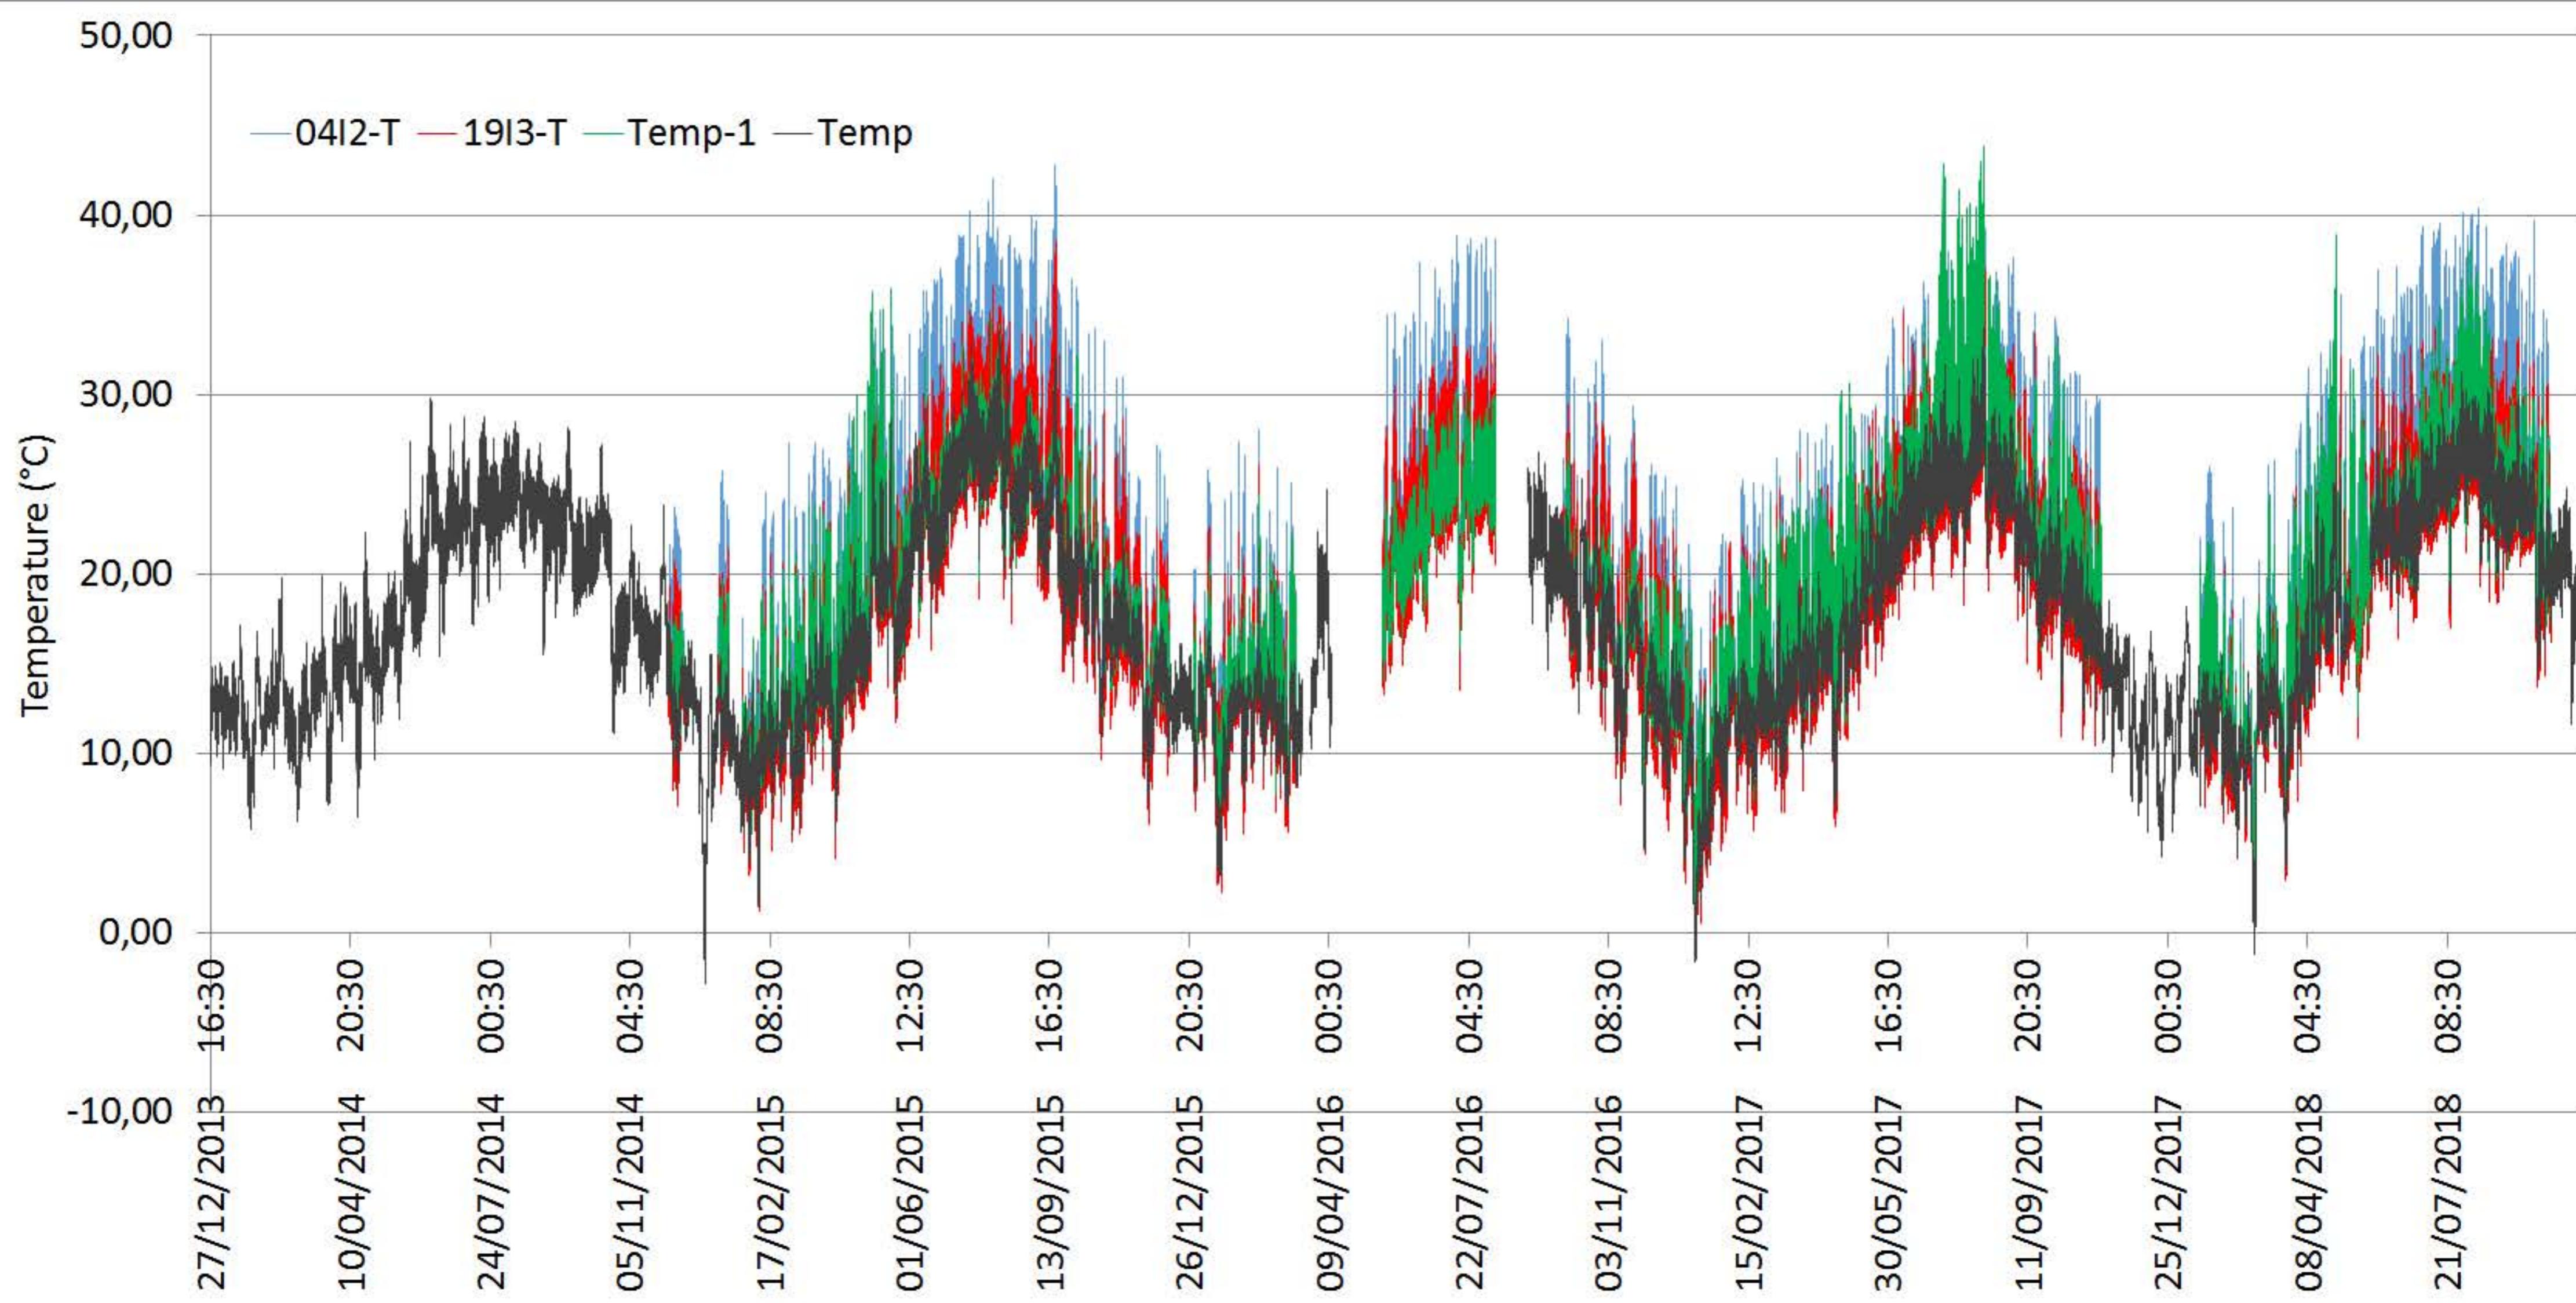
**Figure 10:** Temperature time series showing daily, seasonal and annual variation patterns. Long-term trends, based on about five consecutive years of data, show annual cyclicity. Air temperature and near-rock-surface air temperature are fully synchronous; peaks in near-rock-surface air temperatures (19I3-T, 04I2-T and Temp-1) are sometimes higher than those of air temperature (Temp). Data are incomplete in some months.

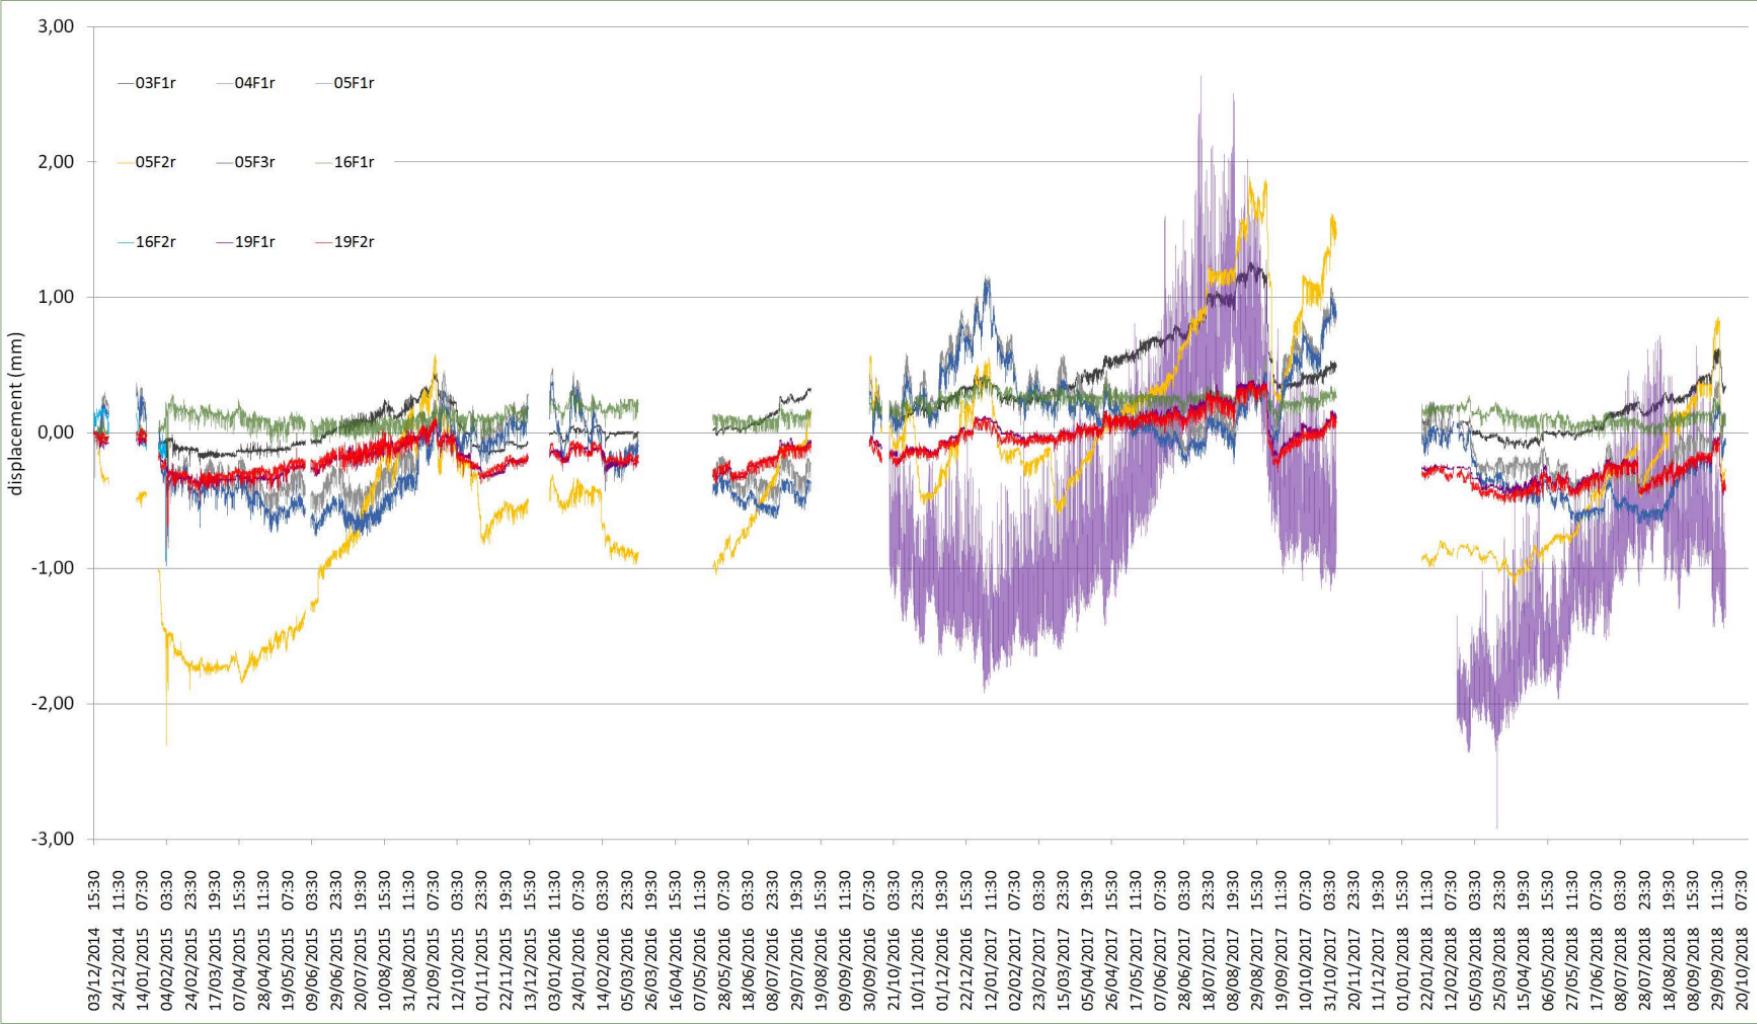
**Figure 11:** Crack aperture variation time series showing daily, seasonal and annual deformation patterns. Long-term trends, based on about four consecutive years of data (December 2014 to October 2018), show from +0,1 to +1,2 mm cumulative deformation. Data are incomplete in some months.
