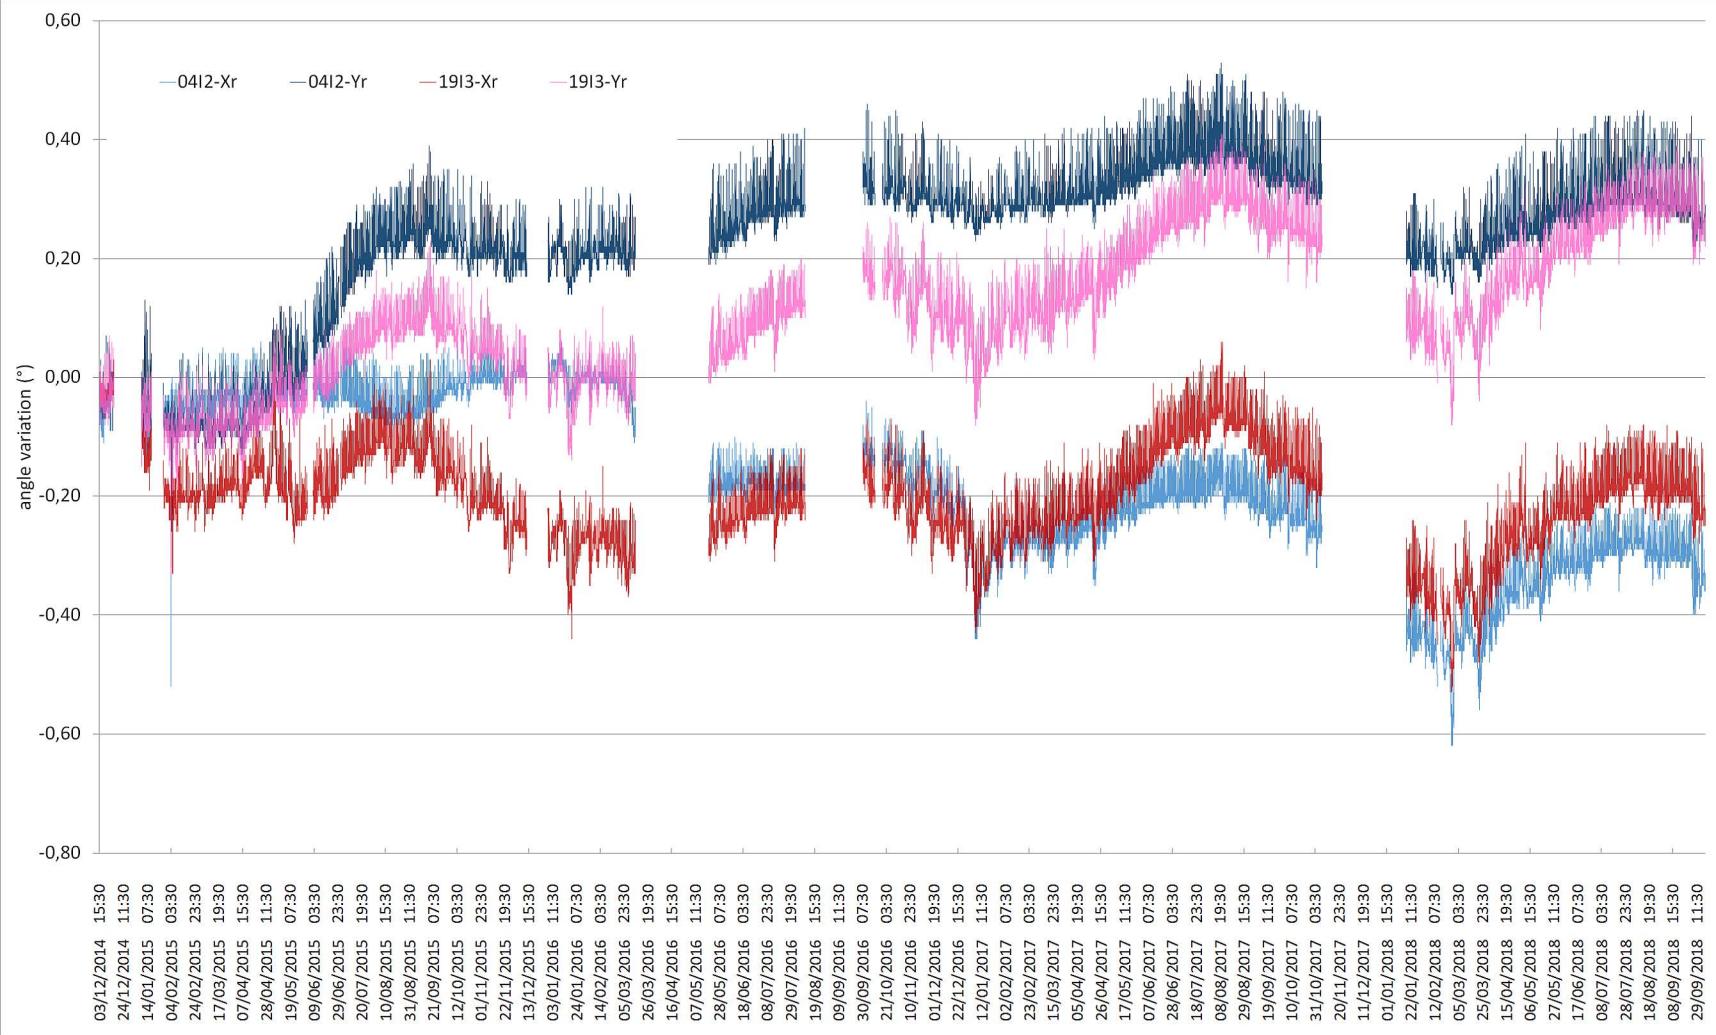
**Figure 12:** Angle variation time series data showing daily, seasonal and annual deformation patterns. Long-term trends, based on about four consecutive years of data (December 2014 to October 2018), show from 0,1° to 0,4° cumulative angle variation. Horizontal and vertical angle variation show opposite evidences for each block. Data are incomplete in some months.

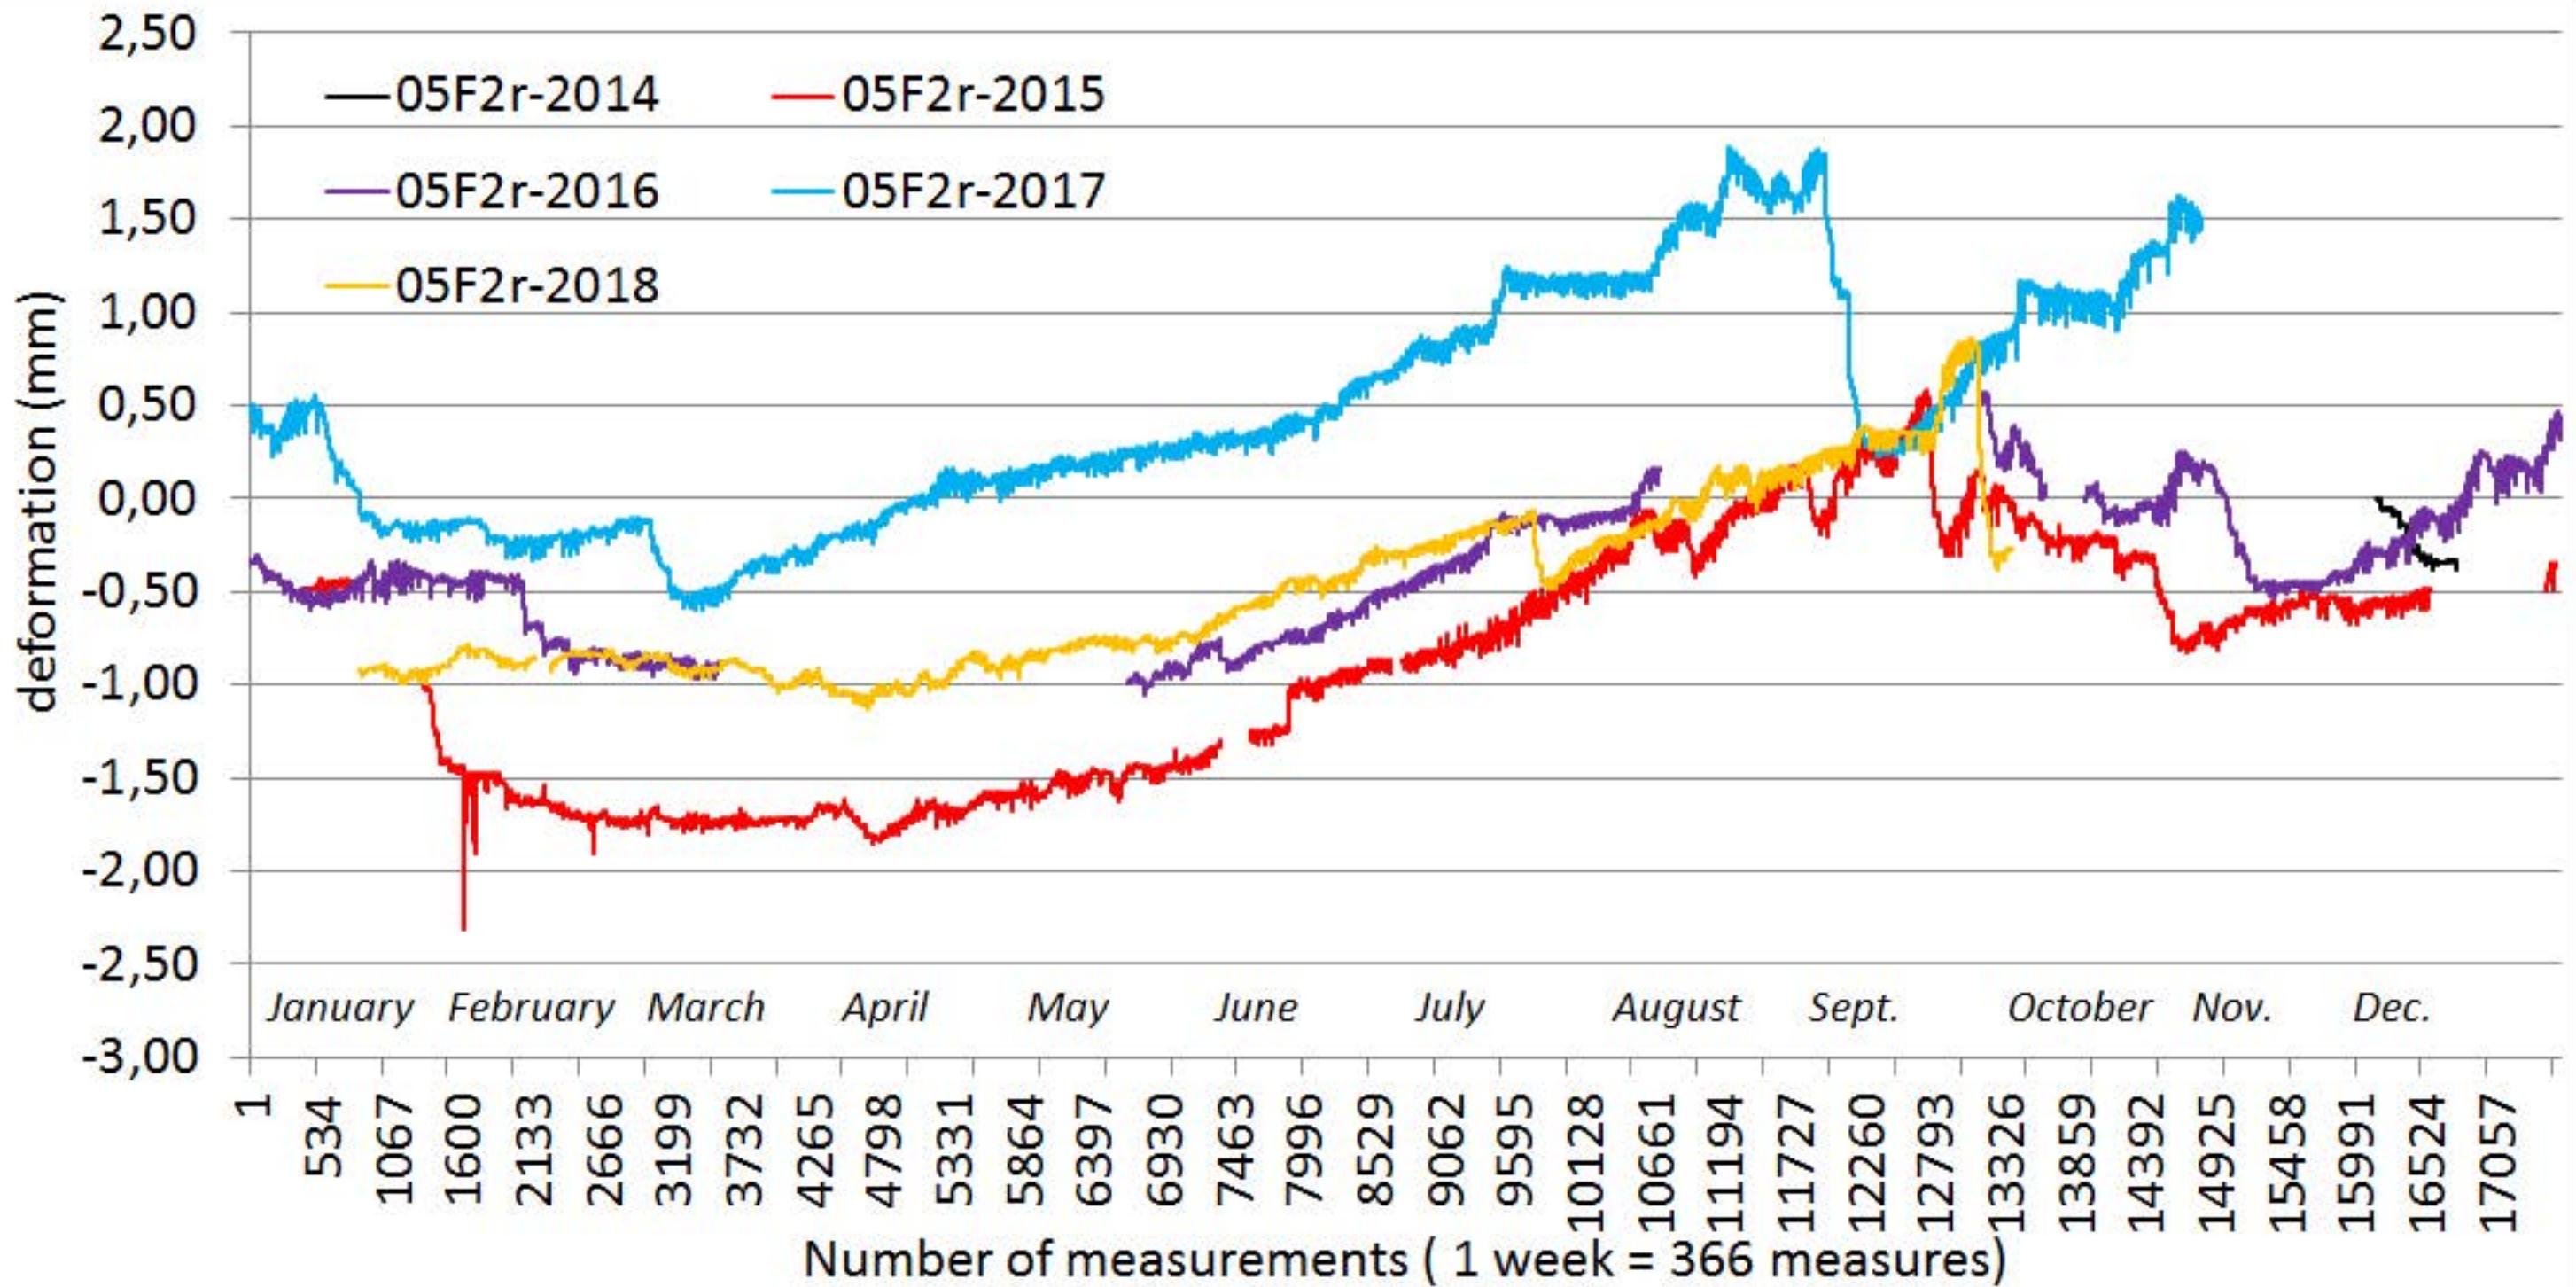
**Figure 13:** Annual time series plots of 05F2 crackmeter showing partly repetitive seasonal deformation patterns.

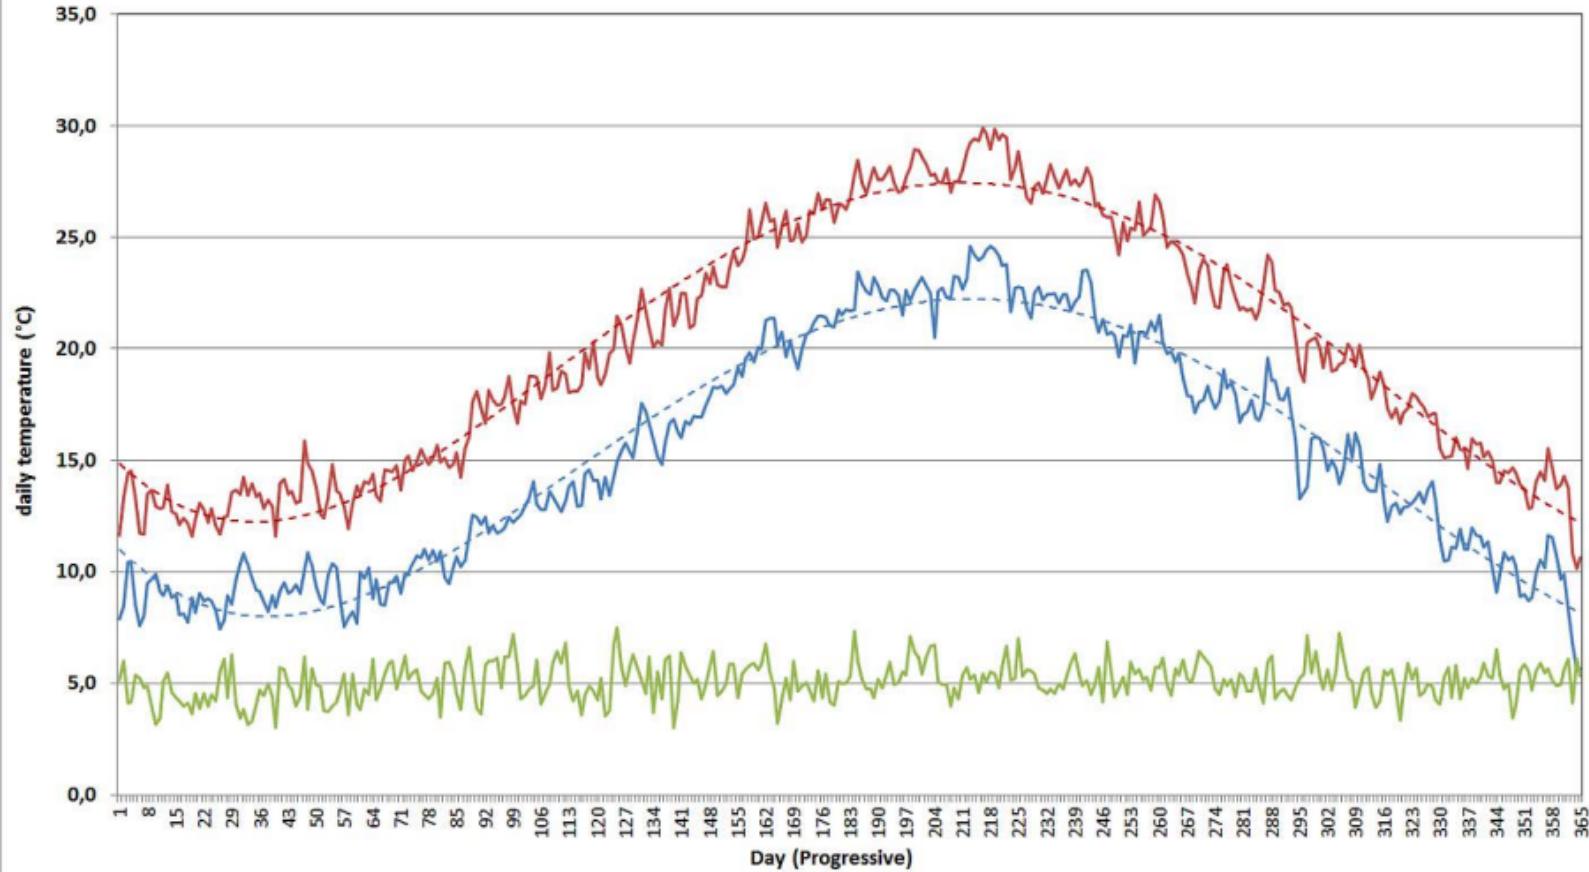
**Figure 14:** Average daily thermal trend, referred to 2014-2018, recorded by Denza weather station with 4<sup>th</sup> grade polynomial equation. Maximum temperature values are indicated with red line, minimum values with blue line and daily temperature range with green line.

$$y = 1,462E-08x^4 - 1,259E-05x^3 + 3,135E-03x^2 - 1,860E-01x + 1,118E+01$$

$$y = 1,517E-08x^4 - 1,296E-05x^3 + 3,167E-03x^2 - 1,748E-01x + 1,503E+01$$

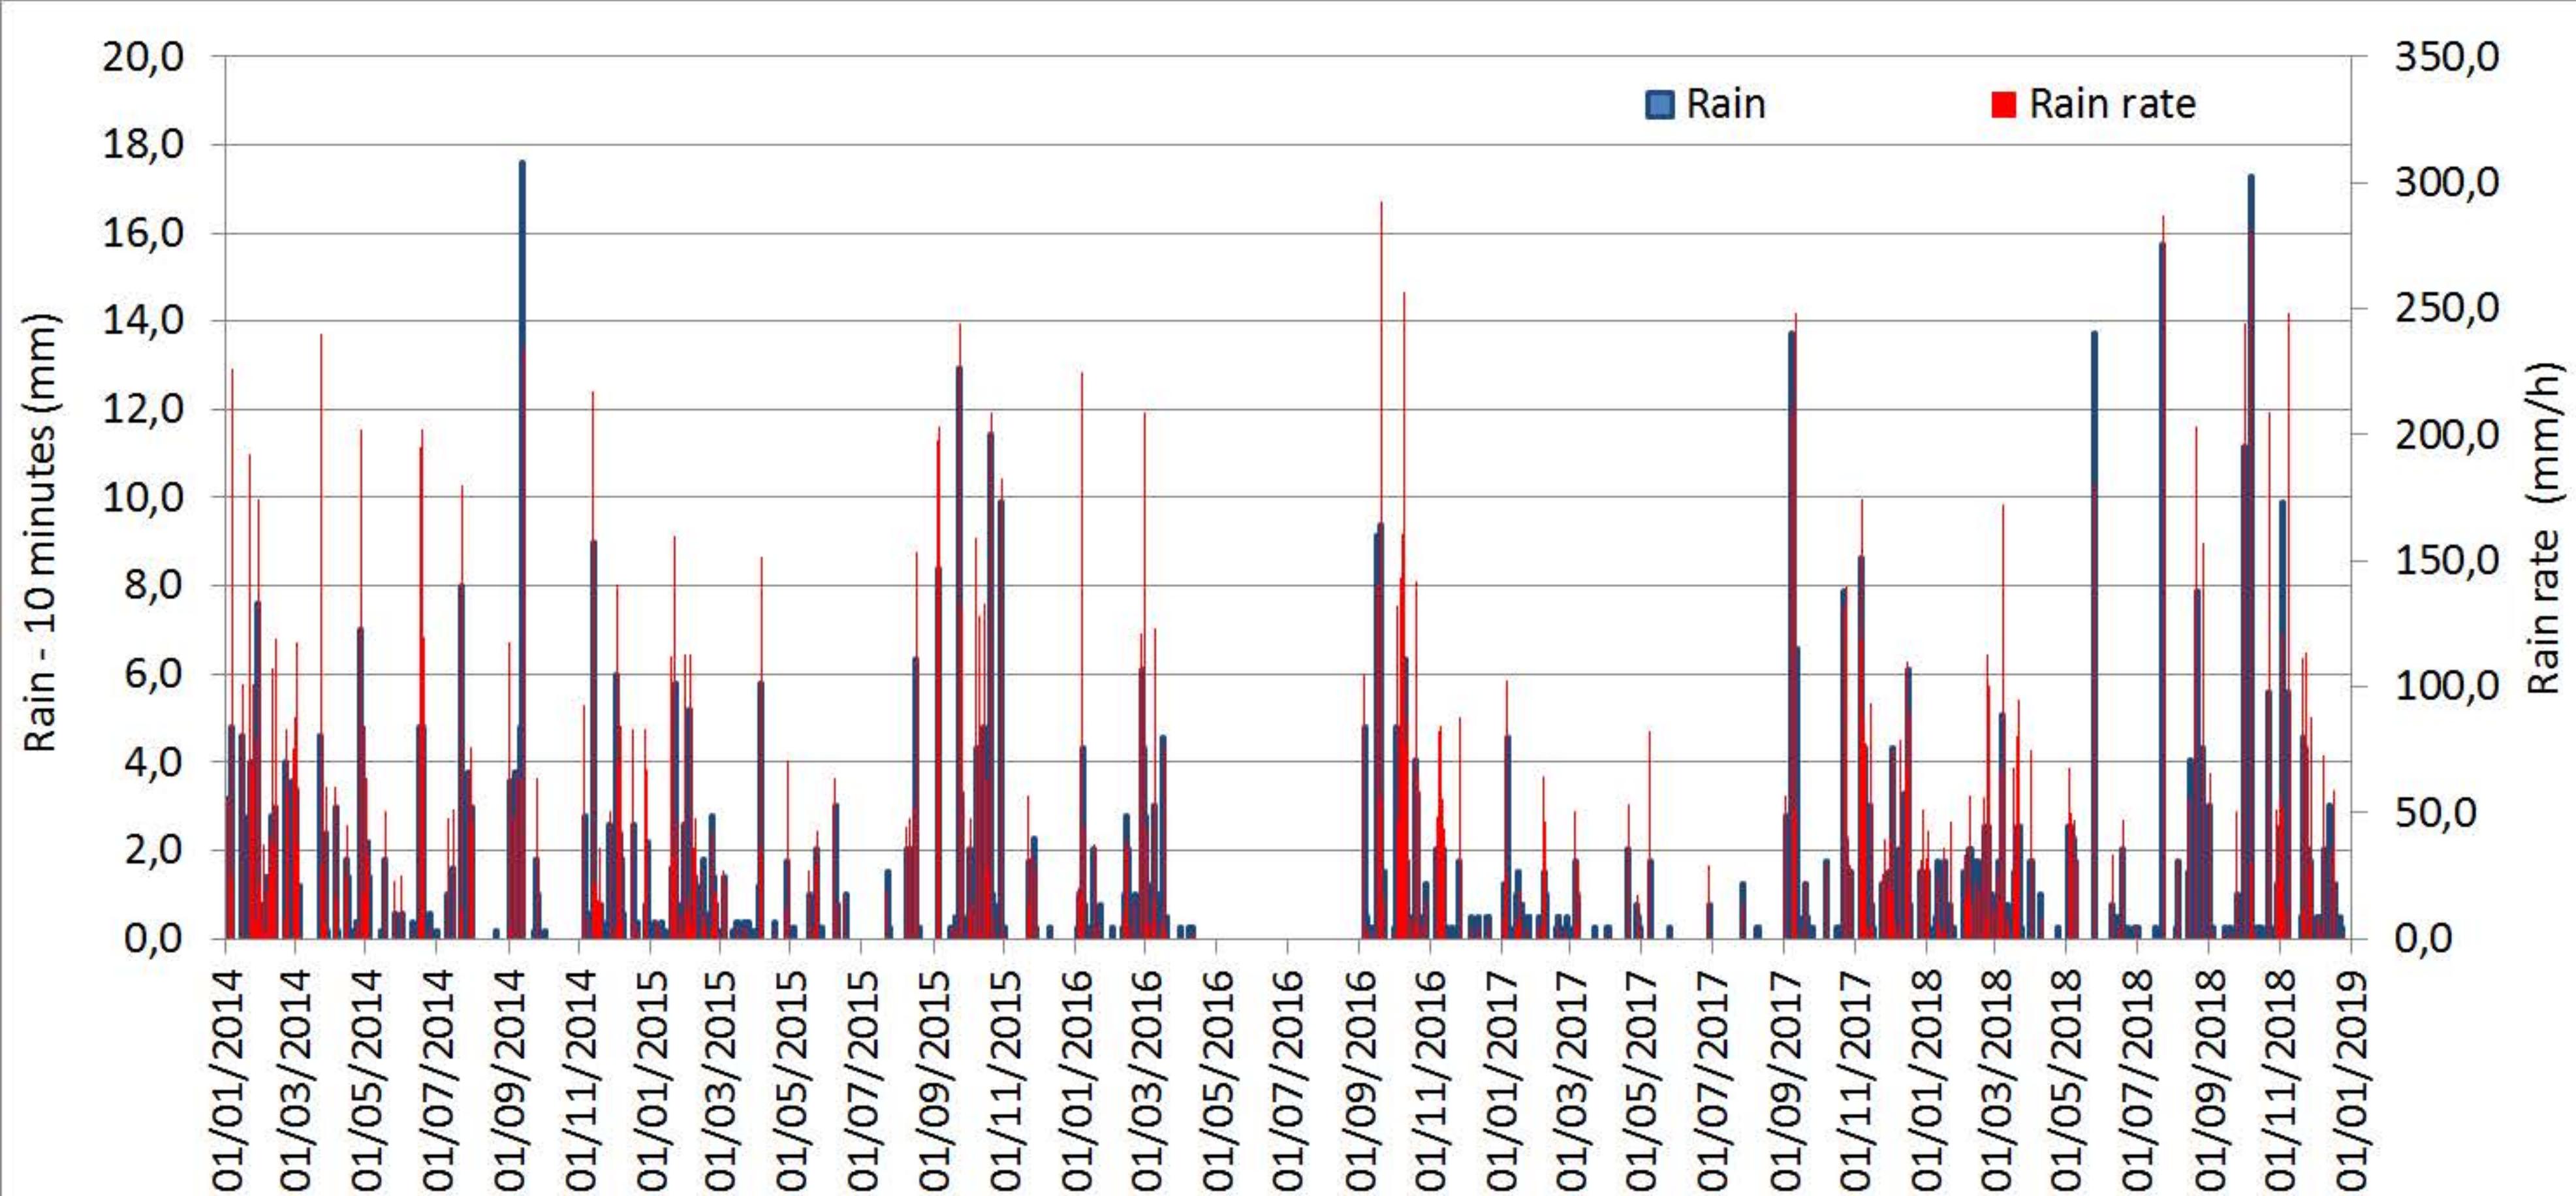
**Figure 15:** Rain amount (10 minutes) and rain rate time series data showing daily, seasonal and annual variation patterns in the Denza station during 2014-2018.

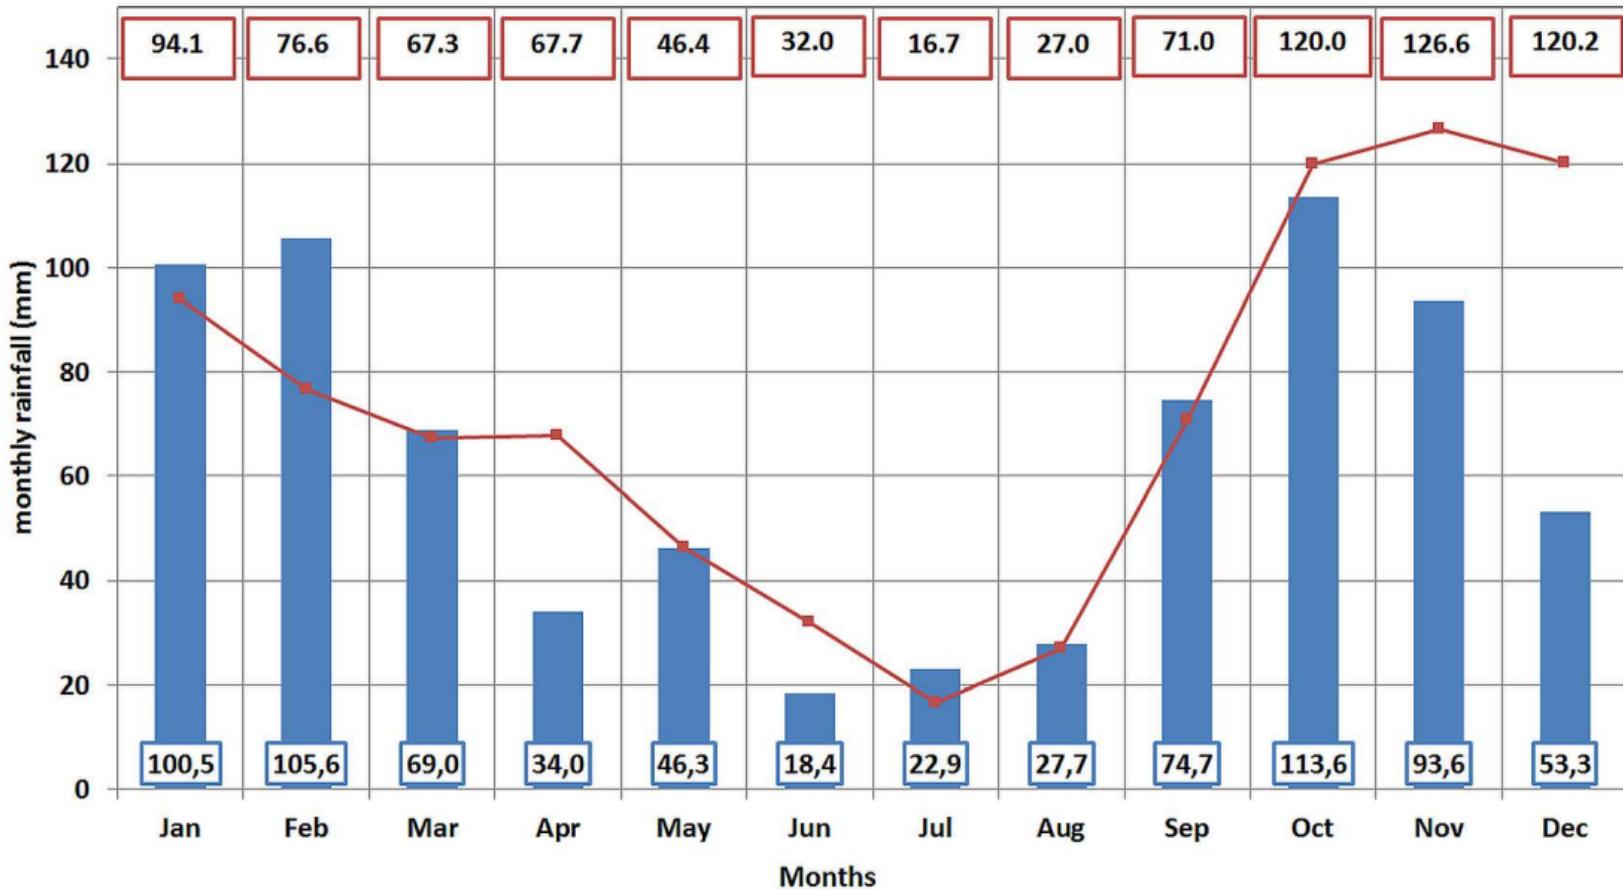
**Figure 16:** Average cumulative monthly rainfall data histogram referred to 2014-2018. Diagram reports also average monthly values of rainfall, measured at Meteorological Observatory of University of Naples “Federico II” since 1872 (Mazzarella, 2006). Rainfall values are reported, respectively, in blue squared cells and red squared cells.

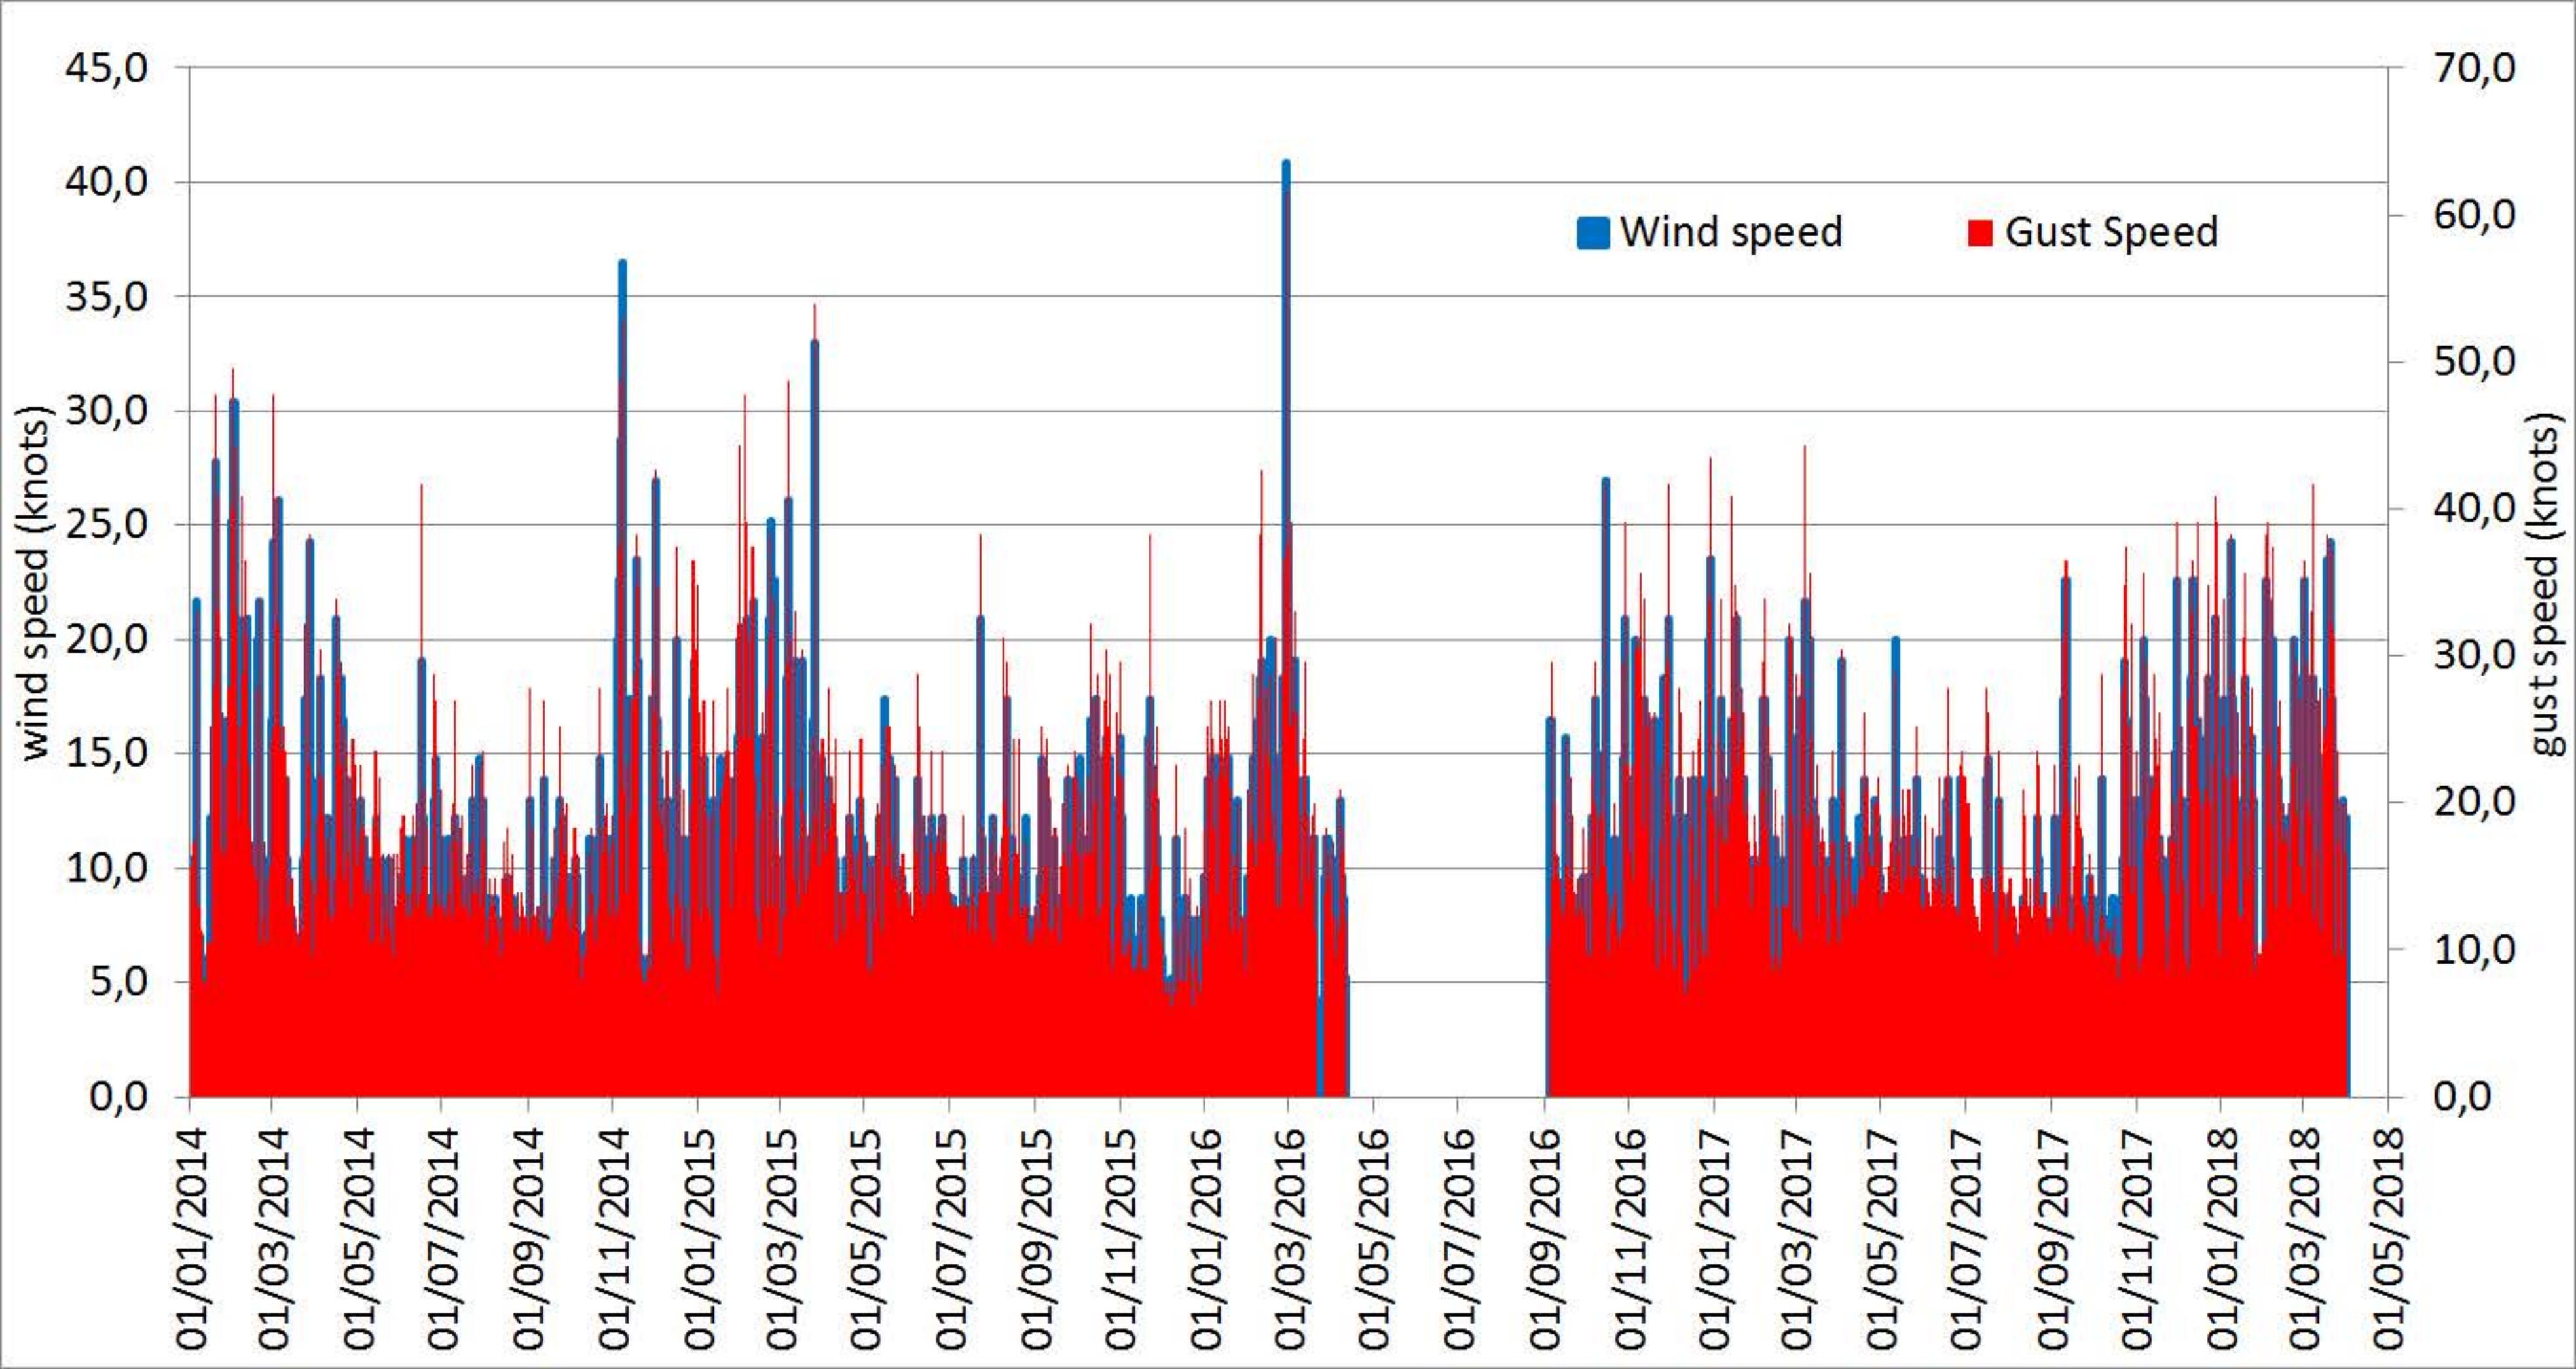
**Figure 17:** Wind and gust speed time series data showing daily, seasonal and annual variation patterns in the Denza station during 2014-2018.

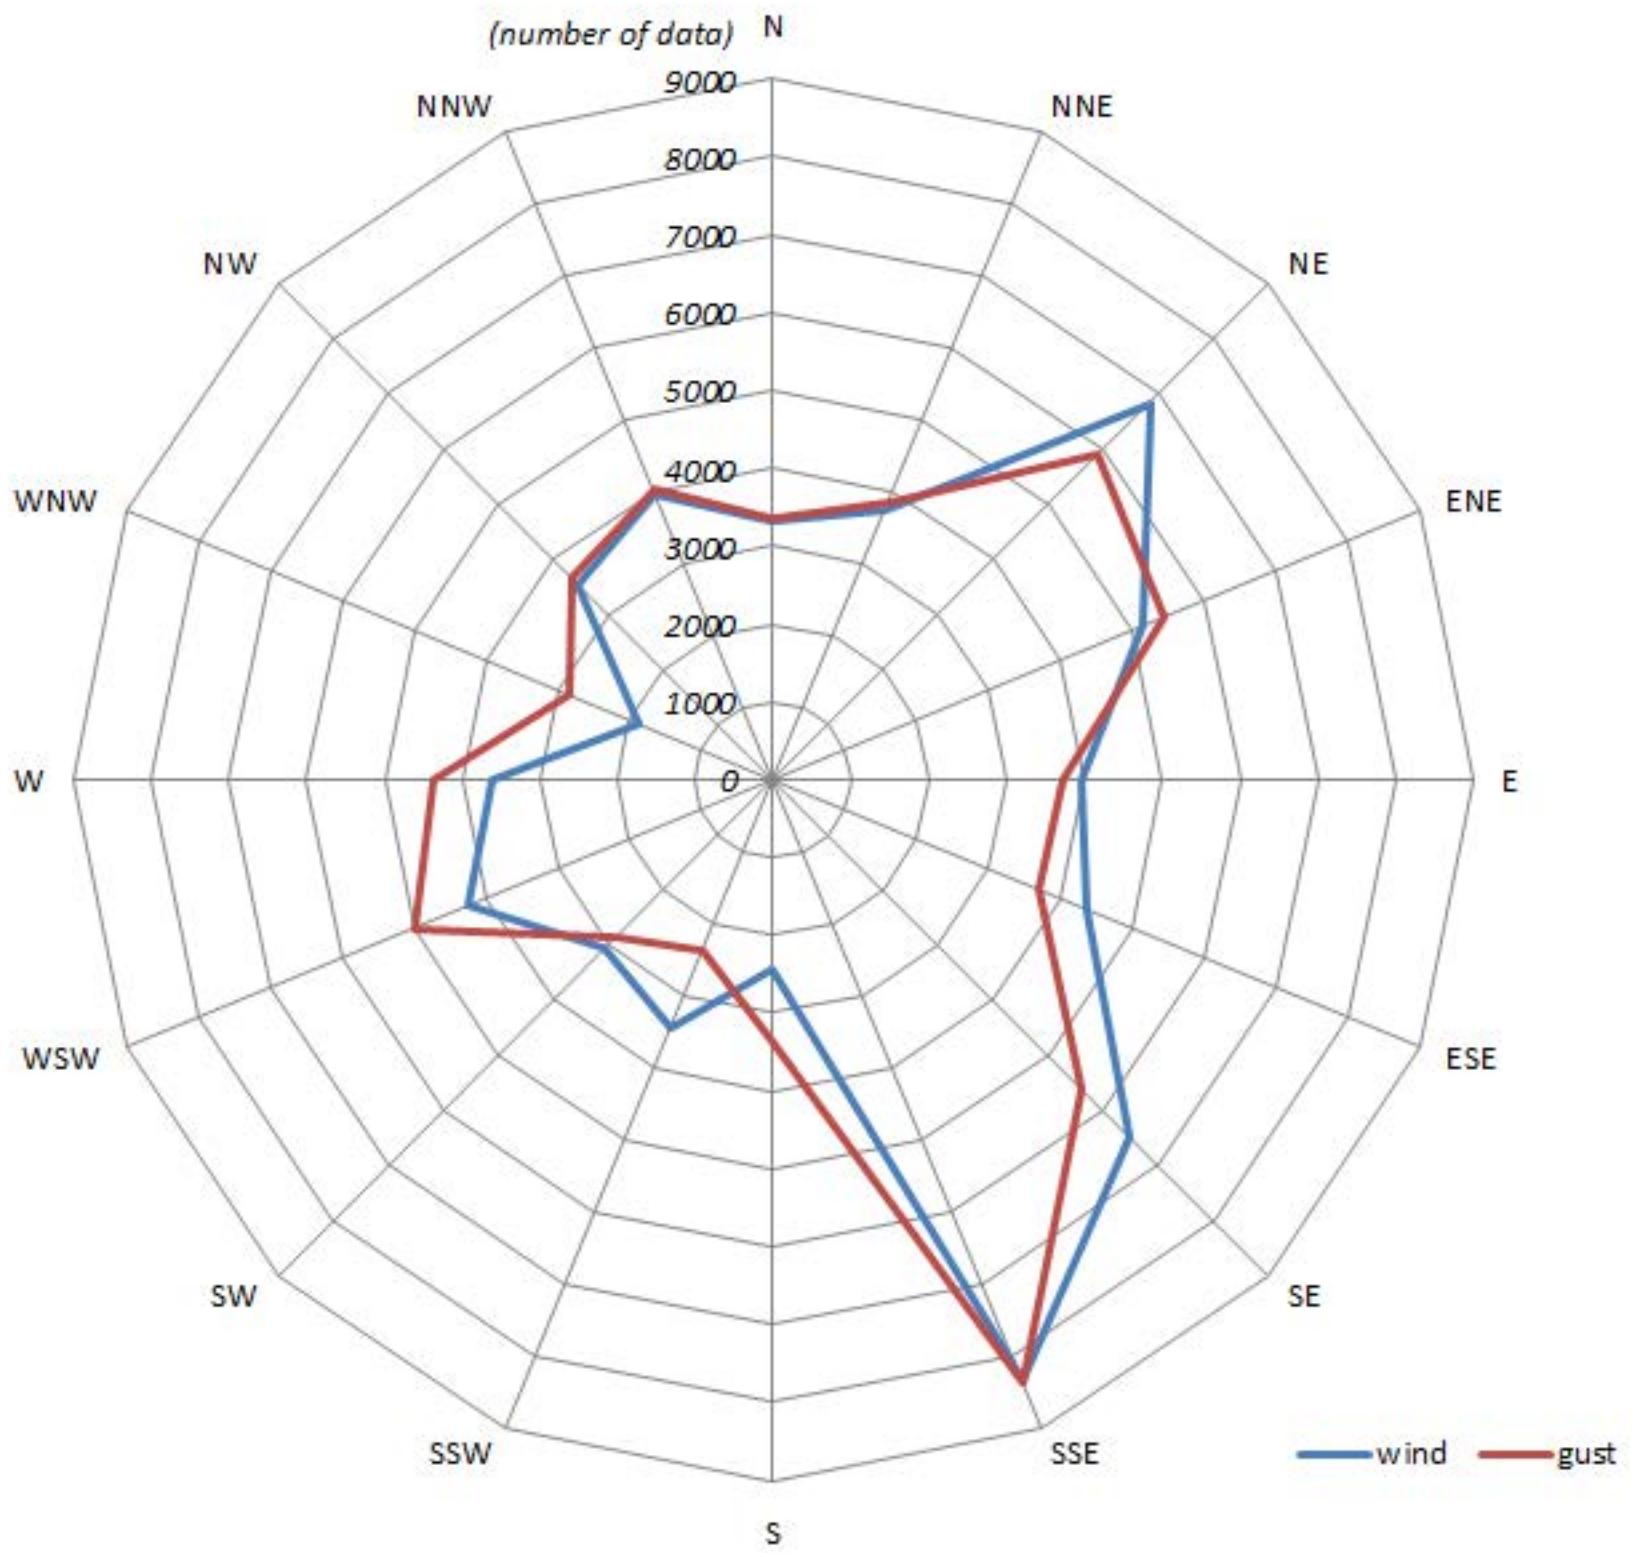
**Figure 18:** Frequency distribution of wind and gust directions measured during 2014-2018.

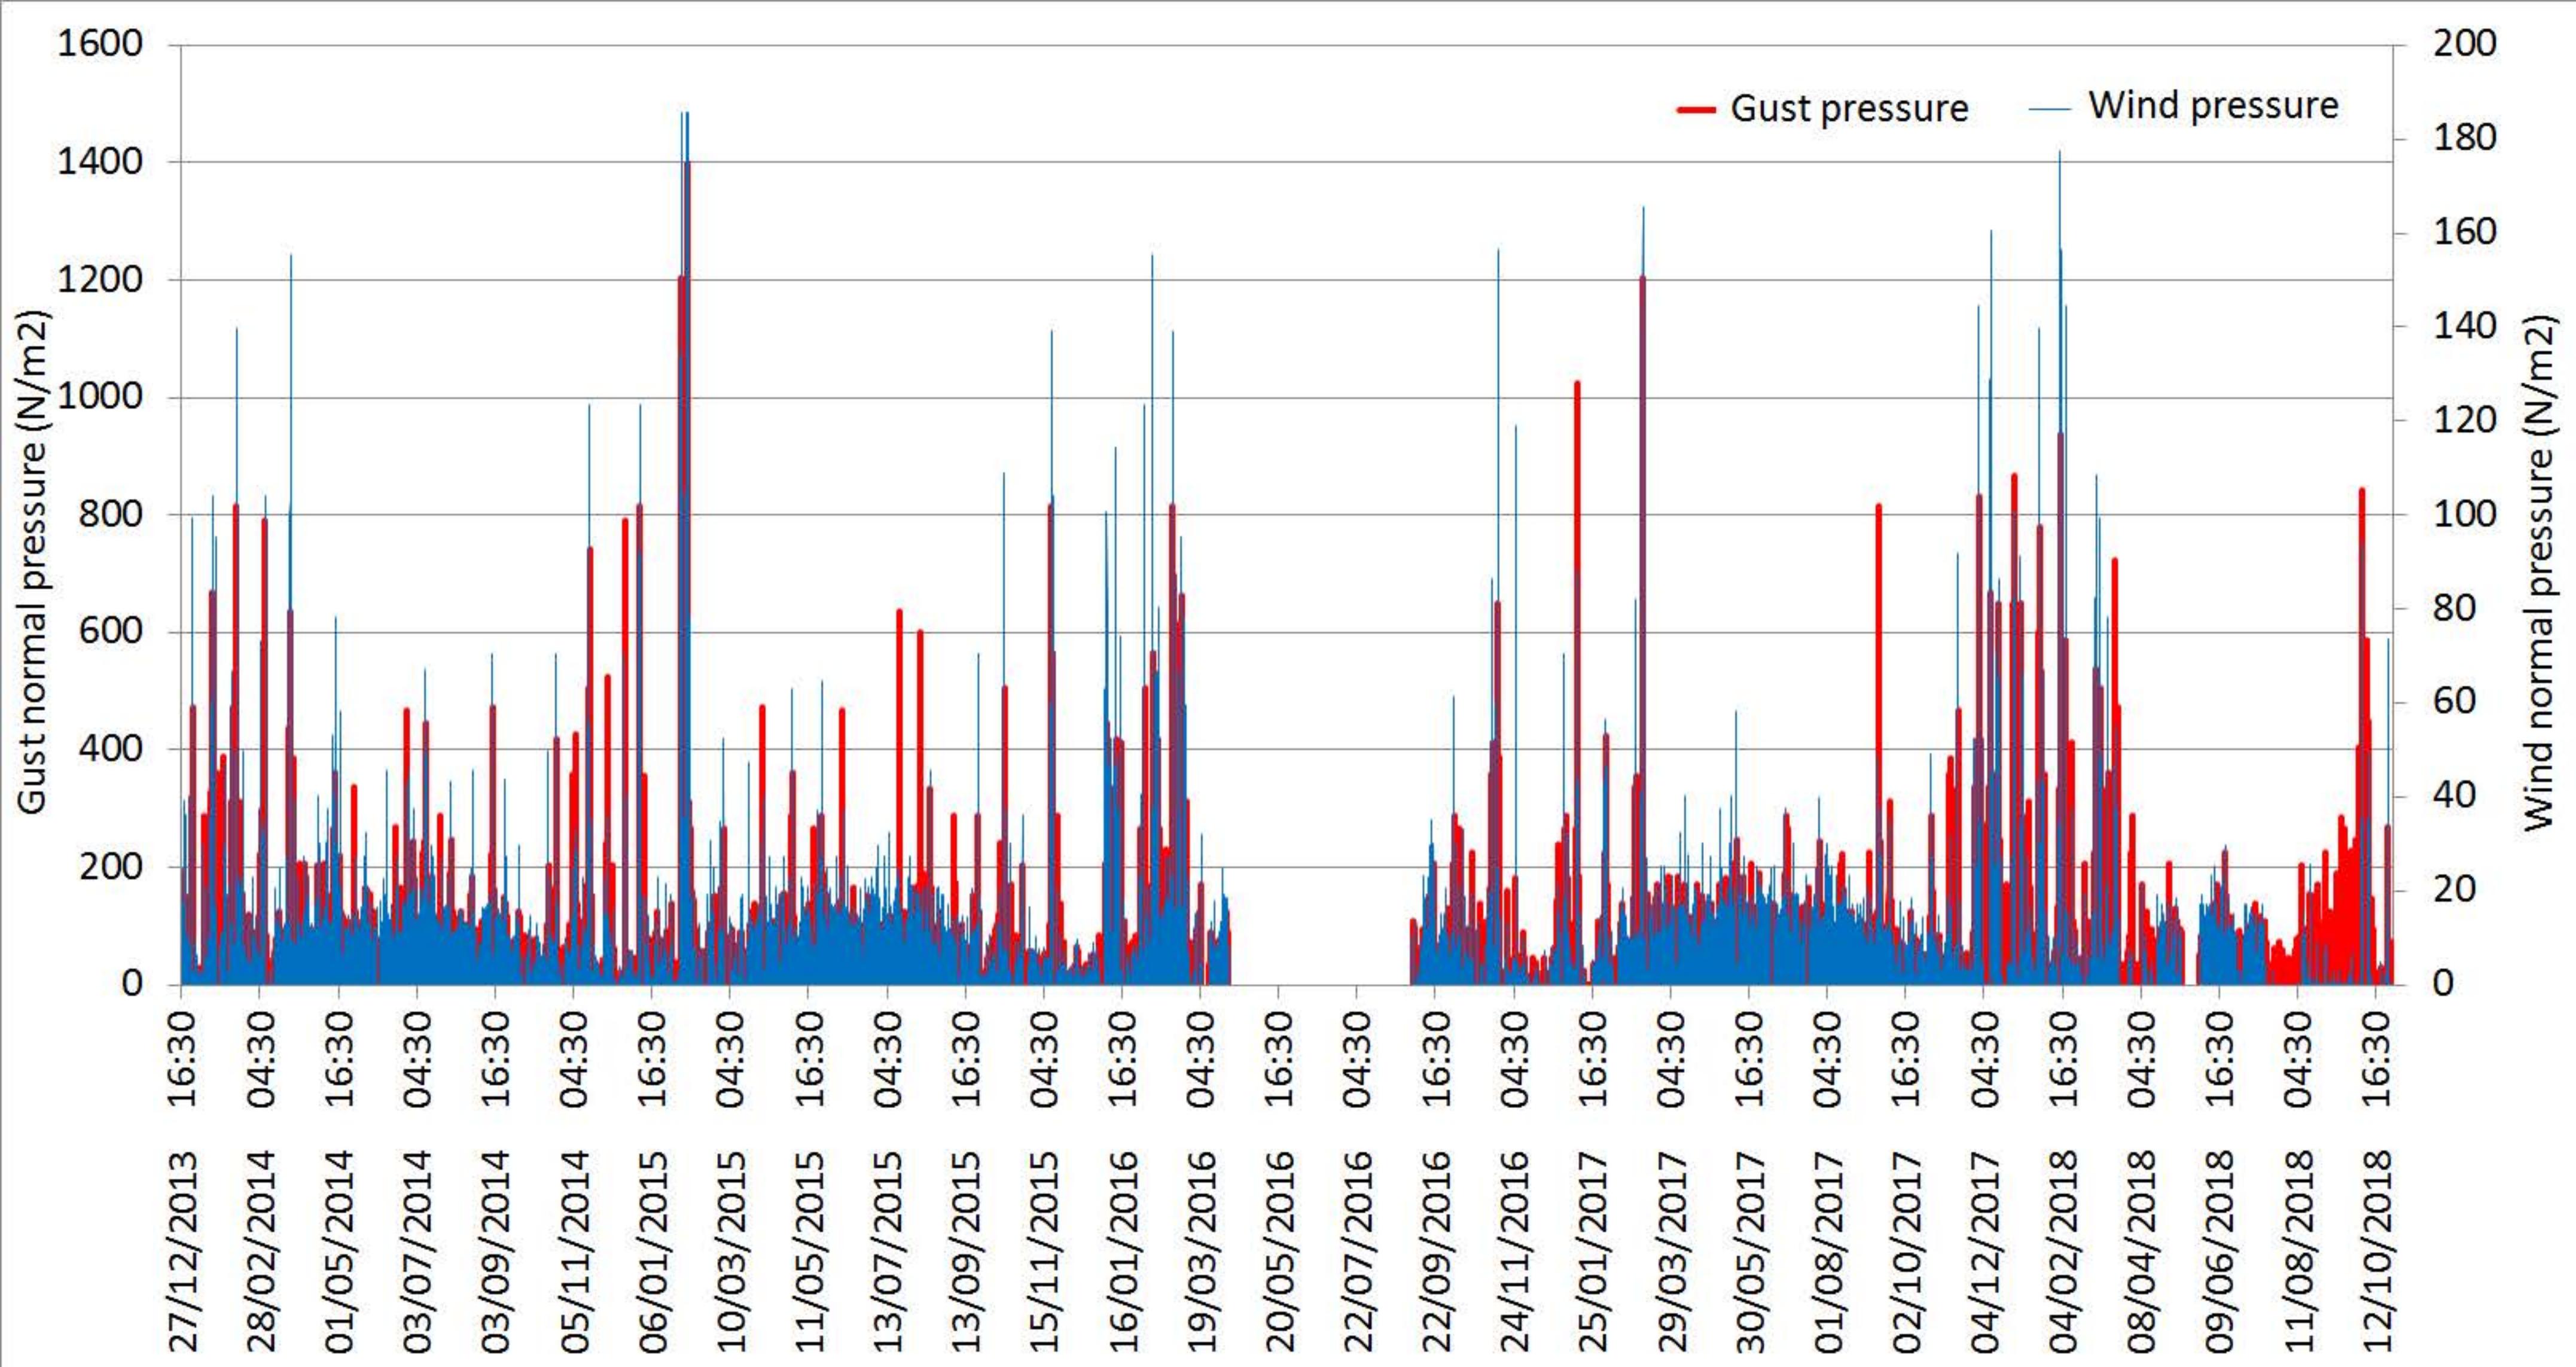
**Figure 19:** Wind and gust normal pressure time series data showing daily, seasonal and annual variation patterns in the Denza station during 2014-2018.
