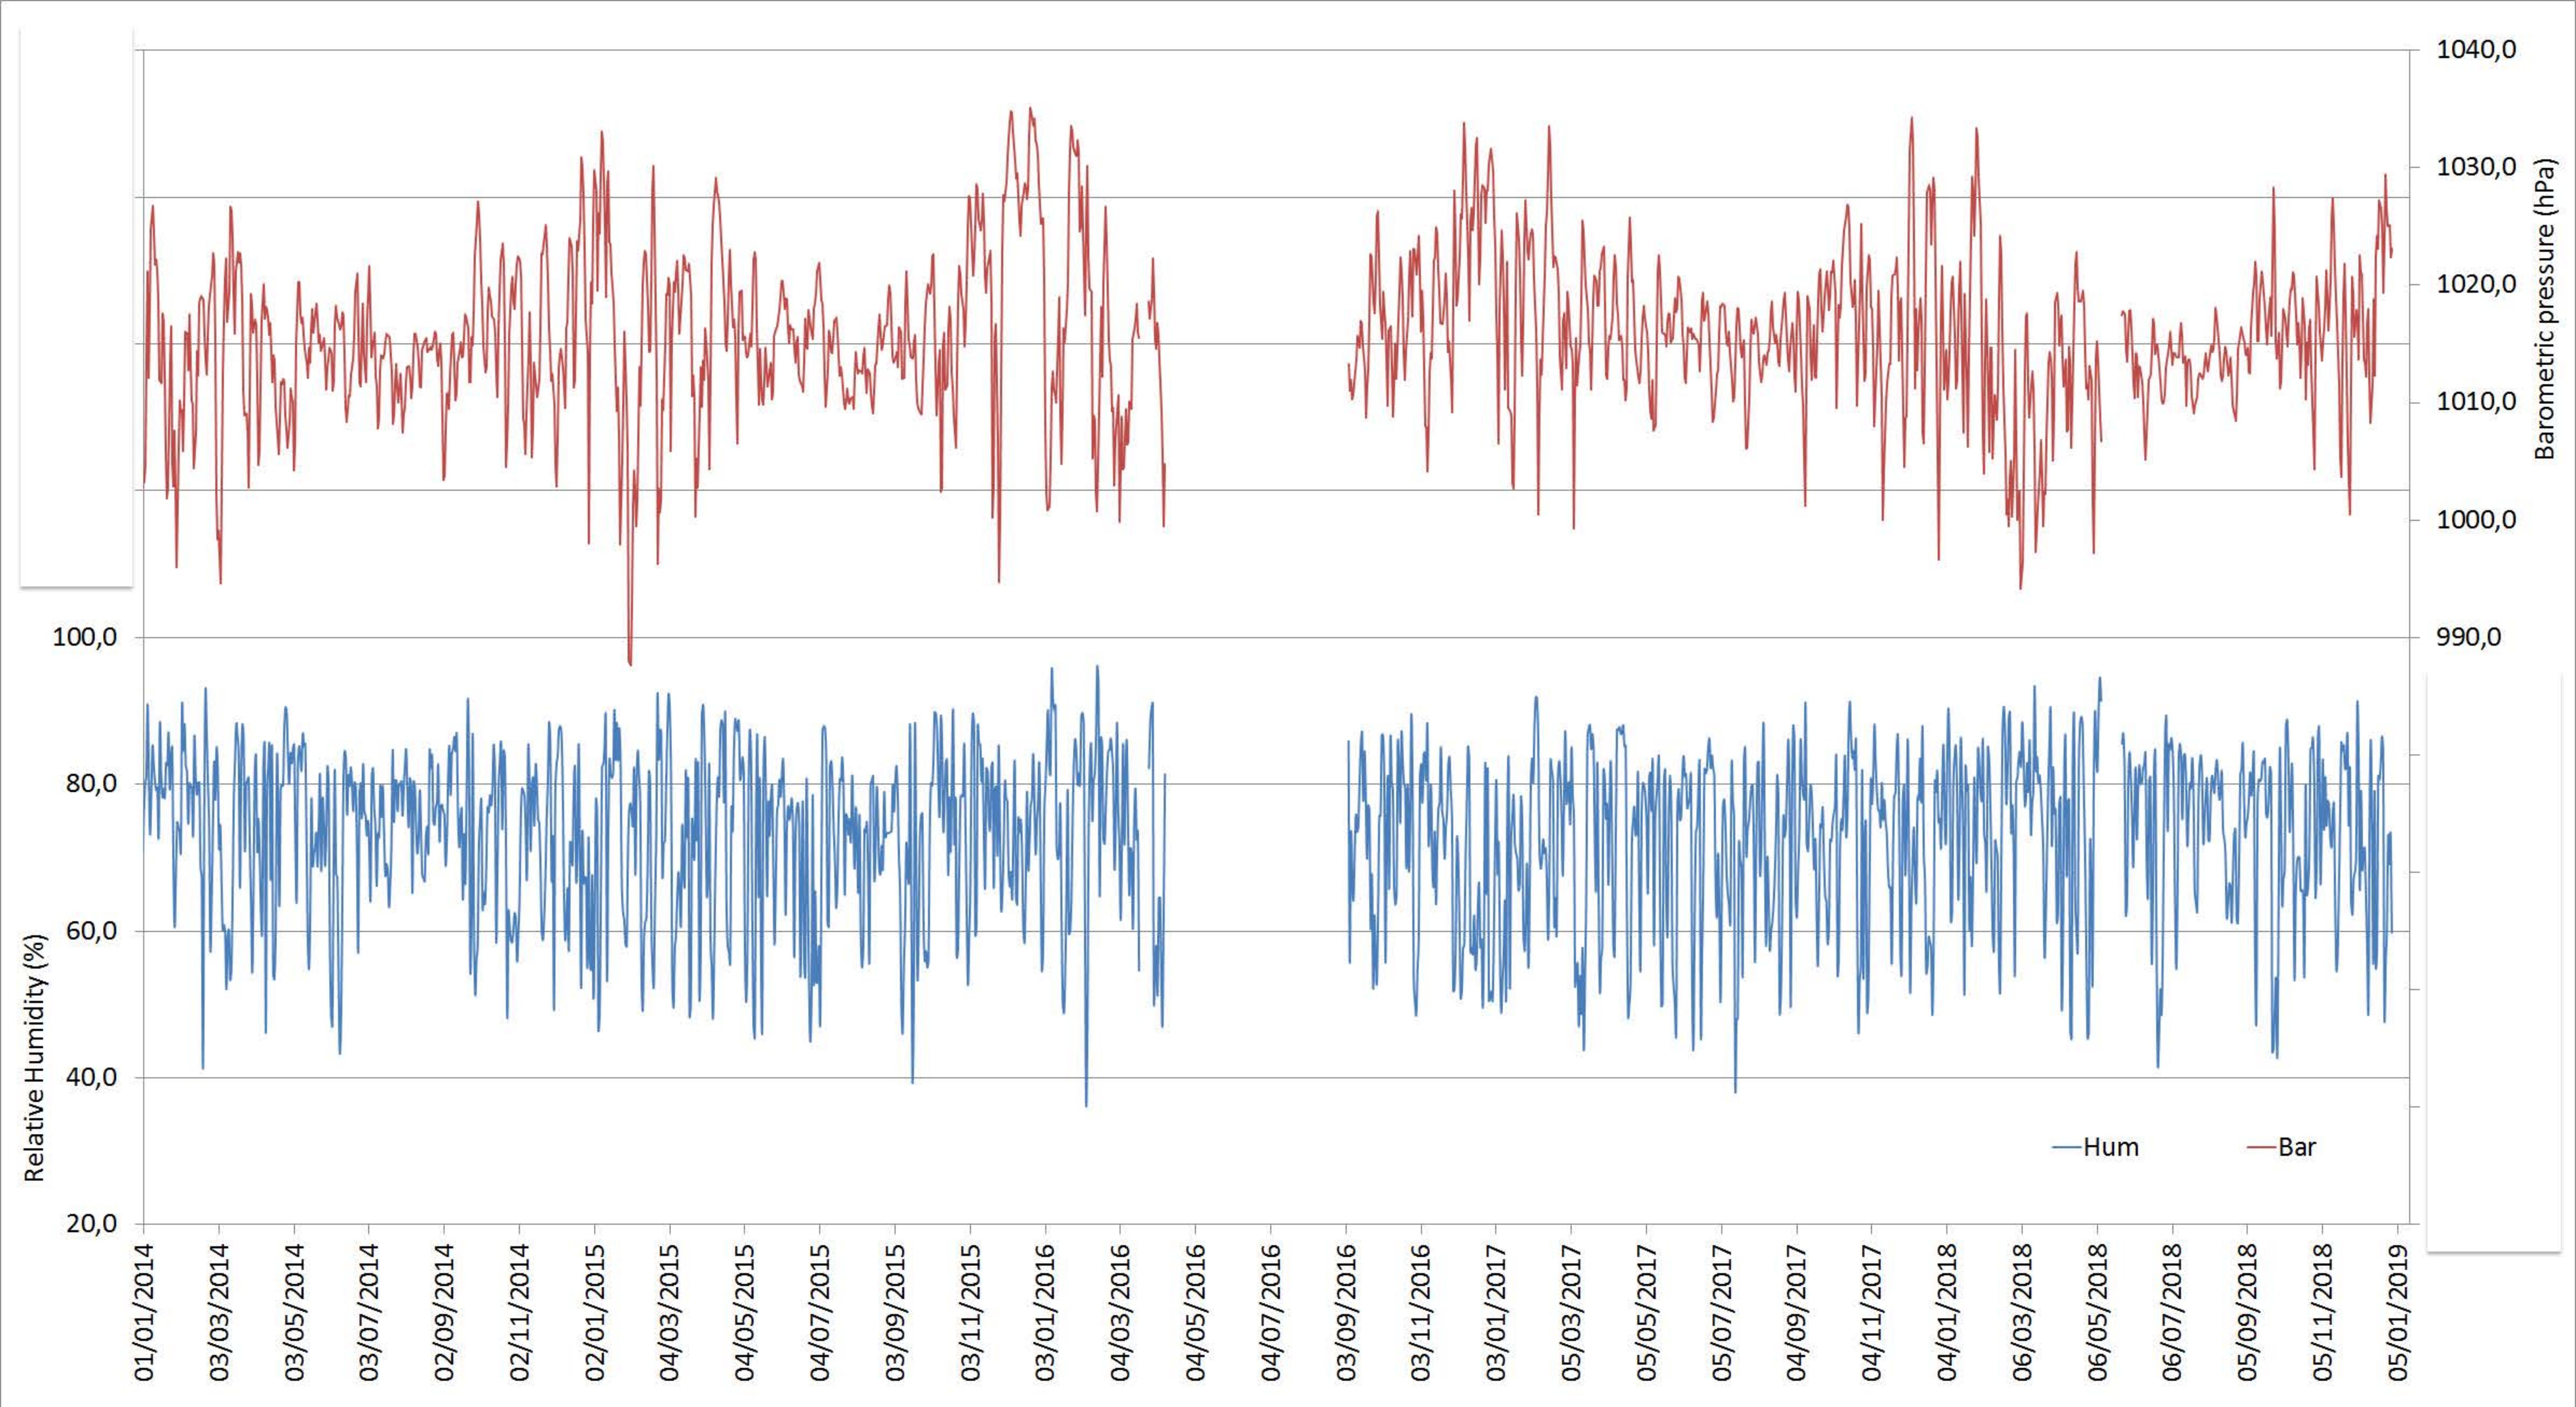
**Figure 20:** Barometric pressure and humidity time series data showing seasonal and annual variation patterns in the Denza station during 2014-2018.

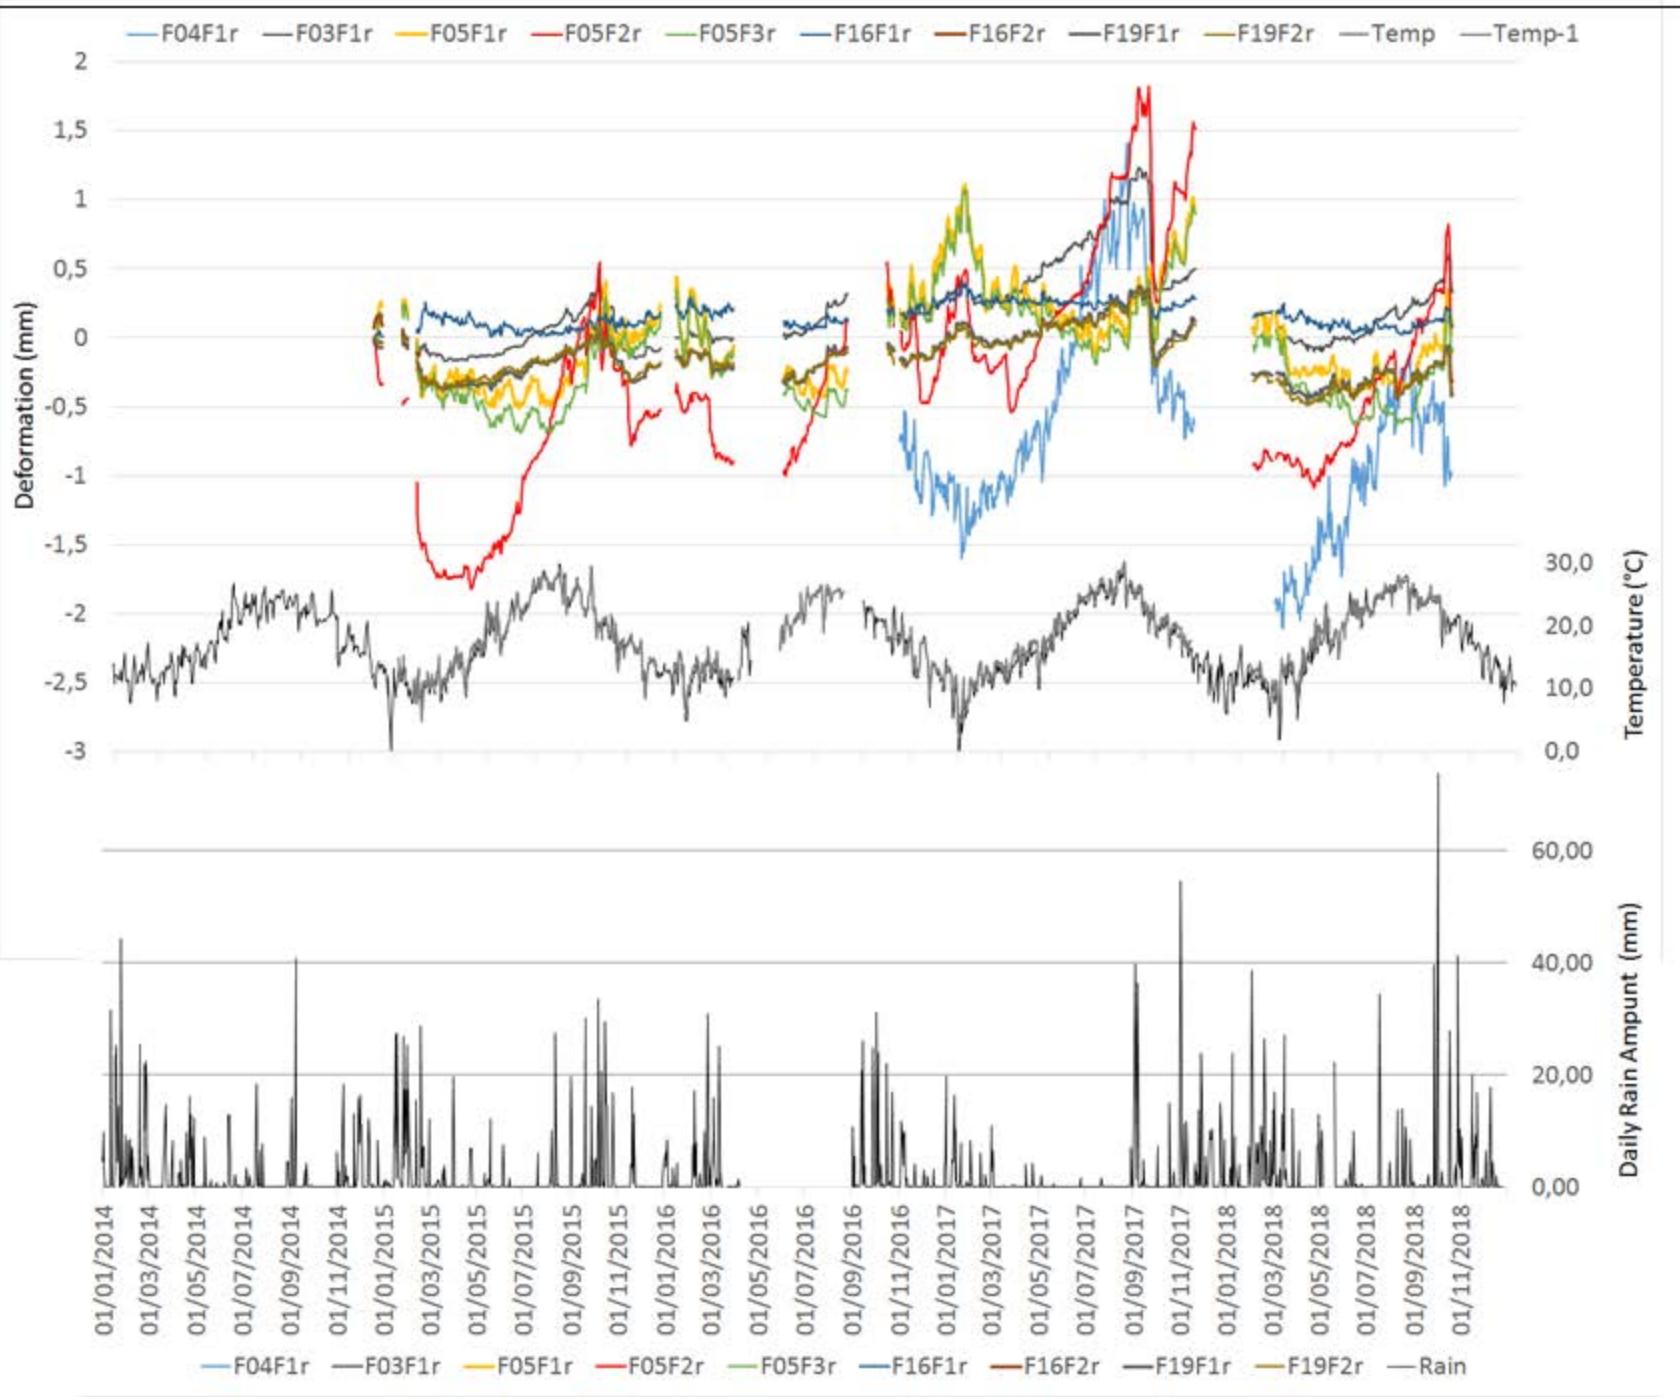
**Figure 21:** Comparison between crackmeter measurements, rain amount and temperature daily data time series.

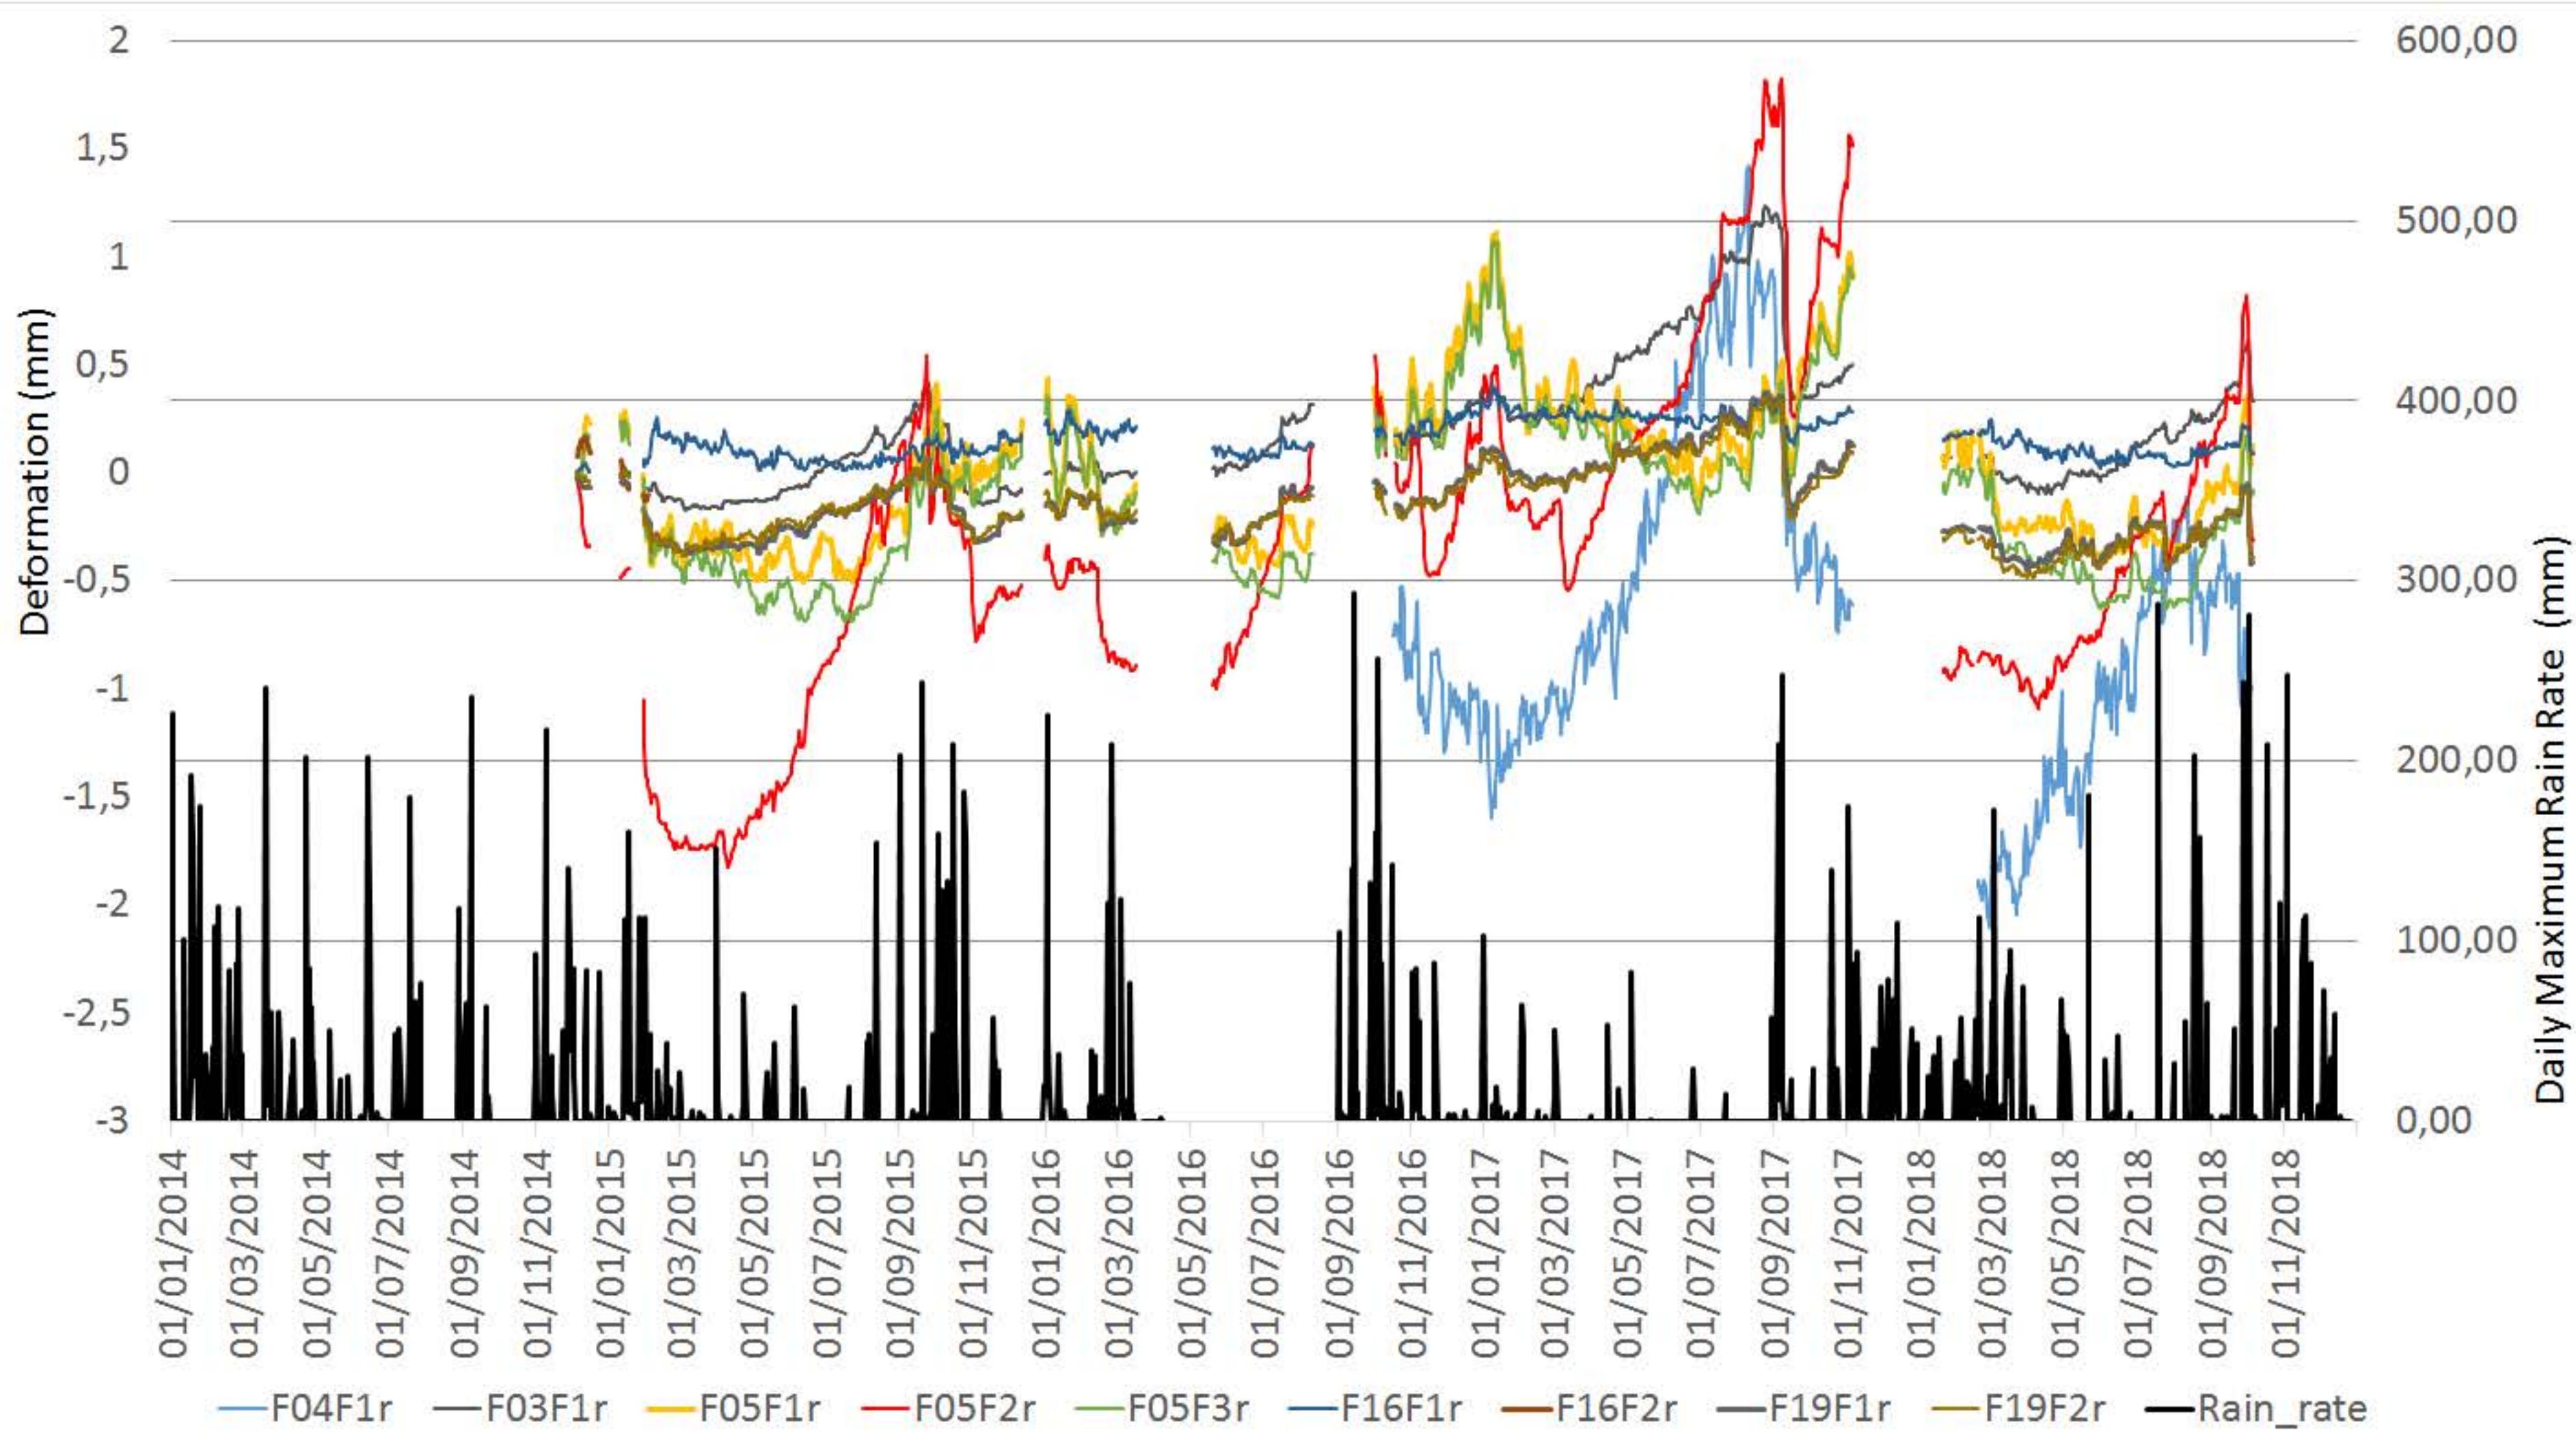
**Figure 22:** Comparison between crackmeter measurements and maximum rain rate daily data time series.

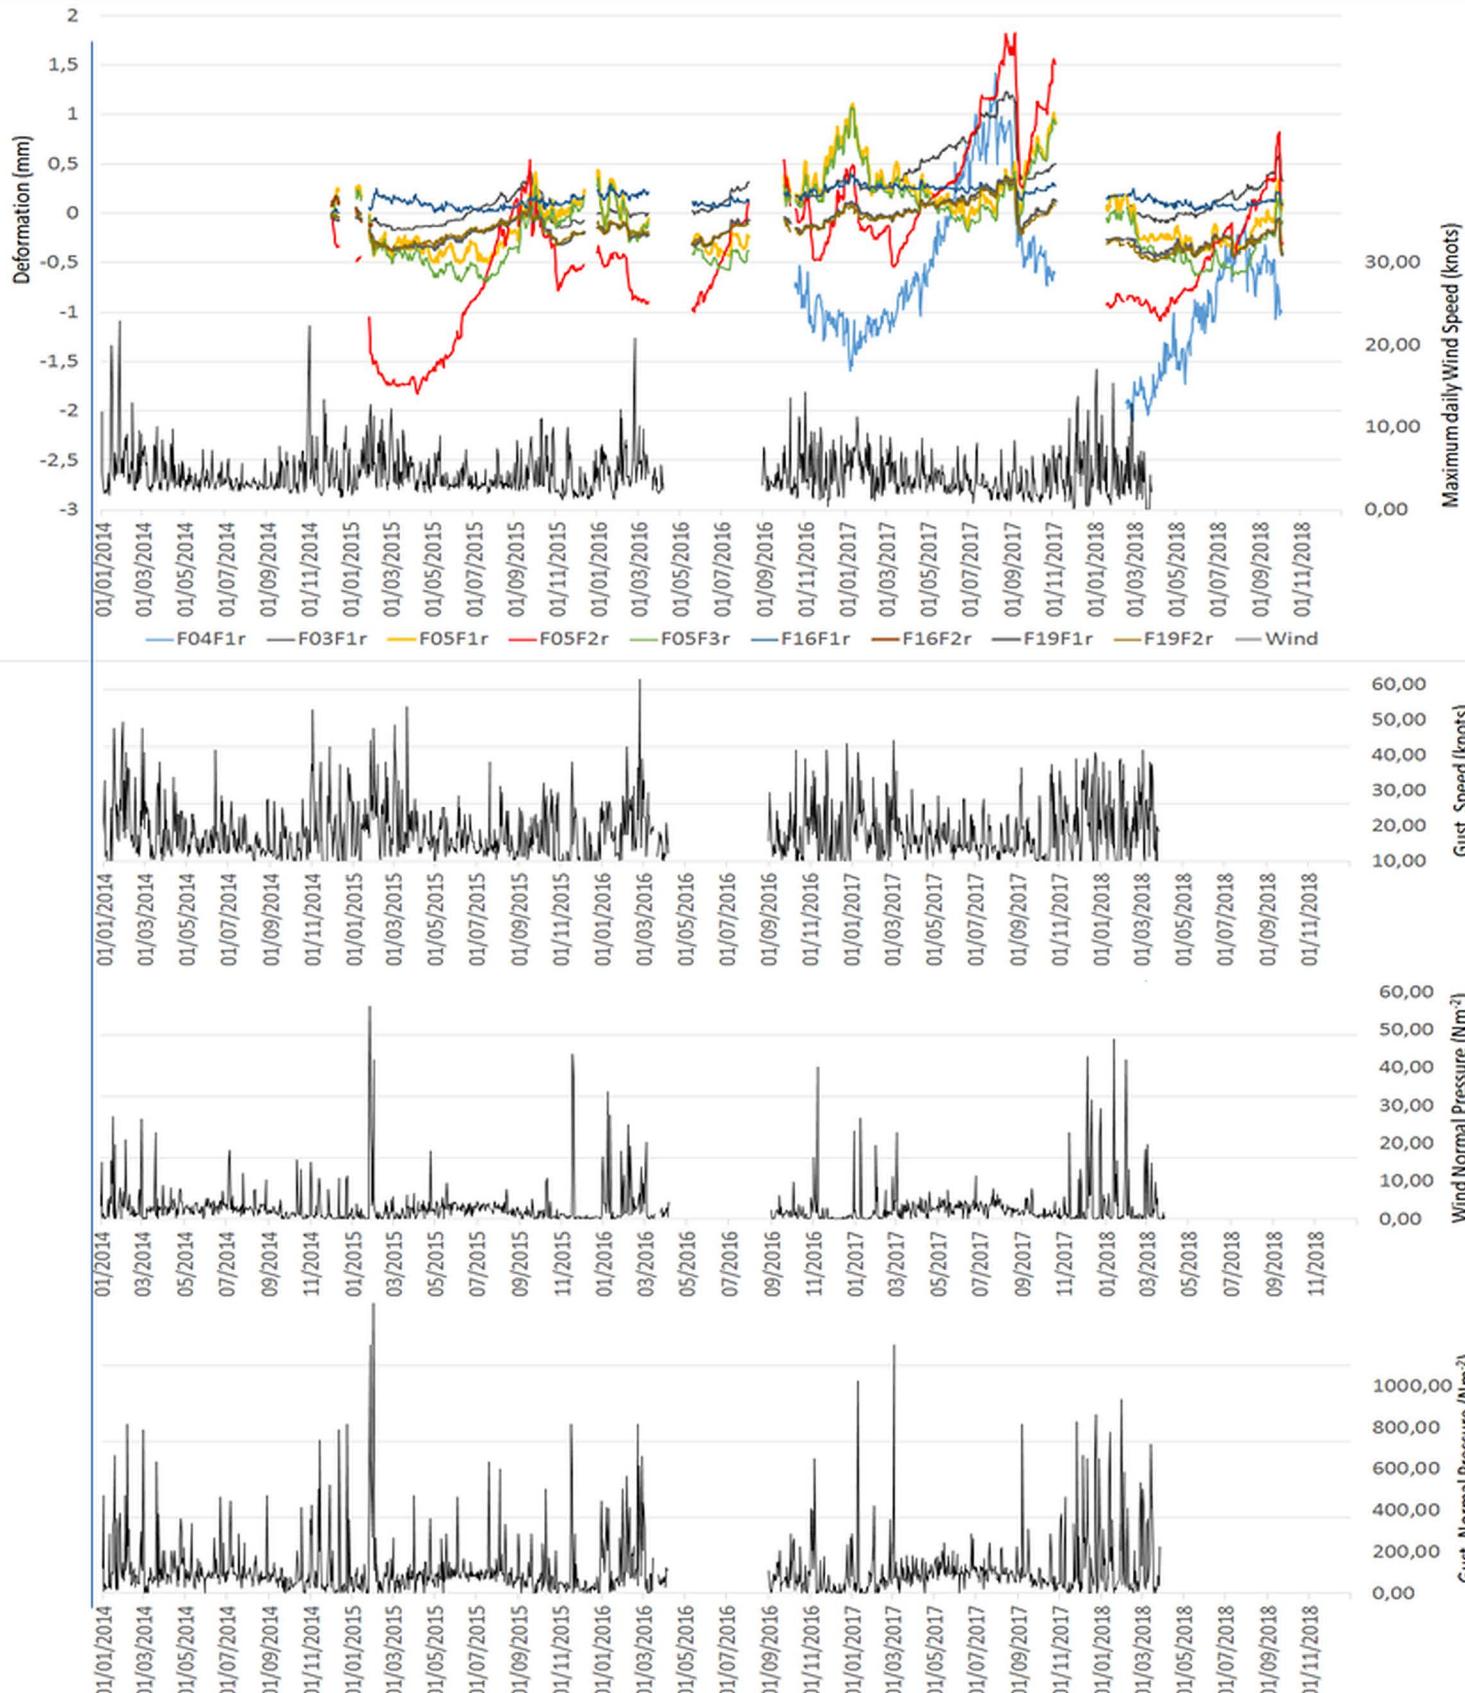
**Figure 23:** Comparison between crackmeter measurements and wind (wind speed, gust speed, wind normal pressure, gust normal pressure) daily data time series.

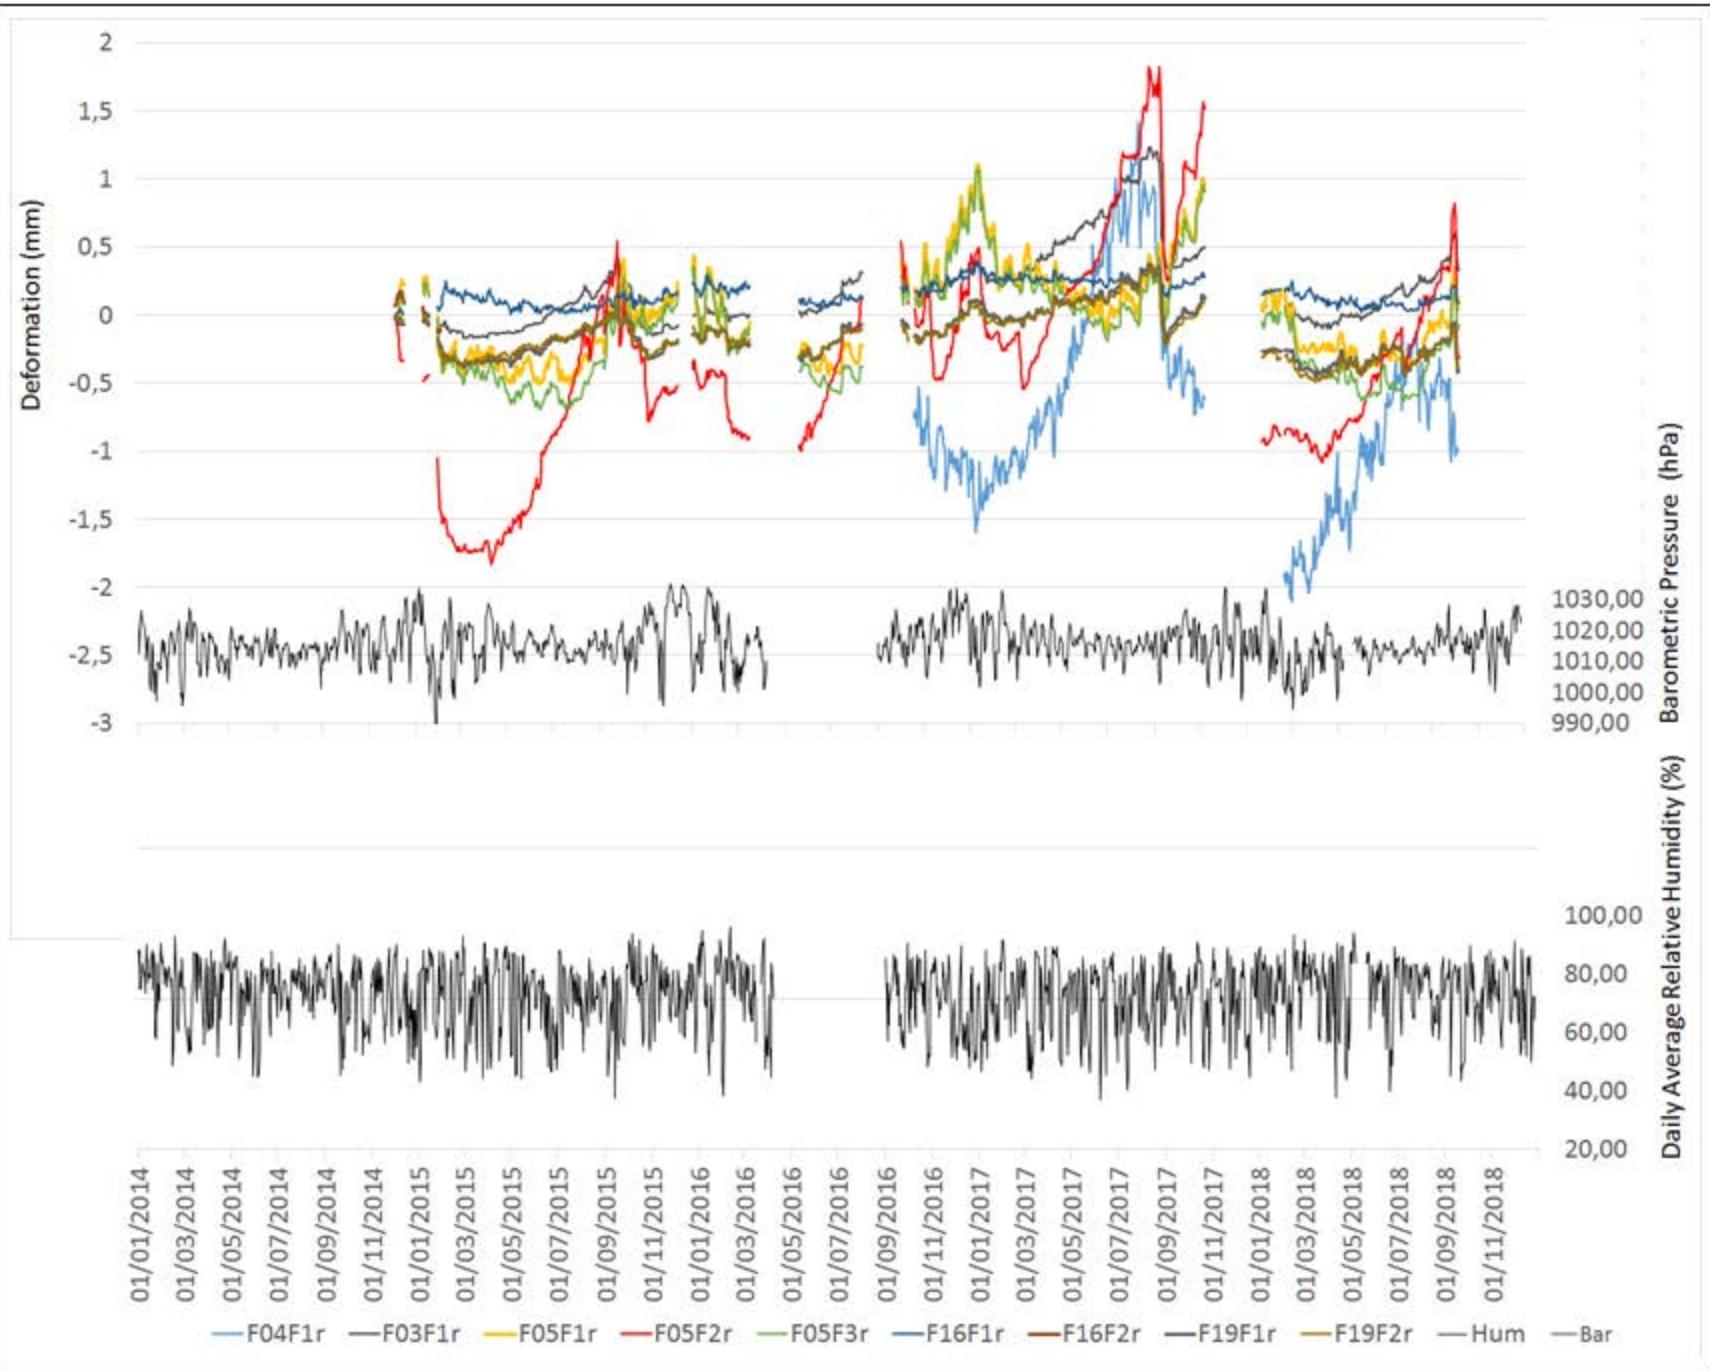
**Figure 24:** Comparison between crackmeter measurements, relative humidity and barometric pressure) daily data time series.

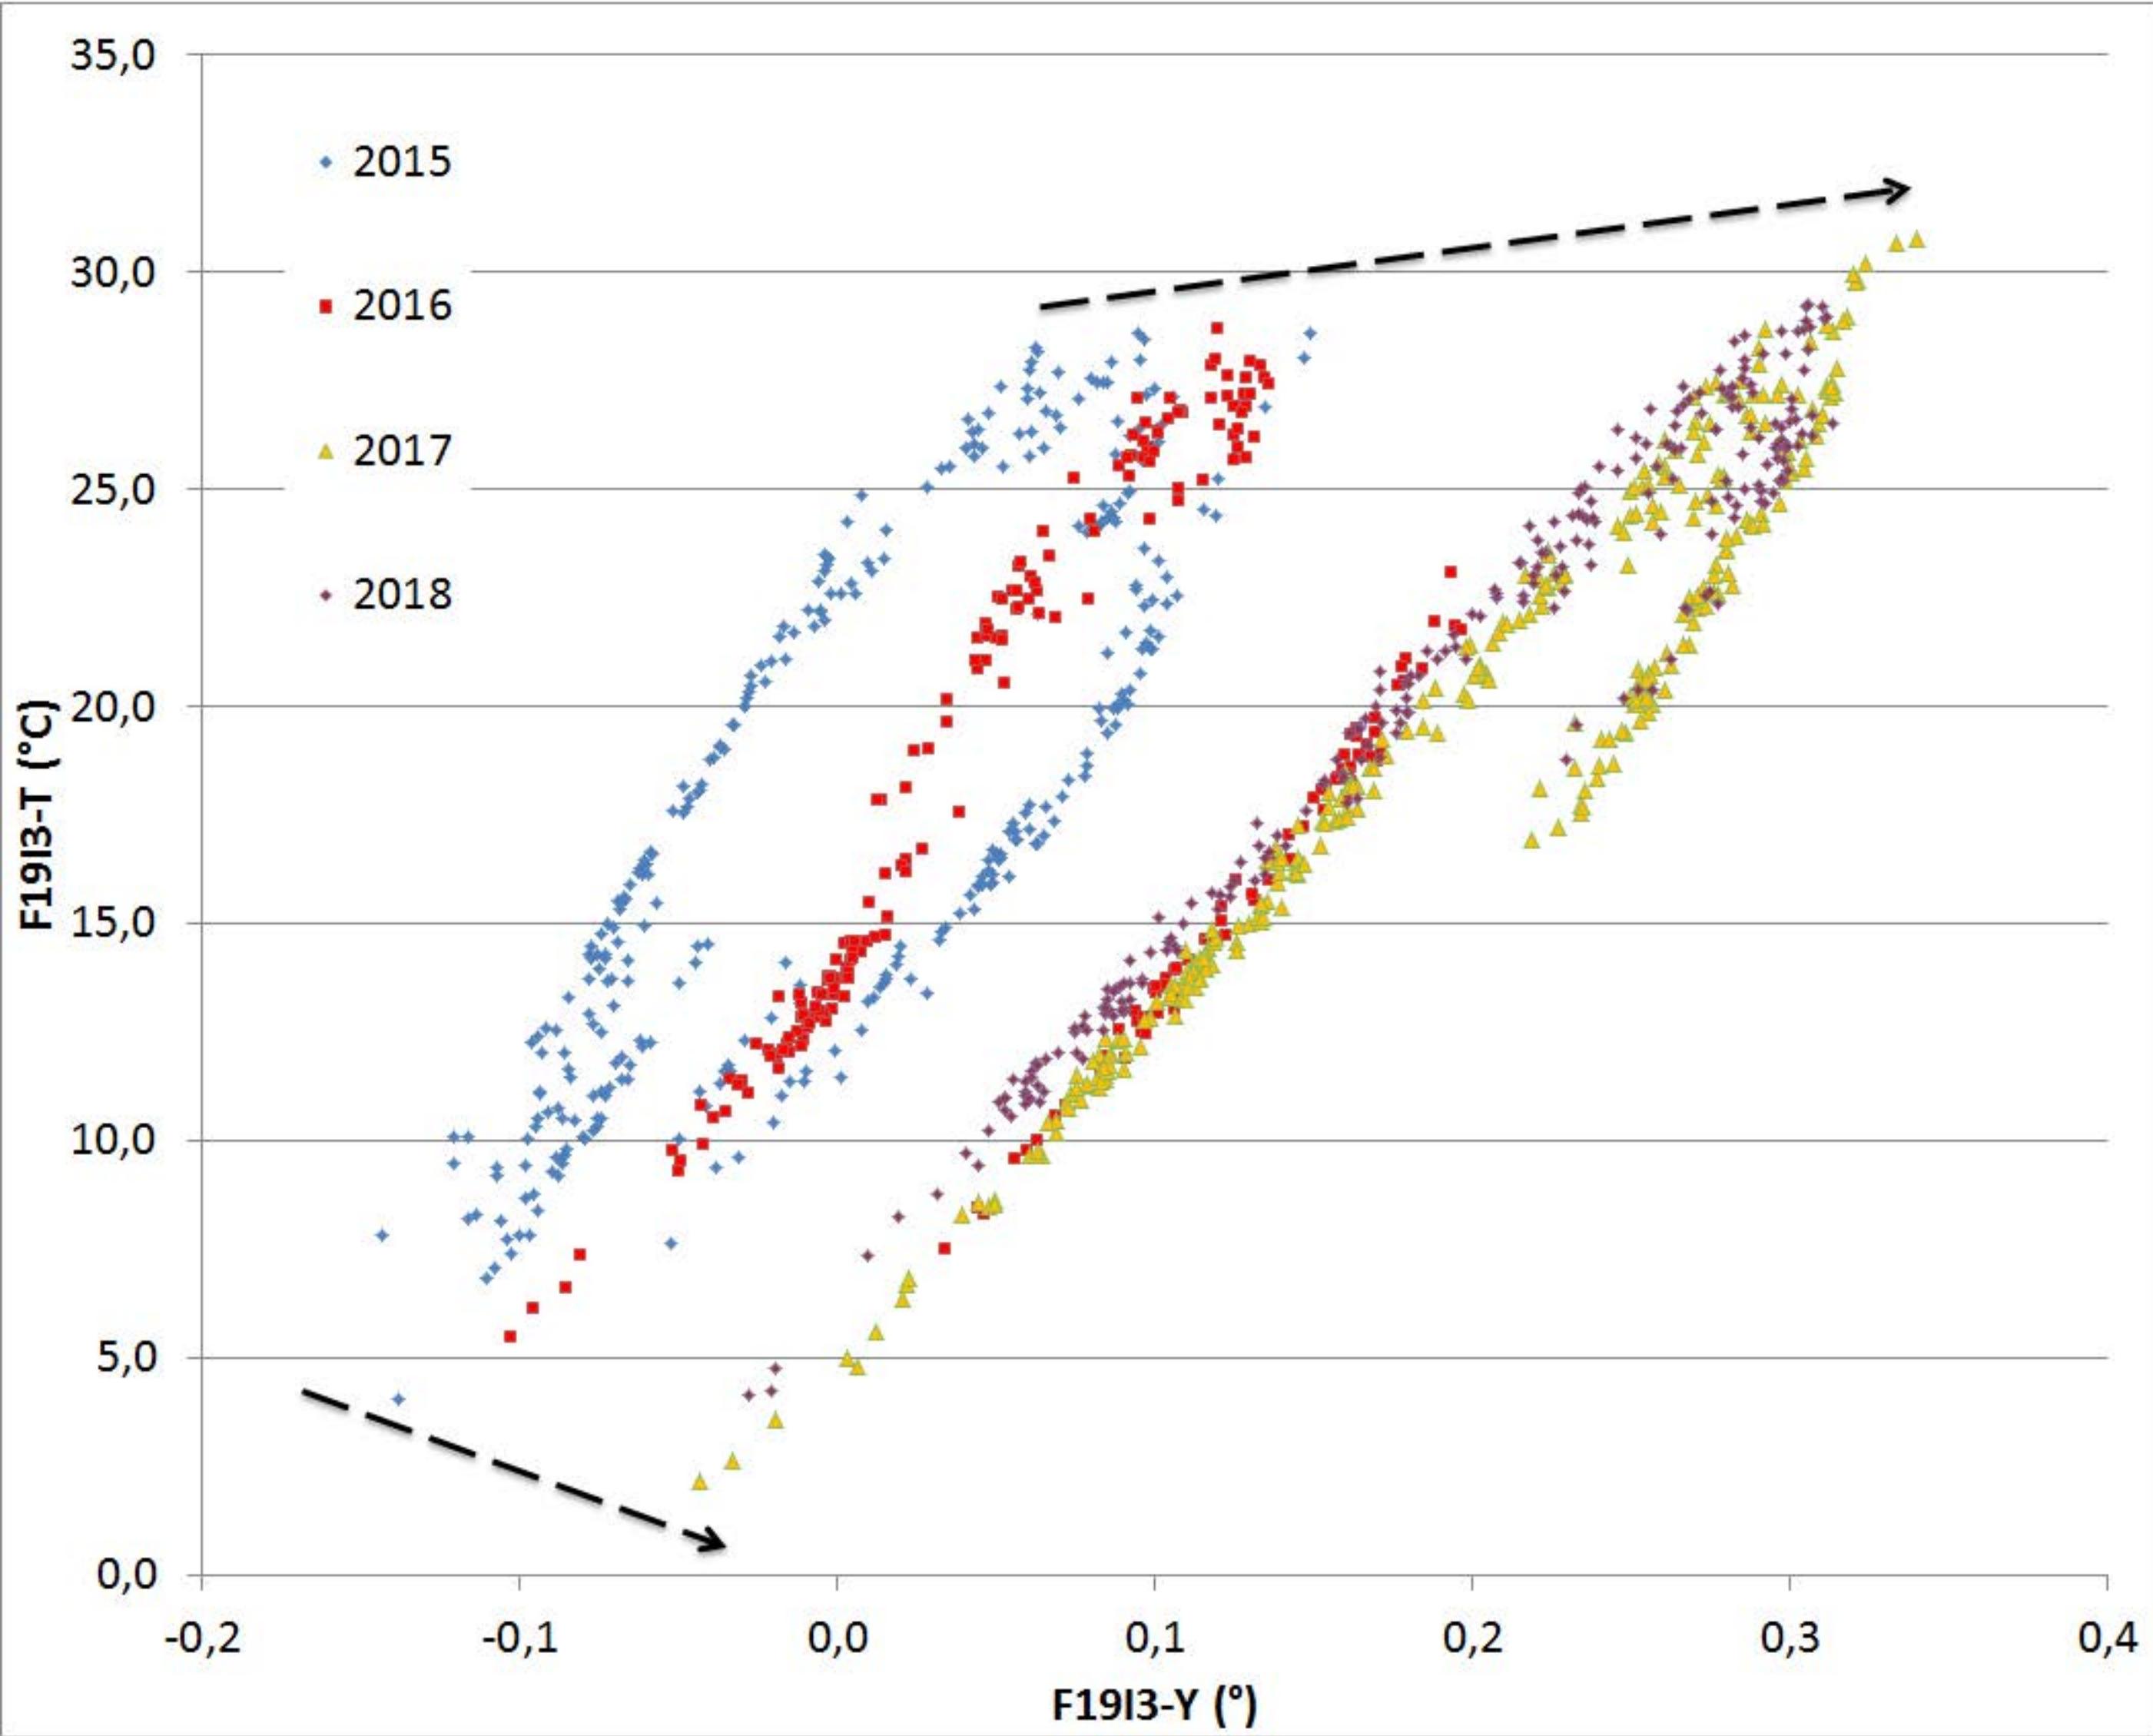
**Figure 25:** Progressive increase of tiltmeter F19I3-Y measurements values (see dashed arrows) from 2015 to 2018 referred to local temperature.
