# Slope deformation, reservoir variation and meteorological data at the Khoko landslide, Enguri hydroelectric basin (Georgia), during 2016-2019

The Greater Caucasus mountain belt is characterized by deep valleys, steep slopes and frequent seismic activity, the combination of which results in major landslide hazard. Along the eastern side of the Enguri water reservoir lies the active Khoko landslide, whose head scarp zone affects the important Jvari-Khaishi-Mestia road, one of the few connections with the interior of the Greater Caucasus. Here, we present a database of measurement time series taken over a period of 4 years (2016-2019) that enable to compare slope deformation with meteorological factors and man-induced perturbations owing to variations in the water level of the reservoir. The monitoring system we used is composed of two digital extensometers, placed within two artificial trenches excavated across the landslide head scarp. The stations are equipped also with internal and near ground surface thermometers. The data set is integrated by daily measurements of rainfall and lake level. The monitoring system – the first installed in Georgia - was set up in the framework of

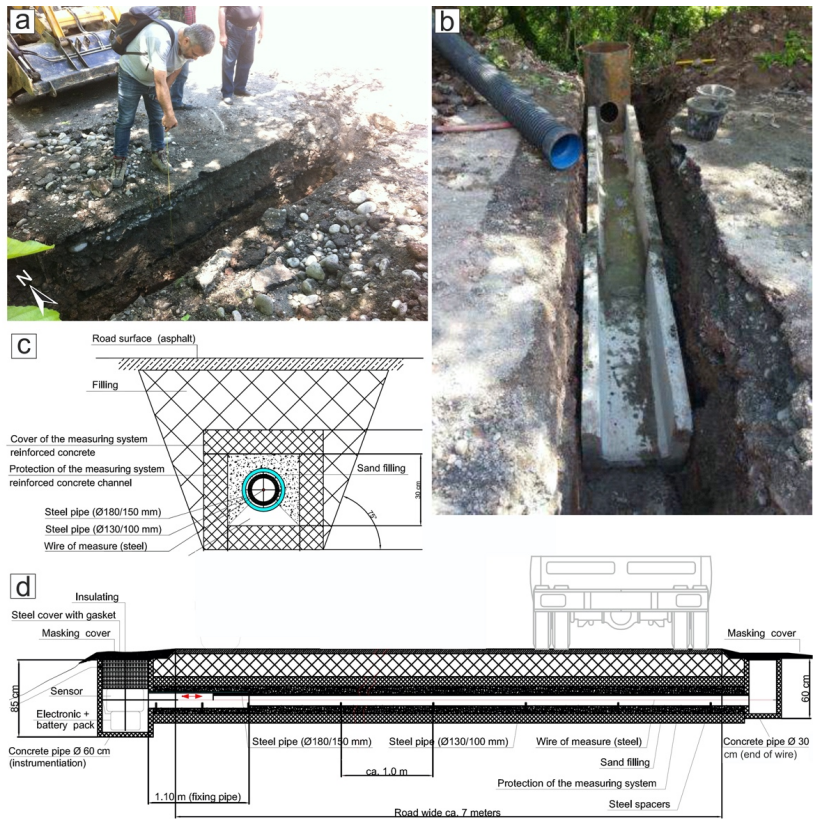
349 **Figure 5.** (a) Opening of trench n. 1. (b) Installation of the concrete protection for the extensometer.  
350 (c) Section transversal to the extensometer system. (d) Longitudinal section of the extensometer  
351 system. Location of the two measurement stations provided in Figure 3a.

306 In 2016, two trenches were excavated across the main head scarps of the Khoko landslide, separated  
 307 by about 240 m. The location of the sites selected for trenching is indicated in Figure 3a, and these  
 308 locations were based upon the presence of clear indicators of active deformation on the road, at the  
 309 foot of the main landslide scarps. Each of the two trenches was suitable for hosting a horizontal,  
 310 digital extensometer (Wire Linear Potentiometric Transducer, SF500). The two trenches were opened  
 311 perpendicularly to the scarp strike, crossing the road at a high angle (Fig. 5a). The instrumentation  
 312 was placed within a protection system aimed at avoiding disturbance or damage from heavy load  
 313 traffic (Figs. 5b-d). The opening of the trenches was performed in two stages, so as to enable vehicles  
 314 to drive through the area along alternating lanes. The protection of the measurement stations consists

316 The instrument is composed of a wire, a digital meter, and a recorder system. The stainless steel wire  
 317 changes its length based on the relative movements of the piercing points to which it is connected.  
 318 The wire was inserted into a pipe, laid down horizontally and protected with sand (Fig. 5c-d). At both  
 319 ends, steel pipes were positioned, aimed at securing the measurement wire and the electronic  
 320 instrumentation. Each vertical tube was equipped with a steel cover and gasket. The two covers were  
 321 buried underneath a 15 cm-thick soil layer. These operations were made more difficult by the presence  
 322 of a pavement in concrete beneath the present-day asphalt layer. The meter is a wire potentiometric  
 323 position transducer that turns a linear motion into a resistance variation. It is made of a precision  
 324 rotating potentiometer operated by the winding or unwinding stainless steel wire.
