# Slope deformation, reservoir variation and meteorological data at the Khoko landslide, Enguri hydroelectric basin (Georgia), during 2016-2019

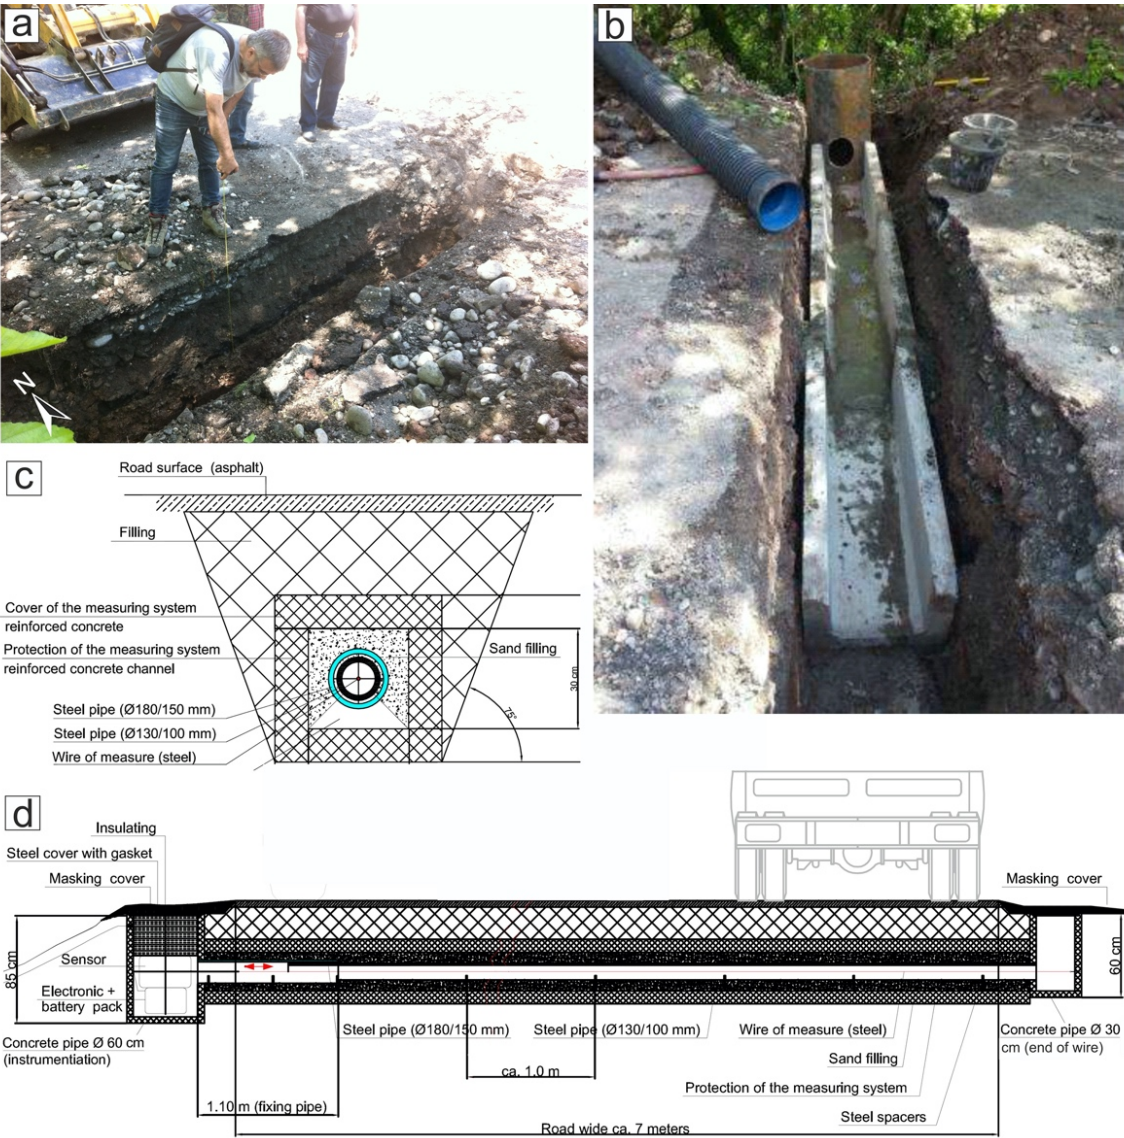
251  
 252 **Figure 5.** (a) Opening of trench n. 1. (b) Installation of the concrete protection for the extensometer.  
 253 (c) Section transversal to the extensometer system. (d) Longitudinal section of the extensometer  
 254 system. Location of the two measurement stations provided in Figure 3a.  
 255

In 2016, two trenches were excavated across the main head scarps of the Khoko landslide, separated by about 240 m. The location of the sites selected for trenching is indicated in Figure 3a, and these locations were based upon the presence of clear indicators of active deformation on the road, at the foot of the main landslide scarps. Each of the two trenches was suitable for hosting a horizontal, digital extensometer (Wire Linear Potentiometric Transducer, SF500). The two trenches were opened perpendicularly to the scarp strike, crossing the road at a high angle (Fig. 5a). The instrumentation was placed within a protection system aimed at avoiding disturbance or damage from heavy load traffic (Figs. 5b-d). The opening of the trenches was performed in two stages, so as to enable vehicles to drive through the area along alternating lanes. The protection of the measurement stations consists of a channel in reinforced concrete, buried down to a depth of at least 50 cm.

The instrument is composed of a wire, a digital meter, and a recorder system. The stainless steel wire changes its length based on the relative movements of the piercing points to which it is connected. The wire was inserted into a pipe, laid down horizontally and protected with sand (Fig. 5c-d). At both ends, steel pipes were positioned, aimed at securing the measurement wire and the electronic instrumentation. Each vertical tube was equipped with a steel cover and gasket. The two covers were buried underneath a 15 cm-thick soil layer. These operations were made more difficult by the presence of a pavement in concrete beneath the present-day asphalt layer. The meter is a wire potentiometric position transducer that turns a linear motion into a resistance variation. It is made of a precision rotating potentiometer operated by the winding or unwinding stainless steel wire.
