# The 2024 Noto Peninsula earthquake building damage dataset: Multi-source visual assessment

**Abstract.** We present a building damage dataset following the 2024 Noto Peninsula Earthquake. The database was compiled from freely available, multi-source, remote sensing data, verified through opt-in crowd-sourced information. The dataset consists of geo-referenced ~~vector~~ polygons representing the pre-event building footprints of 140,208 structures. Each building was classified through visual inspection using pre-disaster and ~~post-disaster~~ post-disaster vertical, oblique, survey, and verifiable news reporting imagery. Entries were validated using voluntary-submission data sourced through a web-API hosting a live version of the database. We calculate classification metrics for a subset of the database where ground survey photographs were provided by independent surveyors. An average  $F_1$ -score of 0.94 suggests that the proposed assessment is consistent and high quality. We aim to inform future ~~disaster~~ research such as ~~disaster~~ disaster-specific physical dynamics models; statistical and machine learning damage models; logistics and evacuation studies. The present wor

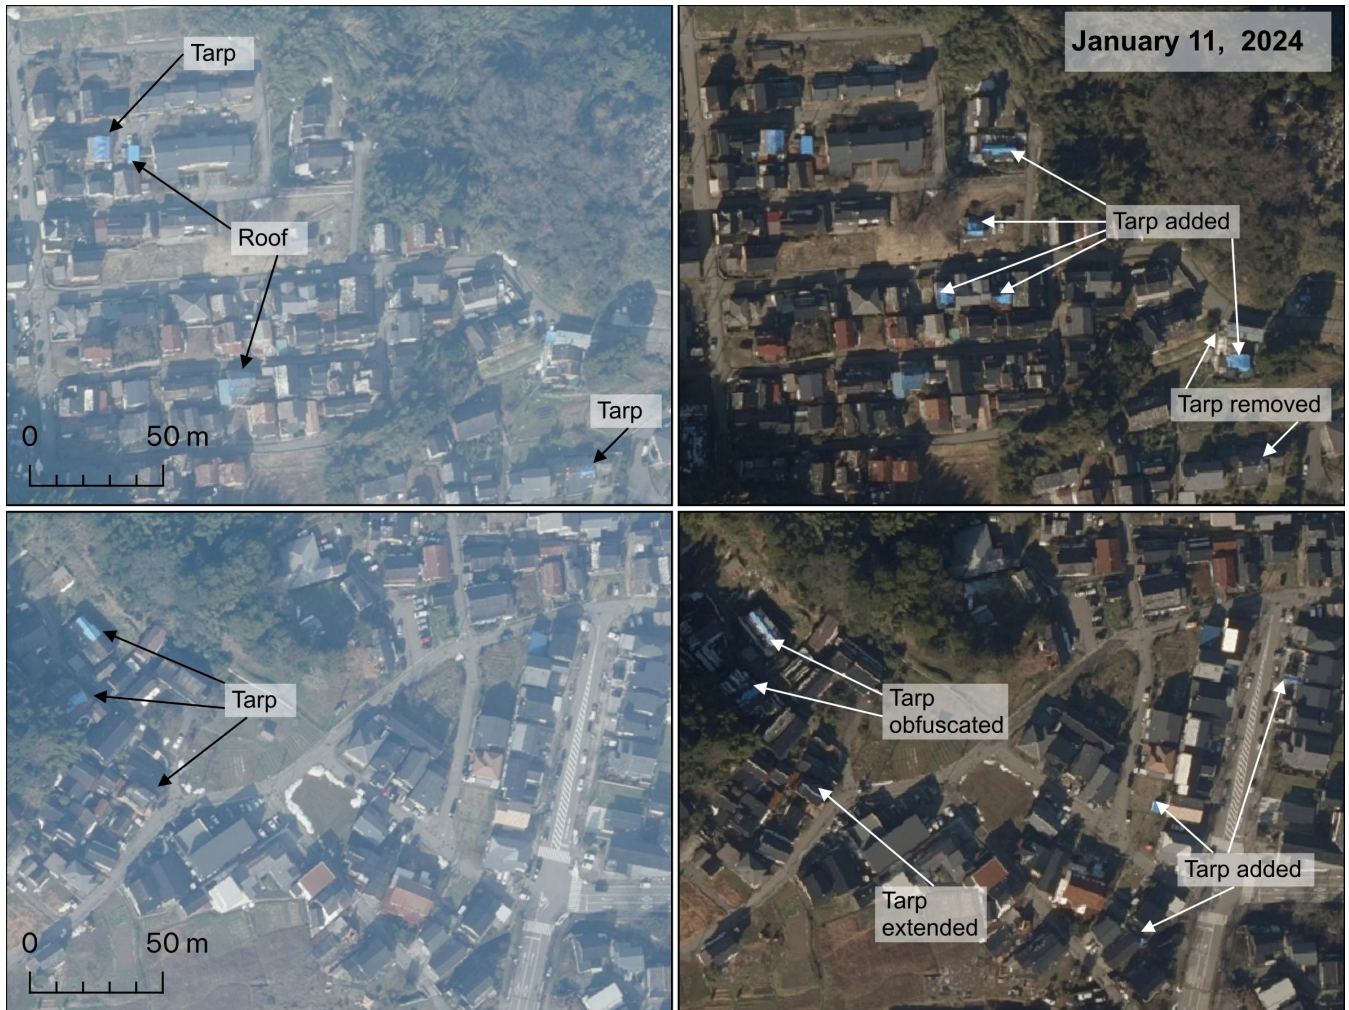
**Figure 6.** Examples of change in blue tarp coverage in Wajima City between aerial imagery capture missions. The figure highlights challenges faced through potential issues in coverage, atmospheric conditions, and source mismatch. Aerial imagery courtesy of [GSI \(2024\)](#).
