# The 2024 Noto Peninsula earthquake building damage dataset: Multi-source visual assessment

**Abstract.** We present a building damage dataset following the 2024 Noto Peninsula Earthquake. The database was compiled from freely available, multi-source, remote sensing data, verified through opt-in crowd-sourced information. The dataset consists of geo-referenced polygons representing the pre-event building footprints of 140,208 structures. Each building was classified through visual inspection using pre-disaster and post-disaster vertical, oblique, survey, and verifiable news reporting imagery. Entries were validated using voluntary-submission data sourced through a web-API hosting a live version of the database. We calculate classification metrics for a subset of the database where ground survey photographs were provided by independent surveyors. An average  $F_1$ -score of 0.94 suggests that the proposed assessment is consistent and high quality. We aim to inform future research such as disaster-specific physical dynamics models; statistical and machine learning damage models; logistics and evacuation studies. The present work describes the data collection process, damage assessm

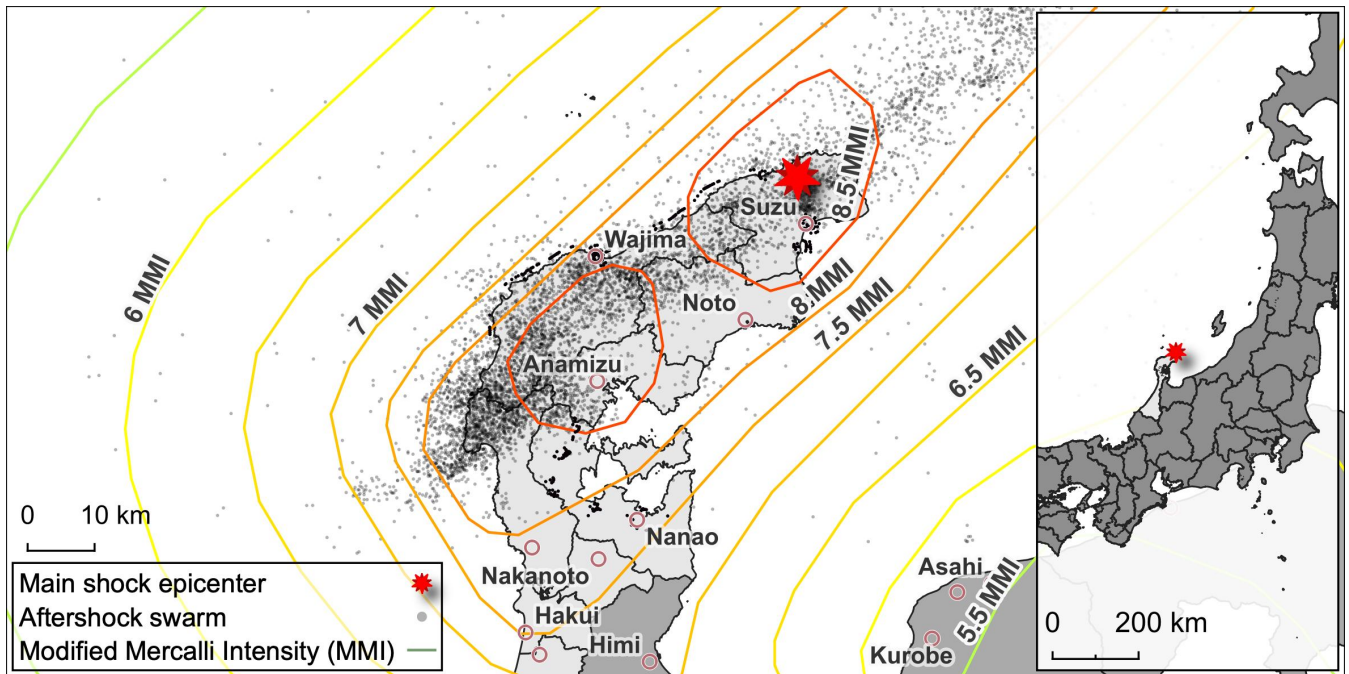
**Figure 1.** Seismic context of the 2024 Noto Peninsula Earthquake showing the distribution of the earthquake swarm following the aftershocks (USGS, 2024; GSI, 2024).

At 16:10 January 1st 2024, shallow reverse faulting produced a  $M_w$  7.5 earthquake (USGS, 2024) that propagated from the north-most point of Suzu City, Ishikawa Prefecture (Figure: 1). The disaster poses unique challenges for the disaster geophysics community due to its context and outfall. The intraplate faulting occurred on the relatively inert western coast of Honshu Island, Japan, following a 3 year long earthquake swarm (Ishikawa and Bai, 2024). Affected areas were the Suzu, Noto, Wajima, Nanao, Shika and Anamizu municipalities (NASA, 2024; Japan Meteorological Agency, 2024; Japanese Red Cross Society, 2024). The Prime Minister’s Office of Japan has provided transcripts for several press conferences and emergency meetings reporting actions taken to address monitoring and relief operations. Initial reporting informed of near instant tsunami

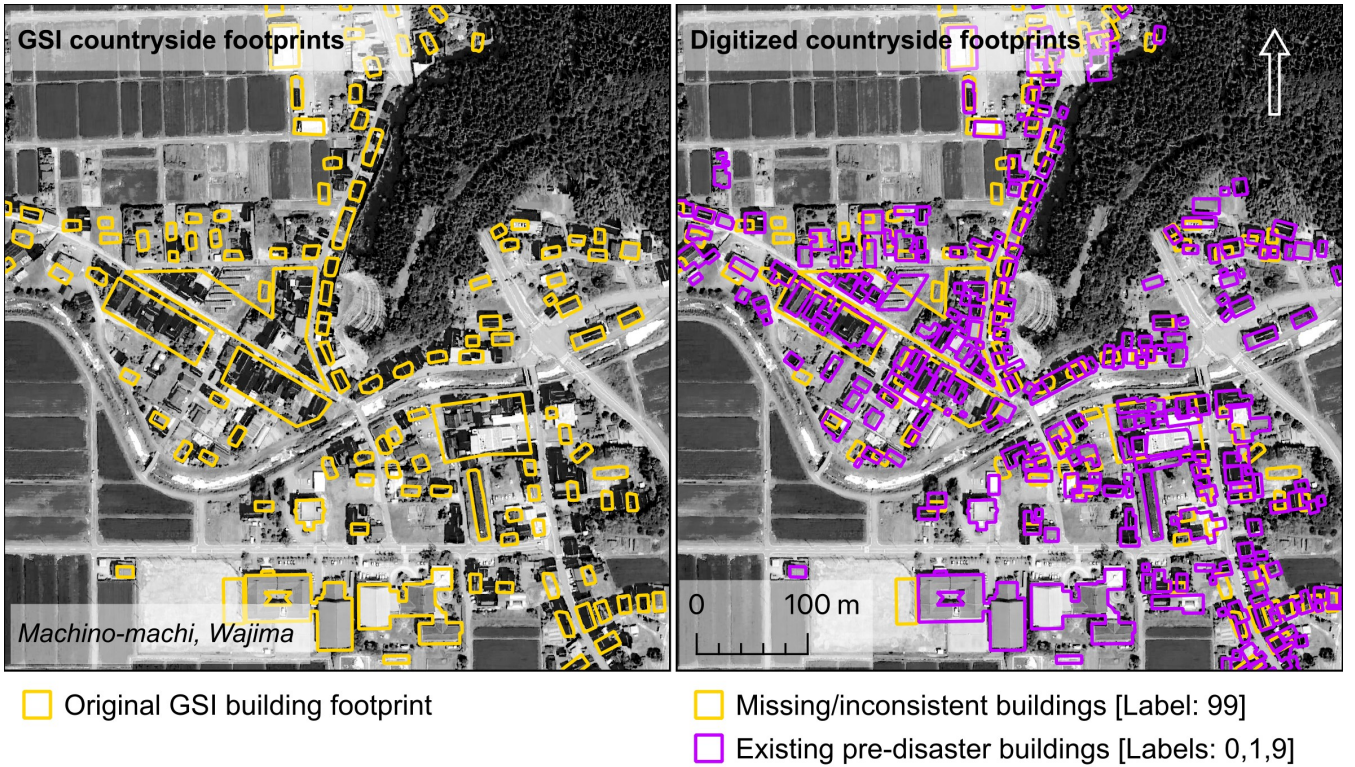
**Figure 2.** Mismatch between original building polygons provided by the Geospatial Information Authority of Japan (GSI) and orthophoto imagery. Inconsistencies appear more prevalent in rural areas, where the building inventory is often inconsistent with or not representative of vertical imagery. As part of the classification process, newly identified buildings were added to the database, while existing building footprints were adjusted to match the orthophoto imagery. In case of ambiguity, the original, ambiguous building polygon marked as 99 (missing or inconsistent). One or more new building polygons are drawn over the ambiguous polygon, based on the most recent pre-event vertical imagery, to more faithfully represent the pre-disaster condition; the new polygons are then classified as described in Section 2 (Basemap attribution: © Google, 2024 Airbus, CNES/Airbus, Japan Hydrographic Association, Landsat/Copernicus, Maxar Technologies 2024).

As mentioned in Section 1, there exist significant discrepancies between the GSI building inventory and the pre-event orthophotos. These discrepancies are particularly pronounced in rural areas where the GSI building inventory is often missing or inconsistent with the orthophoto baseline. These mismatches range from minor misalignments, to geometry changes (in the case of additions, refurbishing, or Knock Down Rebuild), to significant changes in the building footprint that are unattributable even  
130 when cross-checking the historical imagery. When reasonable, we attempted to adjust the GSI building footprints to match the orthophoto baseline, this is done in order to preserve the original GSI building metadata (see Section 3). However, in most cases

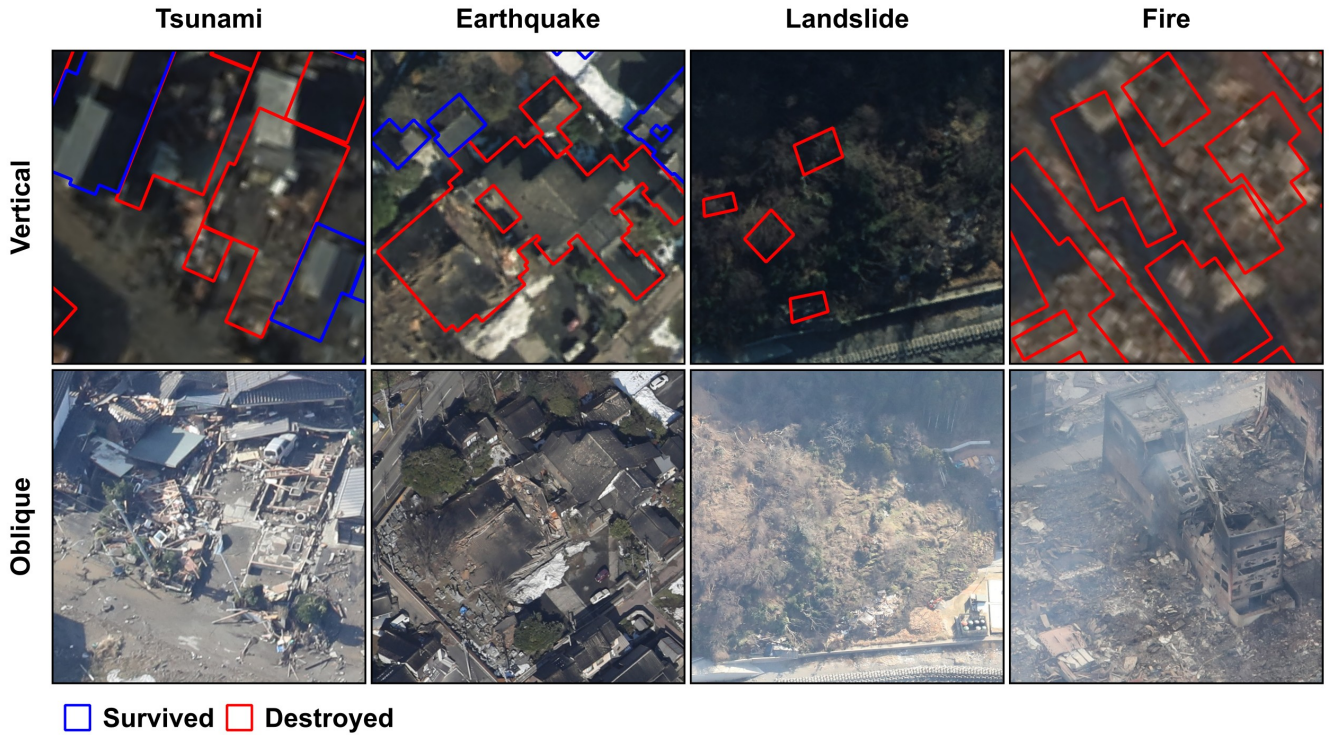
**Figure 3.** Building damage across the Noto Peninsula is split between failure modes consequent to different, often compounding hazards. Vertical aerial imagery by GSI (2024), Oblique imagery by © KKC (2024)

assessments carry inherent limitations beyond human interpretation, such as the capability to generalize between domains and hazard induced damage (e.g. damage to buildings from tsunami, earthquake, fire, etc. all look different). A preliminary investigation of the official building footprint inventory, provided by the Geospatial Information Authority of Japan (GSI), revealed large discrepancies with pre-event imagery (Figure 2). Moreover, the variable aerial survey periods, image capture quality, meteorological conditions (Table 1), and different mechanisms driving building failure (Such as fire, tsunami, earthquake, etc.; Figure 3) contributed to a visually fragmented and inconsistent domain.

The unique nature of the disaster is reflected in its varied impacts on buildings, such as: ground shaking, subsidence, uplifting, tsunami surge, soil liquefaction, landslide, fire, among others (Figure 3). The dataset provides a comprehensive visual assessment of building damage across the Noto Peninsula, including all the aforementioned impacts. With this contribution, we aim to provide a reference for future studies and a benchmark for automated methods.

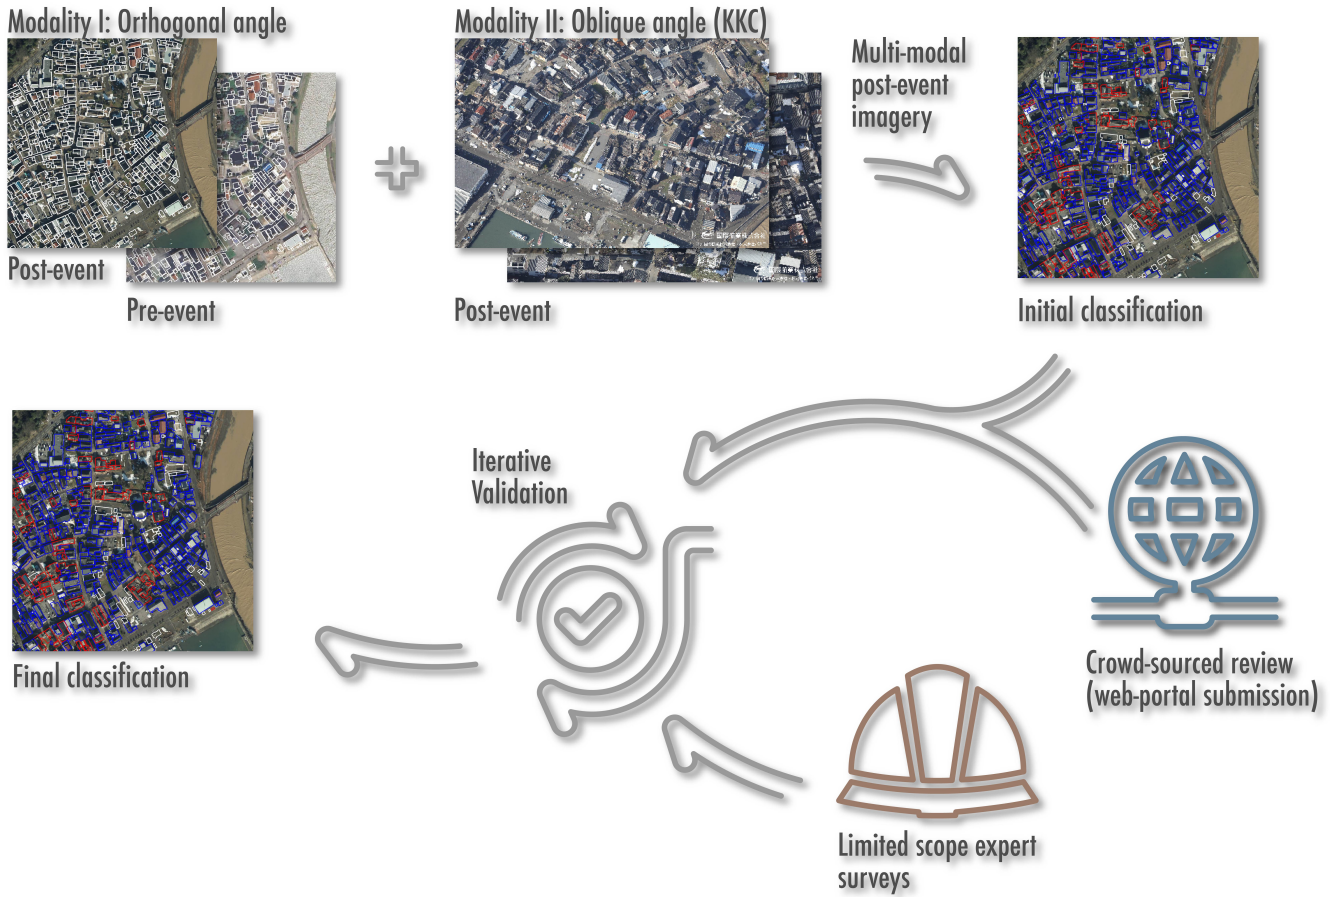
**Figure 4.** Building damage visual assessment workflow illustrating the working group’s approach to multi-source & multi-modal data, each stage of inclusion and expert-feedback-driven iterative validation process. Pre-event orthophoto by © Google 2024, Post event aerial by GSI (2024), All oblique imagery courtesy of © KKC (2024).

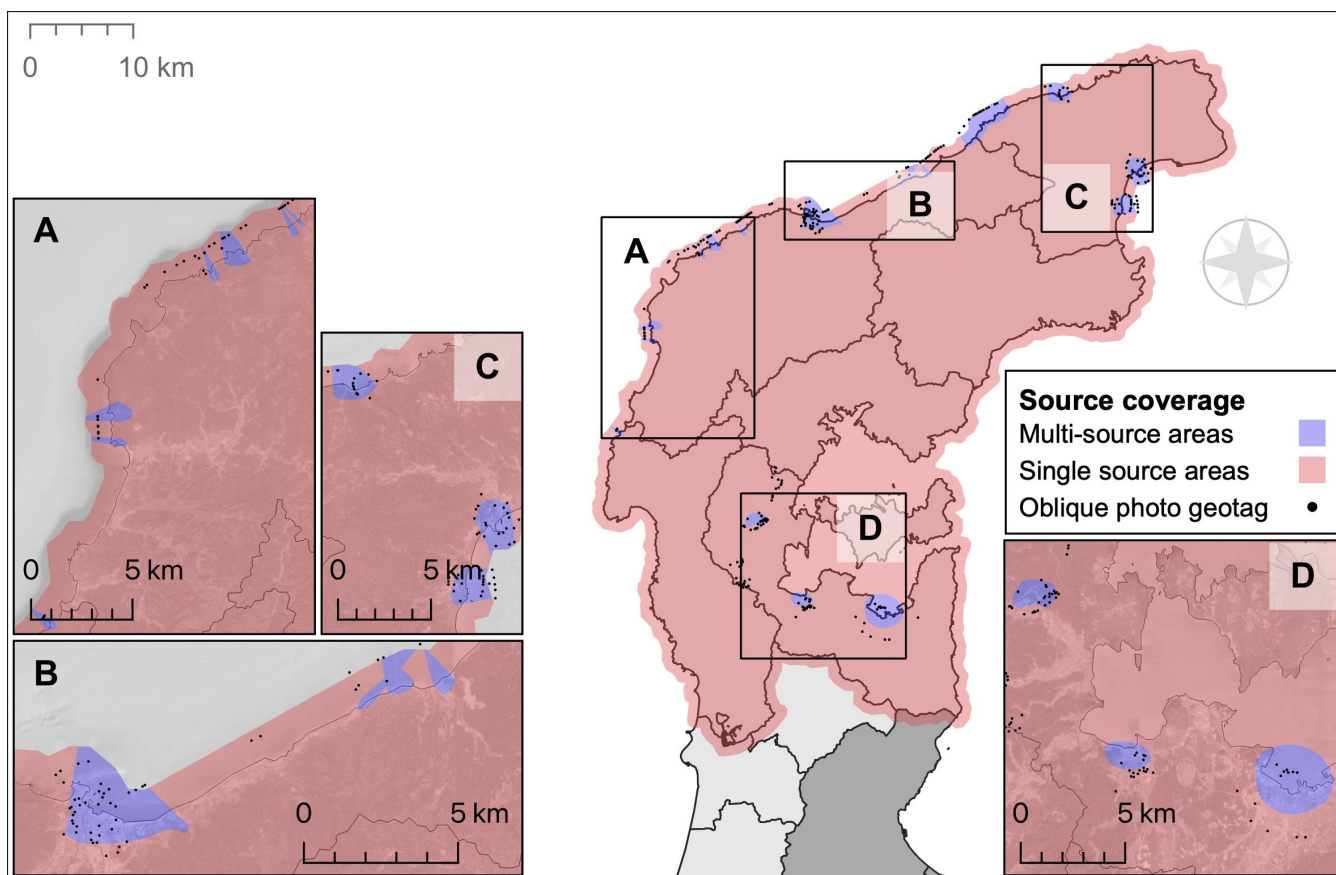
**Figure 5.** Oblique coverage by Kokusai Kogyo (KKC, 2024) and inherent confidence of visual assessment. Inset basemap © Google 2024

125 in the vertical imagery and limited coverage of the obliques conditions disallowed a comprehensive assessment (Figure 5).

Since only  $\sim 16\%$  of buildings lie within the viewing angle of oblique imagery a multi-class assessment was deemed less viable. [Miura et al. \(2020\)](#) make a case for the inclusion of blue-tarp covered buildings as a separate class in their deep learning classification framework: they notice that presence of blue-tarp covered structures correlated with moderate-heavy building damage classes. Although we initially considered including tarp-covered buildings as a distinct class, there exist mismatches between the GSI provided vertical images: this is observable for segments where overlapping orthophotos are available, such as Wajima City. Figure 6 provides an example of the mismatch in tarp presence between mission dates. In other instances, such as Anamizu-machi, spotty cloud cover makes the identification of tarp-covered buildings particularly challenging. Ultimately, a conservative approach was deemed preferable.

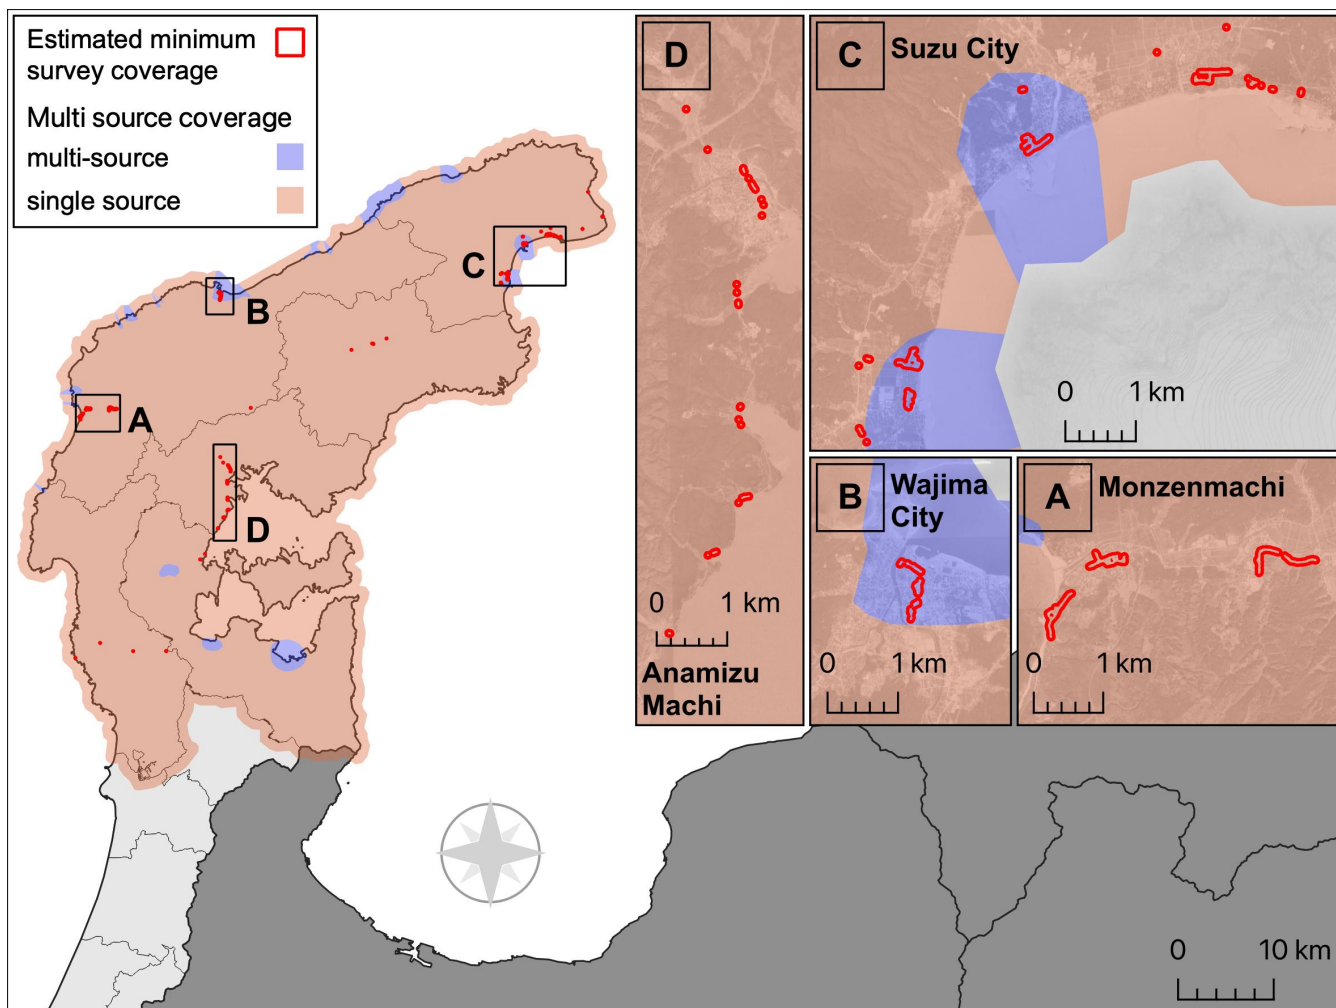
**Figure 9.** Dataset validation areas are estimated from imagery provided by an independent survey team. A path was fit through the location metadata of each photo. We assume a 40 m range buffer around the path as a reasonable visible area for the survey team, judging by the photographic evidence provided. Inset basemap courtesy of © Google 2024.

and destroyed classes is 0.939, suggesting high confidence in the assessment. A spatial representation of the survey coverage is given in Figure 9, notably a large portion of the surveyed areas are outside of multi-source coverage, suggesting that despite the limitations described above, the proposed visual assessment framework is robust. We hope that this exercise in crowd-sourced and survey validation will permit further statistical investigations into the features and limitations of manual image-based rapid building damage visual assessments.

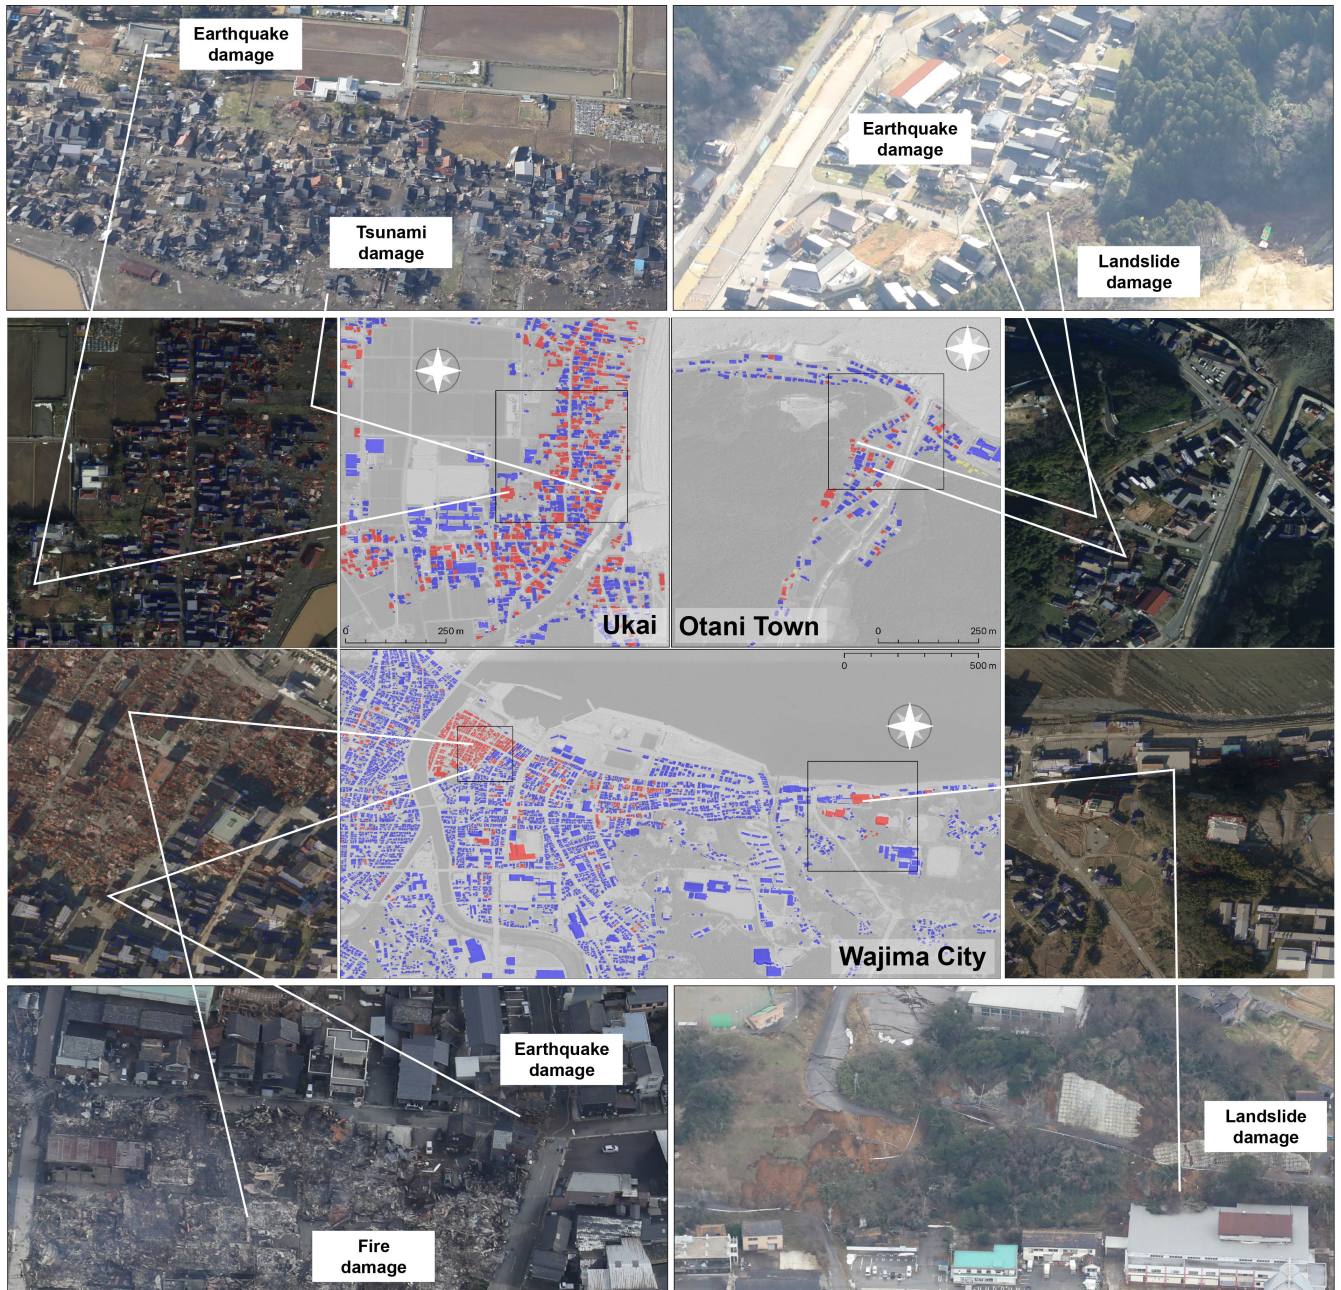
**Figure 10.** Different impacts across contiguous areas of the Noto Peninsula illustrate how multiple hazards may manifest across a single event with extreme proximity. Basemap courtesy of © Google 2024, Obliques by © KKC (2024).

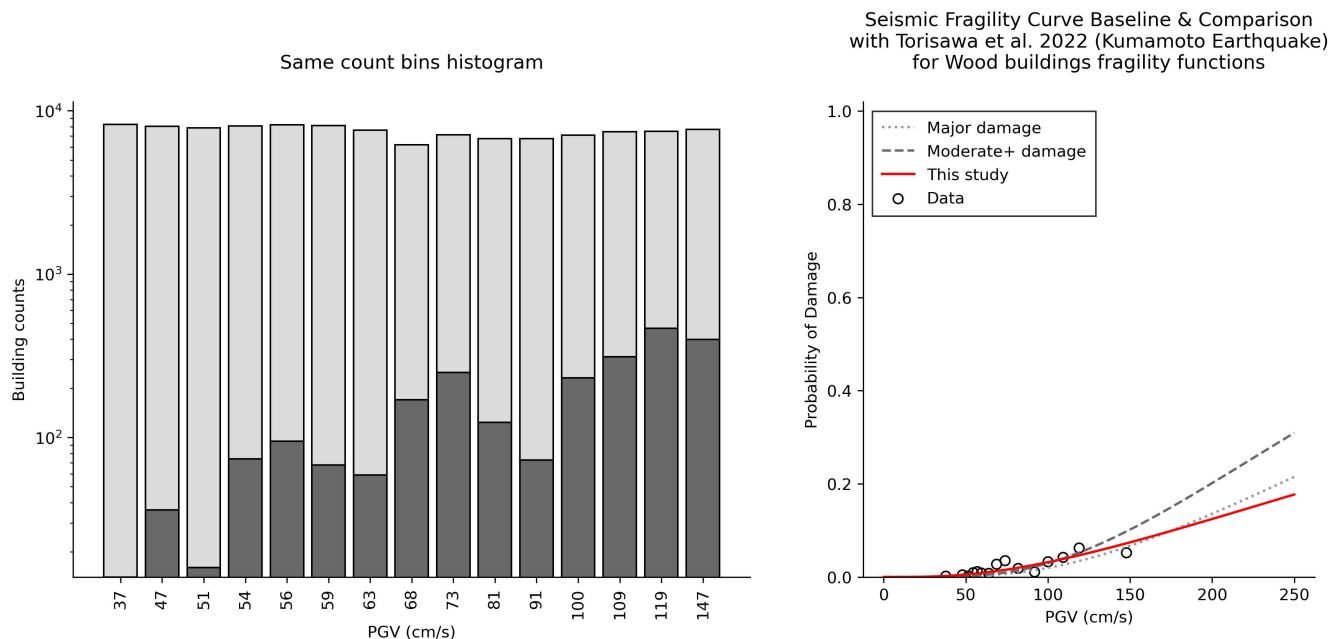
**Figure 12.** Left: Histogram of aggregated building damage. Right: Empirical fragility function (red solid line) for earthquake-affected buildings relative to PGV. We provide two wood buildings fragility functions for “Major” and “Moderate+” damage classes (respectively dotted line and dashed line) proposed by Torisawa et al. (2022) for buildings built between 2001 and 2016 and affected by the 2016 Kumamoto Earthquake.

To stoke the research community’s engagement, we provide a statistical baseline of the damage across the non-inundated portion of the Noto Peninsula dataset (Figure 12). We propose an aggregated seismic empirical fragility function relative to

damage is solely due to seismic shaking. We fit the aggregated data using a lognormal distribution (Equation 1) and estimate the parameters using ordinary least squares ( $\mu = 6.436, \sigma = 0.9869$ ).

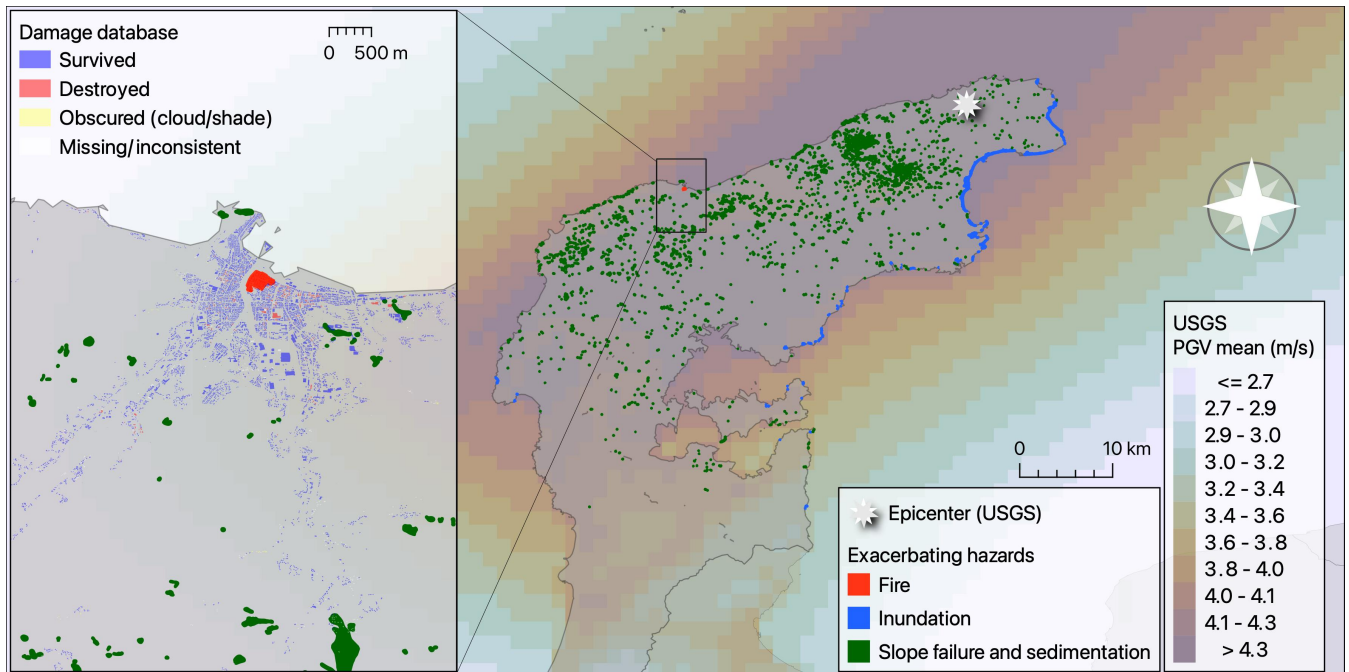
**Figure 13.** Composite of exacerbating hazards (in addition to seismic impact). Inundation, fire area, and slope failure/sedimentation extents are provided by the GSI (2024). Peak ground acceleration estimates provided by KKE (2024) in collaboration with NIED (2019).

270 the Peak Ground Velocity (PGV) registered during the event. Importantly, this fragility function is built on the subset of data that was not affected by aggravating hazards (inundation, fire, or landslide) illustrated in Figure 13. Hence we assume that the
