# The 2024 Noto Peninsula earthquake building damage dataset: Multi-source visual assessment

**Abstract.** We present a building damage dataset following the 2024 Noto Peninsula Earthquake. The database was compiled from freely available, multi-source, remote sensing data, verified through opt-in crowd-sourced information. The dataset consists of geo-referenced polygons representing the pre-event building footprints of 140,208 structures. Each building was classified through visual inspection using pre-disaster and post-disaster vertical, oblique, survey, and verifiable news reporting imagery. Entries were validated using voluntary-submission data sourced through a web-API hosting a live version of the database. We calculate classification metrics for a subset of the database where ground survey photographs were provided by independent surveyors. An average  $F_1$ -score of 0.94 suggests that the proposed assessment is consistent and high quality. We aim to inform future research such as disaster-specific physical dynamics models; statistical and machine learning damage models; logistics and evacuation studies. The present work describes the data collection process, damage assessm

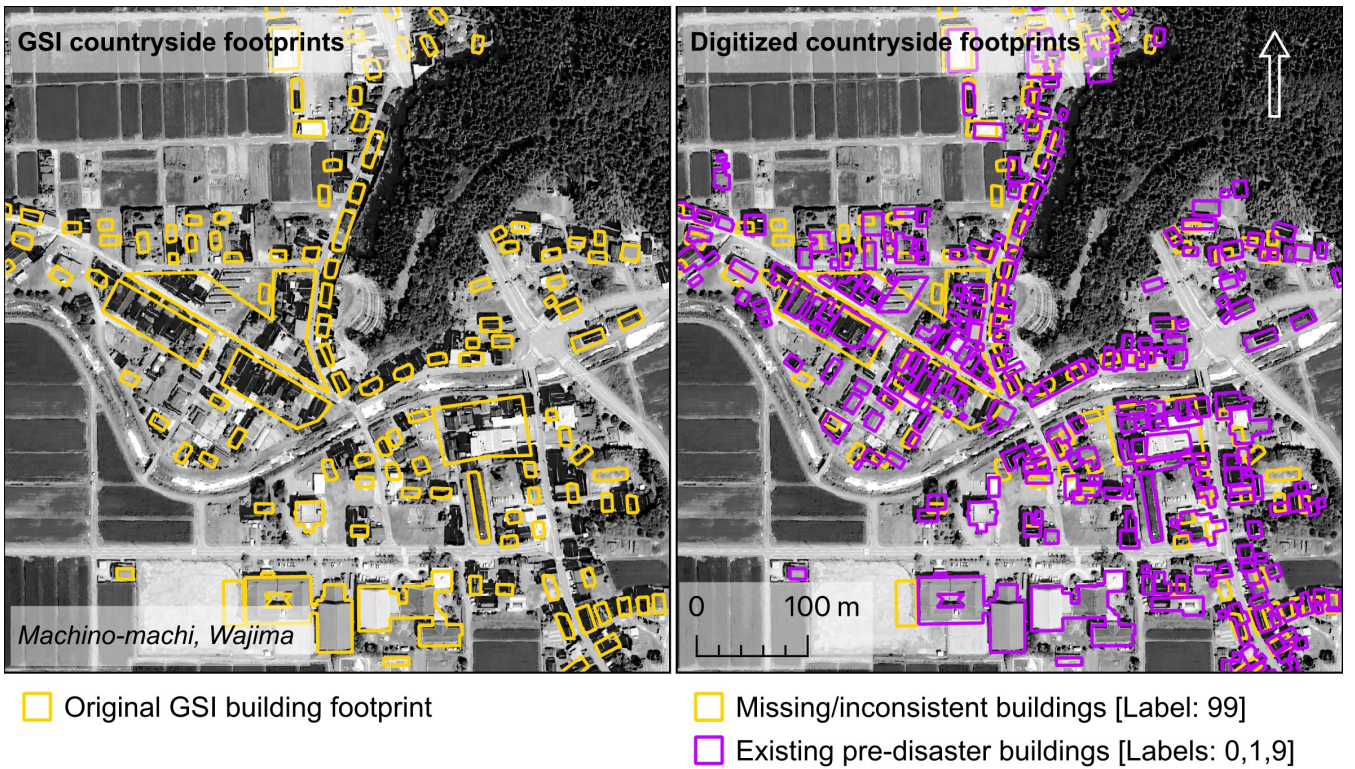
**Figure 2.** Mismatch between original building polygons provided by the Geospatial Information Authority of Japan (GSI) and orthophoto imagery. Inconsistencies appear more prevalent in rural areas, where the building inventory is often inconsistent with or not representative of vertical imagery. As part of the classification process, newly identified buildings were added to the database, while existing building footprints were adjusted to match the orthophoto imagery. In case of ambiguity, the original, ambiguous building polygon marked as 99 (missing or inconsistent). One or more new building polygons are drawn over the ambiguous polygon, based on the most recent pre-event vertical imagery, to more faithfully represent the pre-disaster condition; the new polygons are then classified as described in Section 2 (Basemap attribution: © Google, 2024 Airbus, CNES/Airbus, Japan Hydrographic Association, Landsat/Copernicus, Maxar Technologies 2024).

As mentioned in Section 1, there exist significant discrepancies between the GSI building inventory and the pre-event orthophotos. These discrepancies are particularly pronounced in rural areas where the GSI building inventory is often missing or inconsistent with the orthophoto baseline. These mismatches range from minor misalignments, to geometry changes (in the case of additions, refurbishing, or Knock Down Rebuild), to significant changes in the building footprint that are unattributable even  
130 when cross-checking the historical imagery. When reasonable, we attempted to adjust the GSI building footprints to match the orthophoto baseline, this is done in order to preserve the original GSI building metadata (see Section 3). However, in most cases

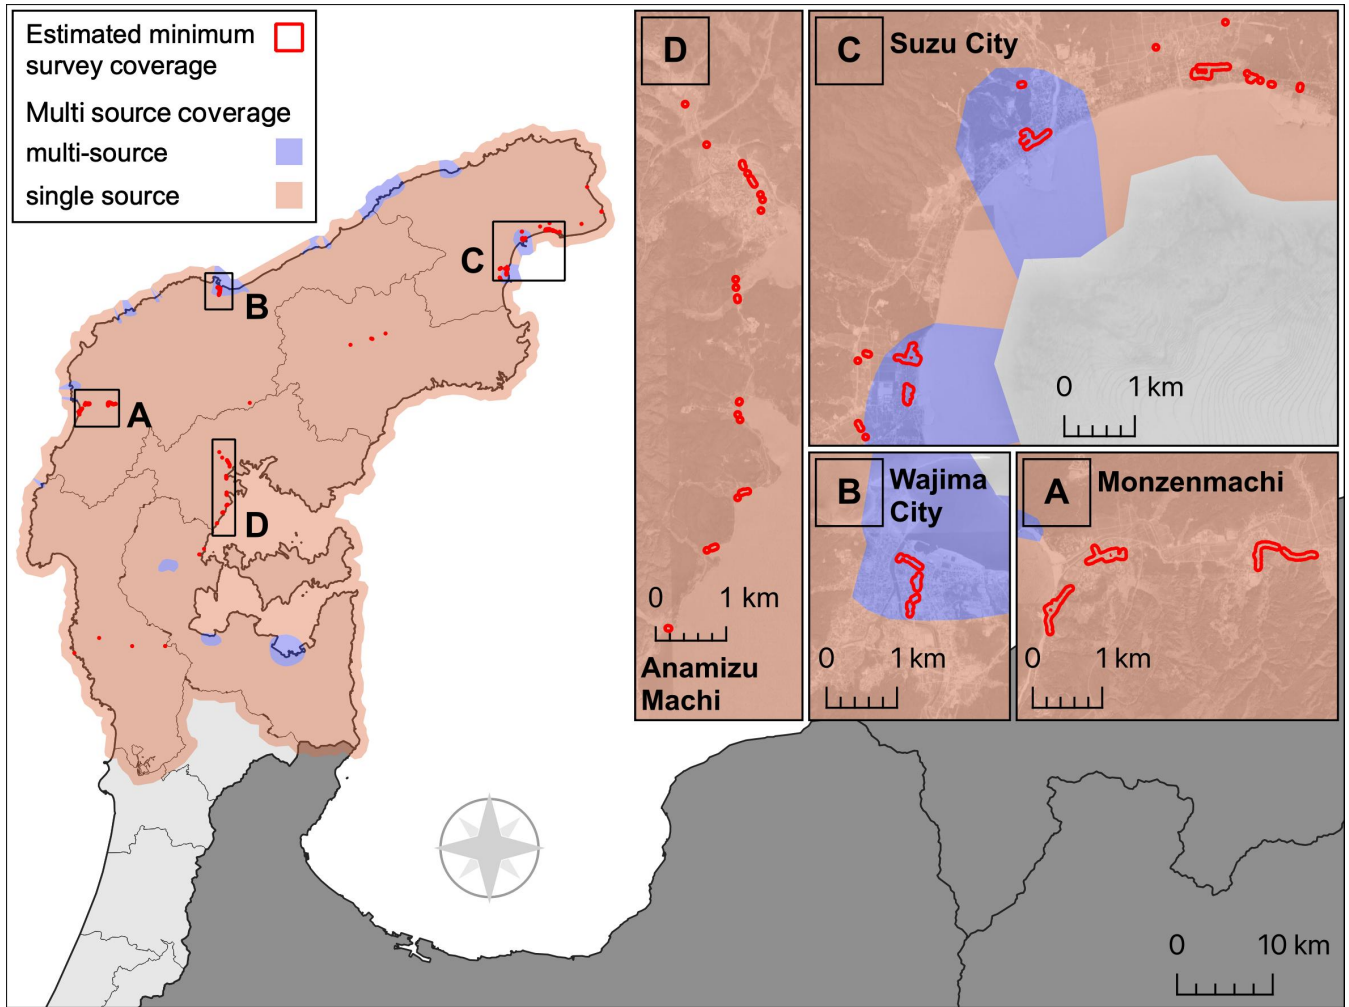
**Figure 9.** Dataset validation areas are estimated from imagery provided by an independent survey team. A path was fit through the location metadata of each photo. We assume a 40 m range buffer around the path as a reasonable visible area for the survey team, judging by the photographic evidence provided. Inset basemap courtesy of © Google 2024.

and destroyed classes is 0.939, suggesting high confidence in the assessment. A spatial representation of the survey coverage is given in Figure 9, notably a large portion of the surveyed areas are outside of multi-source coverage, suggesting that despite the limitations described above, the proposed visual assessment framework is robust. We hope that this exercise in crowd-sourced and survey validation will permit further statistical investigations into the features and limitations of manual image-based rapid building damage visual assessments.

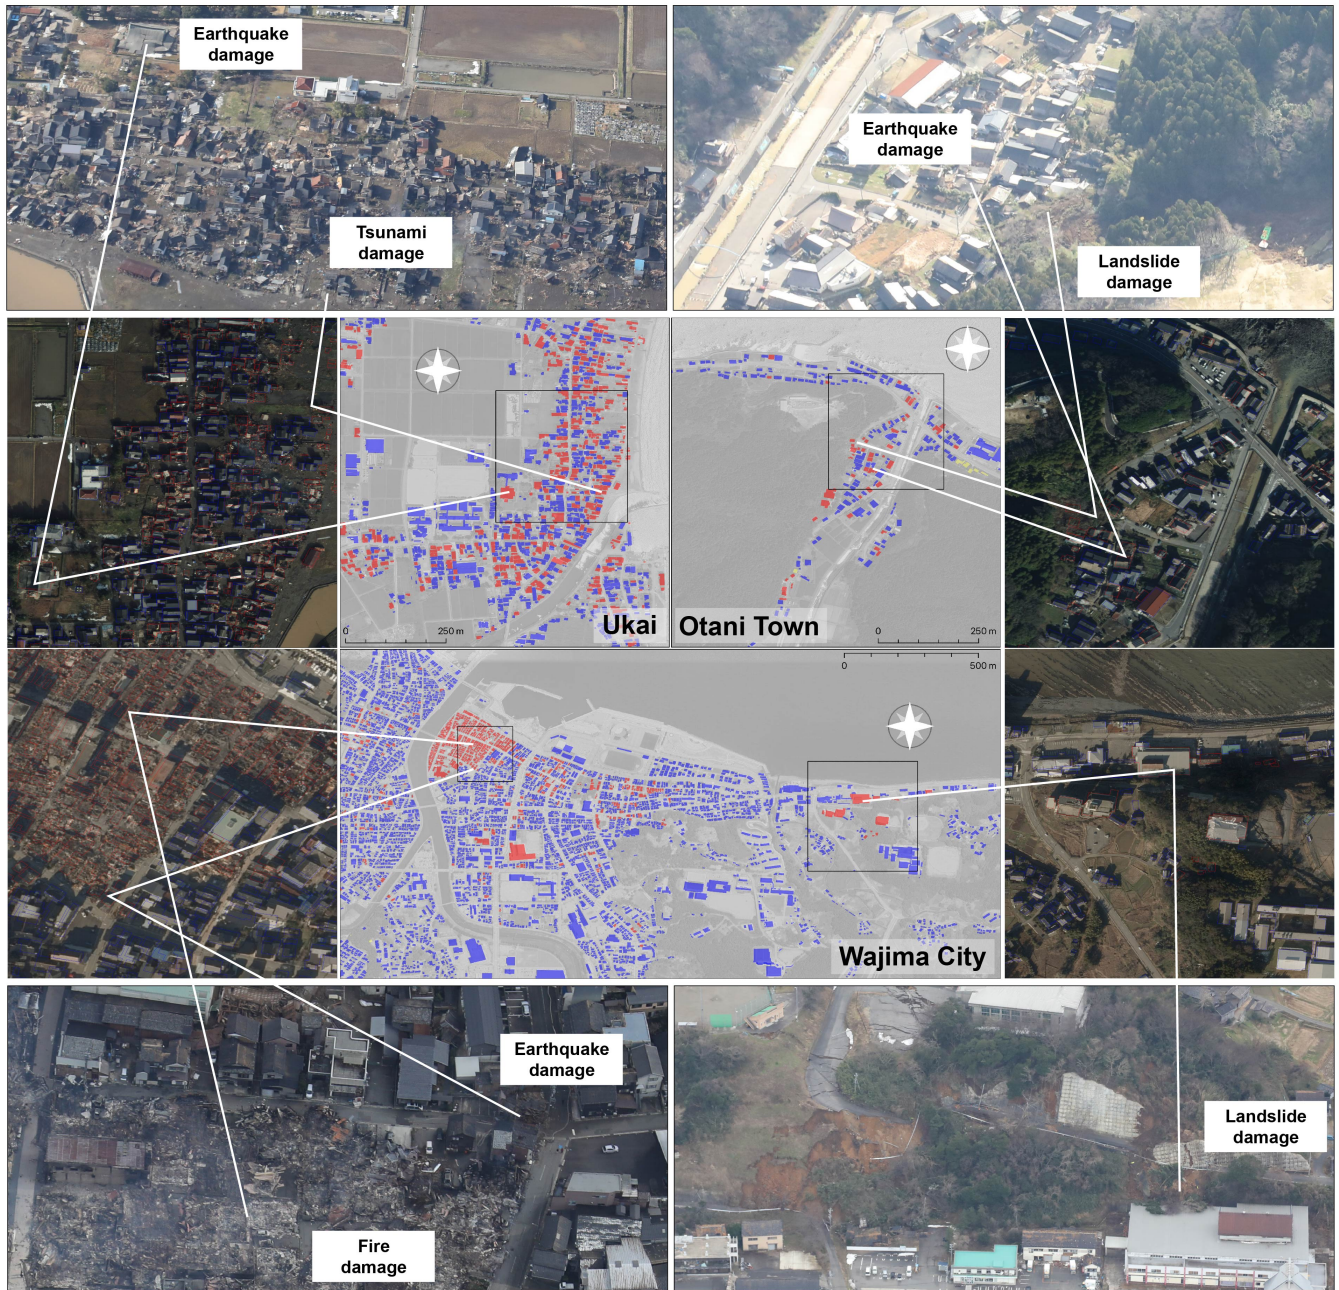
**Figure 10.** Different impacts across contiguous areas of the Noto Peninsula illustrate how multiple hazards may manifest across a single event with extreme proximity. Basemap courtesy of © Google 2024, Obliques by © KKC (2024).

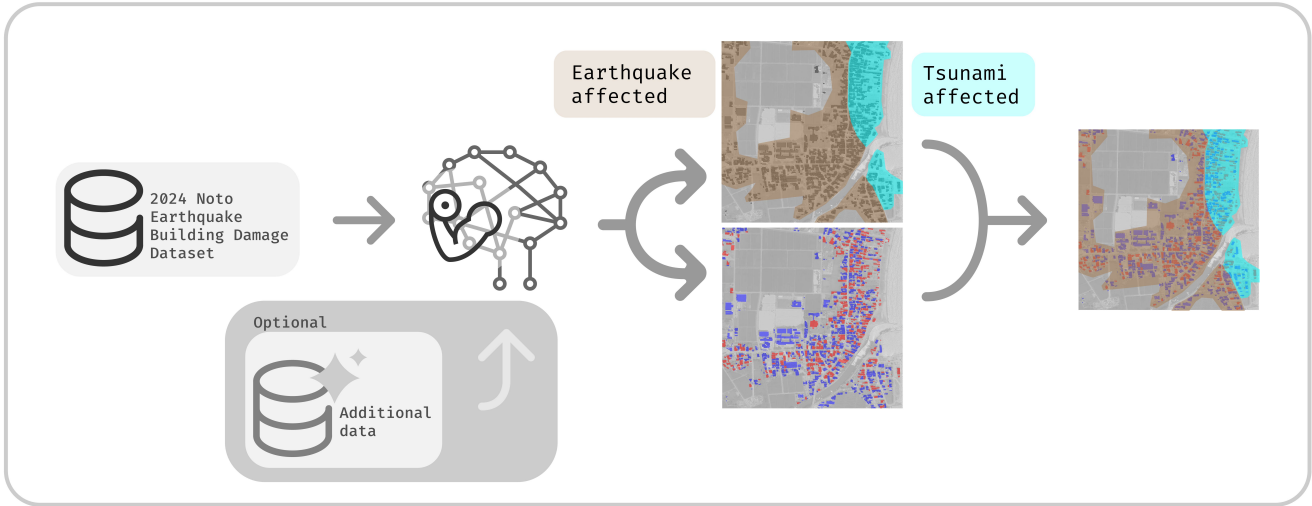
**Figure 11.** A speculative framework that might be used to investigate multi-hazard failure modes (for illustrative purposes). Basemaps courtesy of © Google 2024.
