Reply on RC2

The paper describes a comprehensive survey of sinkholes in a catchment of the Chinese Loess Plateau using UAV- and handheld LiDAR-based remote sensing. The authors report statistics on sinkhole characteristics and examine spatial statistical relationships between topographic and geomorphological factors on the one hand, and the occurrence of sinkholes on the other. The three-dimensional measurement of sinkhole volumes allows for much more accurate estimates of soil loss than simplified geometric methods. The research objective is clearly defined, the methodology is appropriate, and the results are reproducible. The figures are generally informative and well-designed, aside from minor errors (see below). Results and discussion expand the knowledge of sinkholes in loess deposits, and open sharing of the collected field data allows for scientific reuse. The submitted data is complete and supplied in accessible formats.

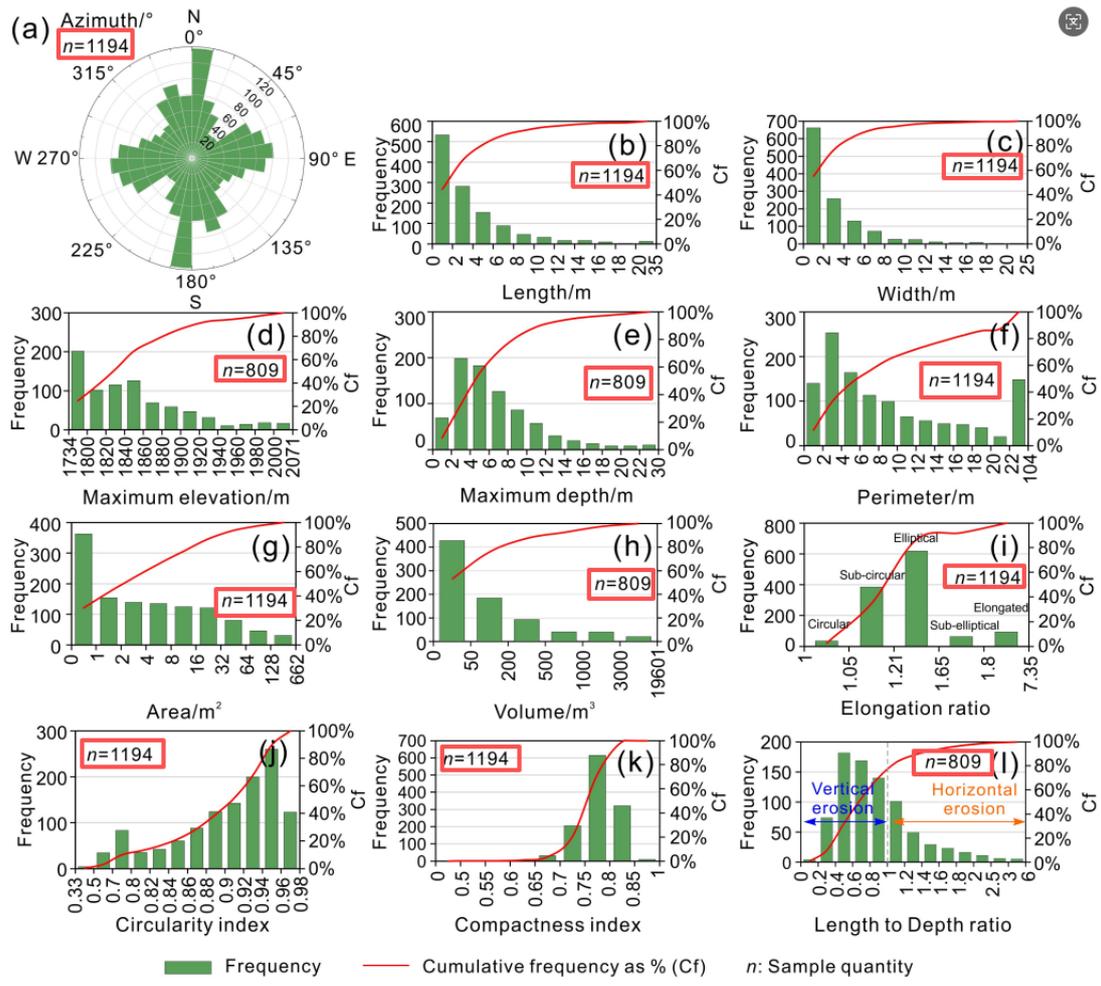
Here below we analyze the spatial and morphometric parameters computed for the 1194 inventoried sinkholes (1162 single, 32 compound), their frequency-size distribution (Fig. 9), as well as some spatial patterns based on the distribution of different value ranges (Fig. 10). It should be noted that the airborne LiDAR returned sparse and limited point clouds when detecting sinkholes with diameters less than 1 m. When calculating parameters related to sinkhole depth and volume (e.g., Maximum Elevation, Maximum Depth, Volume, and Length-to-Depth Ratio), we retained only 809 sinkholes with diameters ≥ 1 m.

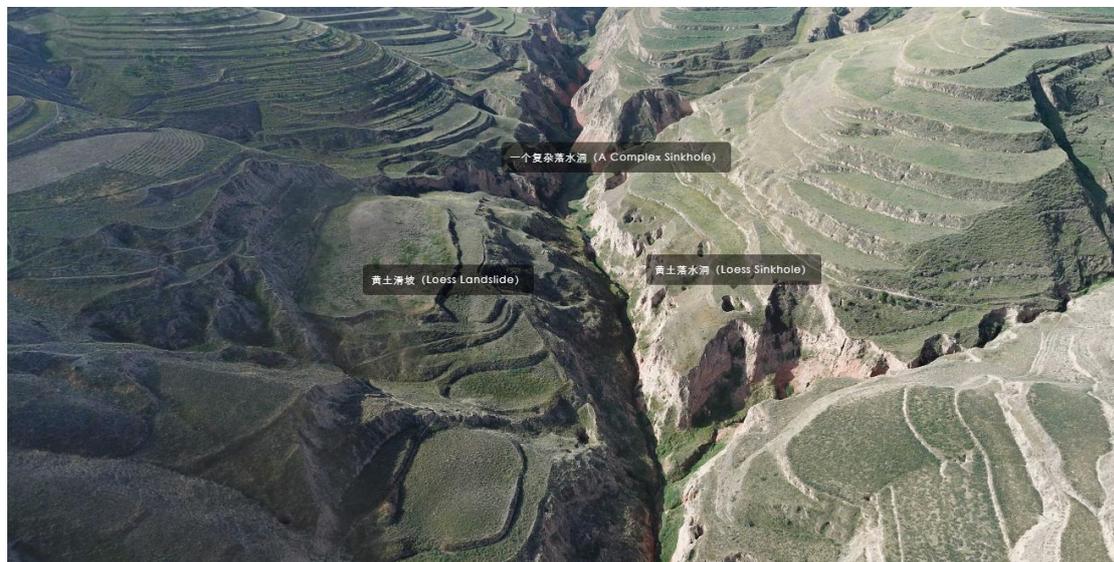
Interestingly, most sinkholes examined in the field display dominant vertical development, while this particular sinkhole exhibits a complex three-dimensional morphology comprising a vertical shaft connected to a subhorizontal pipe. The upper shaft-like portion of the sinkhole (20 m length \times 14 m width \times 20.1 m depth) is situated in loess deposits, while the lower portion (14 m length \times 3.2 m width \times 5.4 m height) is a gently inclined ellipsoidal conduit carved into horizontally bedded and jointed reddish sandstone. This lower conduit ends at the sinkhole outlet perched 8 m above the valley floor (Fig. 14a). However, it is regrettable that due to the lack of precise chronological evidence, we are unable to determine whether the initial development of this sinkhole predates or postdates the valley incision. We interpret that the development of this complex sinkhole started as a backward propagating conduit at the foot of the slope, associated with a seepage outlet point controlled by joints in the loess cover and the bedrock (Figs. 14d-h). Eventually, the enlarging conduit reached a sufficiently large span to initiate upward roof collapse, ultimately originating the sinkhole. At present, five distinct ceiling cupolas can be clearly observed at the top of this pipe (Figs. 14b, c and i), indicating sites of upward roof propagation (stoping).

Additionally, we observed a significant accumulation of horizontally stratified flood deposits resting atop the aeolian loess on the fluvial strath terrace (Fig. 14a). The interior of the sinkhole is relatively cool and damp, with the bottom underlain by collapsed soil. We found remnants of past flash-flood or debris-flow deposits on the sinkhole floor, as well as on the walls and outlet ceiling of the connected lateral pipe (Figs. 14d, f, j). These sediments may include: (1) Horizontally bedded deposits

accumulated during floods in the drainage, with a stage high enough to cause the penetration of flood waters into the sinkhole outlet (backflooding); (2) Massive to poorly stratified deposits derived from collapse and mass wasting processes acting primarily in the pipe roof and sinkholes margins, respectively. It should be particularly noted that the largest loess landslide in this basin occurred on the opposite bank of this sinkhole. Based on field investigations, we believe that this landslide completely blocked the paleo-channel at that time, forming a small-scale dammed lake, and the landslide deposits and lacustrine sediments could easily enter the interior of the sinkhole through lateral pipe.

l 520f: The authors state that the piping developed at a former footslope position, which implies it formed on the elevation of the then-active main channel. Subsequently, the channel incised as a result of uplift, such that the sinkhole is now situated at an elevation of approximately 8 m above the present channel level. I am surprised, however, that the massive landslide on the opposite slope is not considered in this interpretation. As illustrated in Fig. 14a, the toe of the landslide is being undercut, indicating that the river continues to erode its deposits. Progressive reworking of the landslide-derived valley fill, and the associated temporary damming of the channel, could also account for the backflood deposits within the pipe (l. 535) as well as the stratified flood deposits observed on the fluvial terrace (l. 529). This implies a much younger age of the piping and sinkhole formation than the one suggested by valley incision.

sinkhole formed prior to river incision. Therefore, I feel that our previous inference may not have been sufficiently rigorous. Upon reviewing the field photos we took, I found that the giant landslide on the opposite bank of this sinkhole did completely block the river channel at that time, which could have led to landslide or dammed-lake sediments entering this sinkhole. I fully agree with your interpretation. We have revised this part of the discussion accordingly.

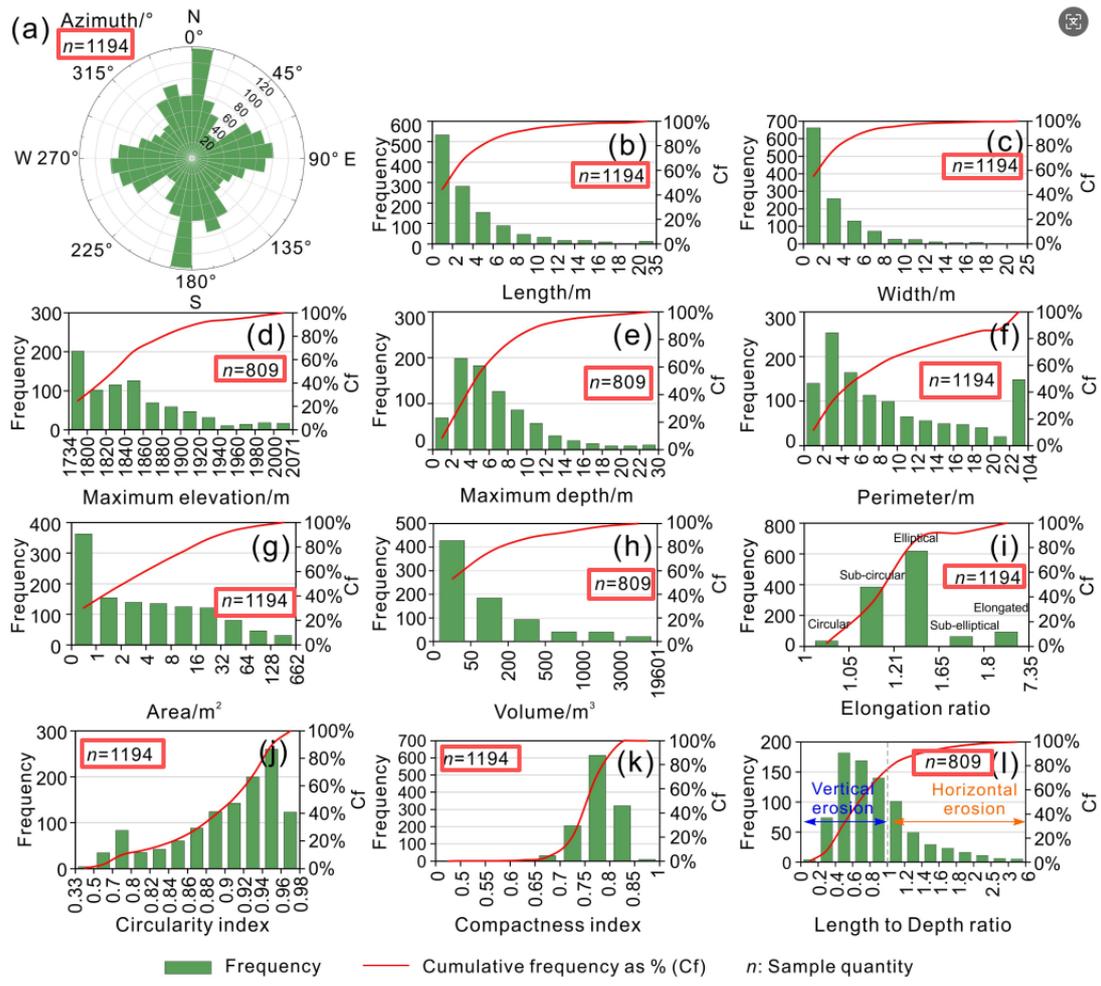
Here below we analyze the spatial and morphometric parameters computed for the 1194 inventoried sinkholes (1162 single, 32 compound), their frequency-size distribution

(Fig. 9), as well as some spatial patterns based on the distribution of different value ranges (Fig. 10). It should be noted that the airborne LiDAR returned sparse and limited point clouds when detecting sinkholes with diameters less than 1 m. When calculating parameters related to sinkhole depth and volume (e.g., Maximum Elevation, Maximum Depth, Volume, and Length-to-Depth Ratio), we retained only 809 sinkholes with diameters ≥ 1 m.
